Tree Assessment

Port of Port Townsend
Port Townsend Brewery building & State Hwy 20

March 11, 2013

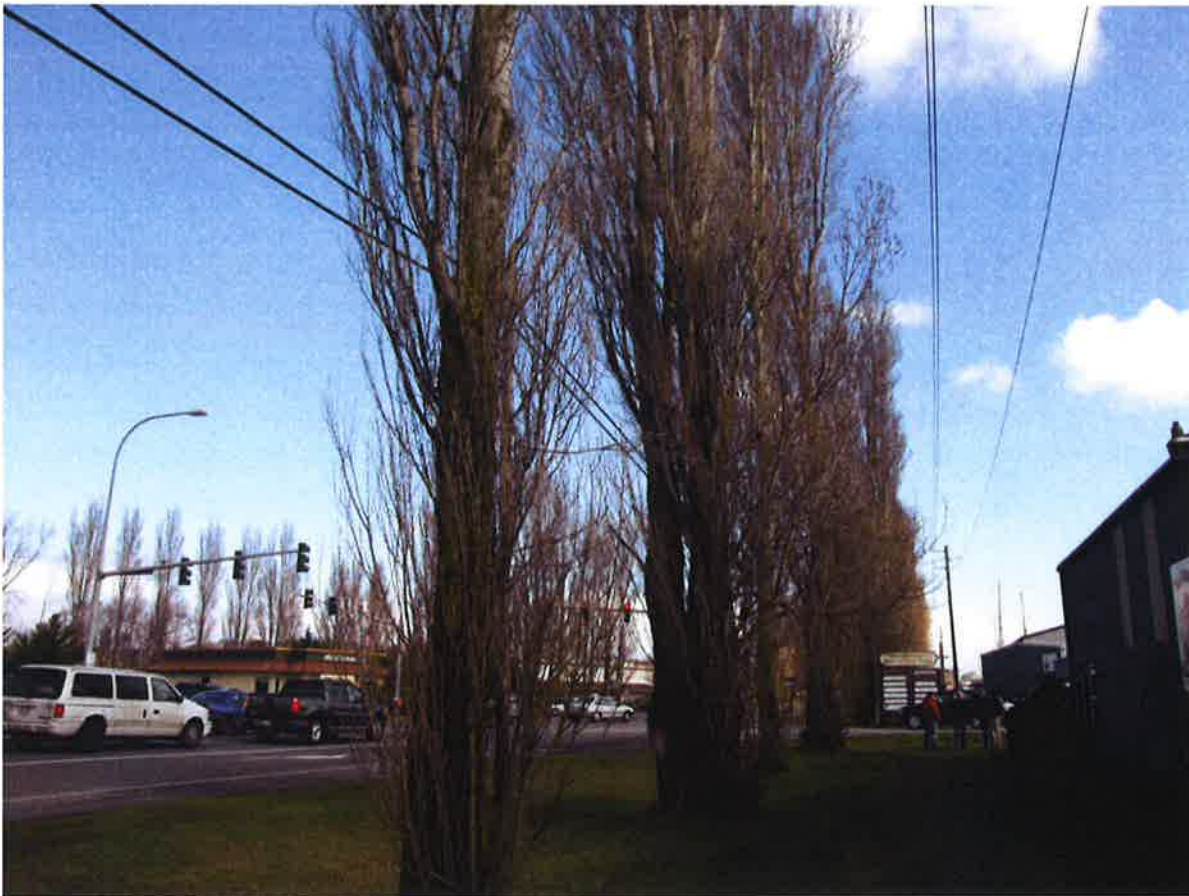
All five Poplars range between 15 and 30 inches in diameter and reach upwards of seventy feet tall. They grow between the Port Townsend Brewery building and State Highway 20 on the north side of the brewery building ([Photo 1](#)). Based on historic aerial photographs viewed by Larry Crockett, they are at least over 50 years old.

Photo 1: Location of the Poplars relative to the brewery building (blue) and State Hwy 20.

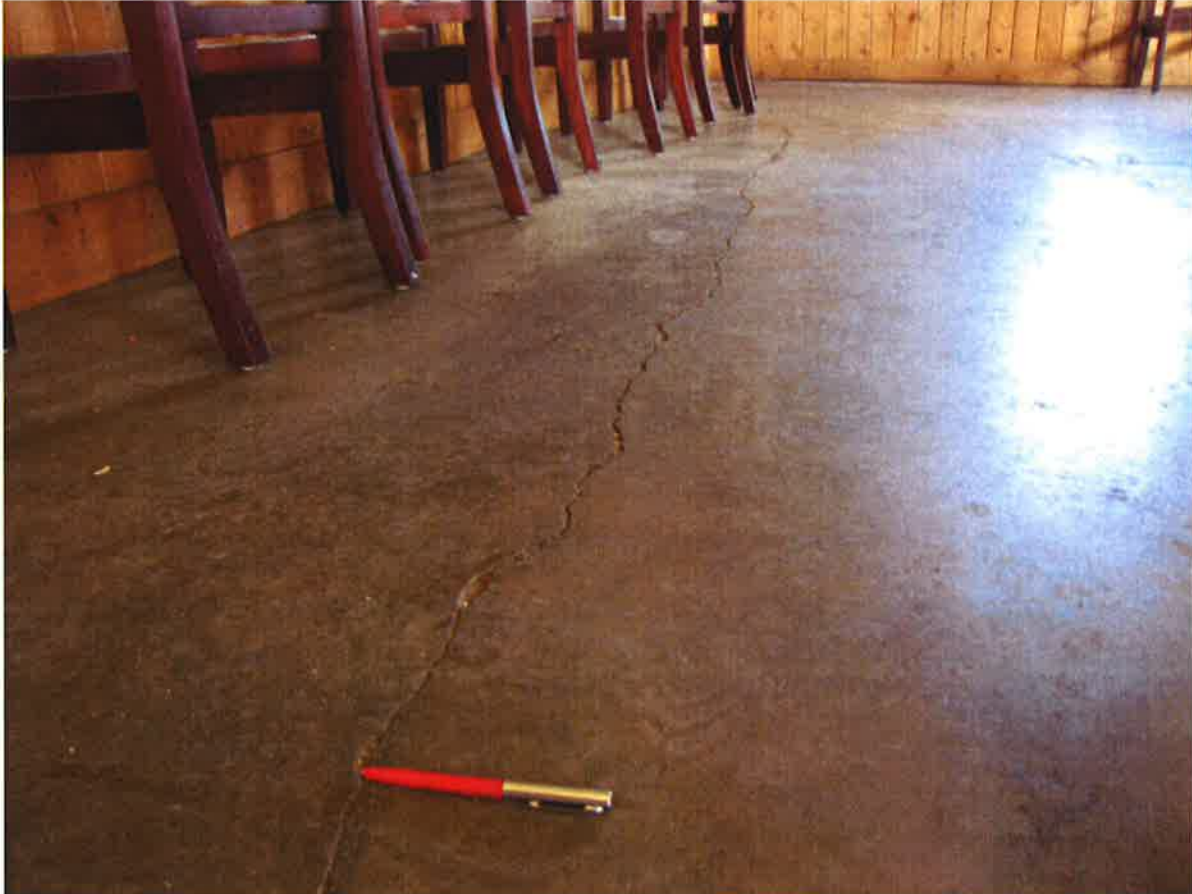
The area of the brewery building that has not been renovated has more cracks in the flooring in the main tasting room and in the bathroom. The crack in the floor of the tasting room extends north to south the entire length of the room and extends outside of the building into the asphalt (Photo 2).

I believe the damage to the brewery building flooring was caused by the Poplar tree roots. Without check, roots will likely continue to seek out the damp and cool conditions under the older concrete flooring and the existing cracks in the floors will expand.

Photo 2: Crack in the brewery's tasting room floor running north south and extending into the pavement to the south, outside the building.

- 1) Use an air spade to clear a ditch on the northern side of the building to expose roots growing toward the building. Once exposed, use a sharp tool to give the roots a clean cut edge at least six inches away from the building. Install root barrier (such as a high density polyethylene plastic sheet) along the length of the building to prevent roots from growing back underneath.
 - a. Air spading exposes roots without damaging them. This process also allows the roots to be visually documented, to help make a better estimation of how much overall root area will be removed and how this will affect a trees vigor.

- 2) Use small heavy machinery to dig a trench along the north side of the building. Once the trench is completed, cut the edge of ripped roots with a sharp tool to give the roots a clean cut. Install root barrier (such as a high density polyethylene plastic sheet) along the length of the building to prevent roots from growing back underneath.
 - a. This method is less preferred as the potential to cause root fracturing beyond the ditch edge is high and the soil around roots can become compacted by the weight of small machinery.

I strongly recommend developing a plan for removing these trees and replanting with more appropriate species. A variety of species that will not interfere long term with power lines or the building infrastructure can grow in the existing soils. If the Poplars are removed, their stumps should be ground out to prevent sucker re-growth.
