March 9, 2022

Port of Port Townsend
ATTN: Eron Berg
Executive Director
2710 Jefferson St.
Port Townsend, WA 98368

Re: Poplar Trees - Sims Way, Port of Port Townsend

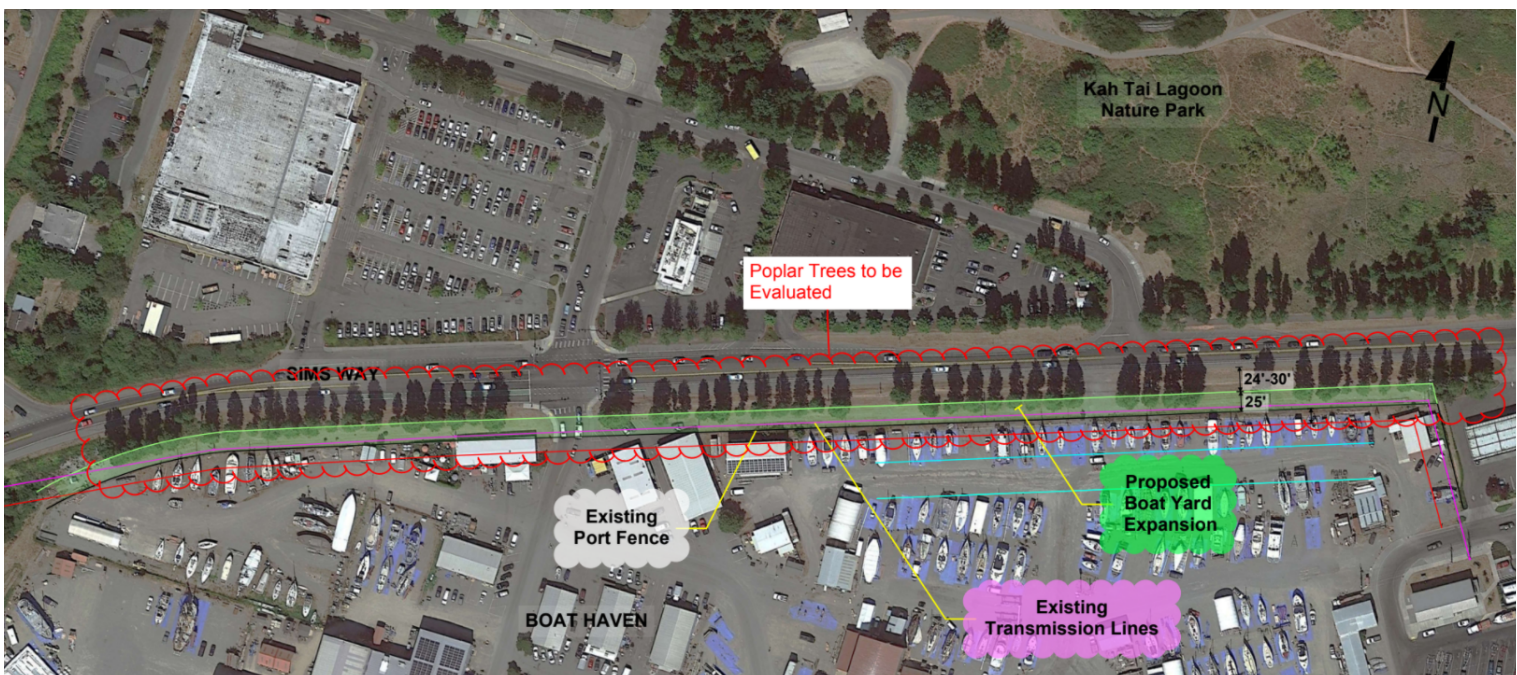
Map 1

During this meeting we discussed the desire by PUD to underground transmission lines that currently stand south of the row of trees, and the desire of the Port to expand their boatyard property north to incorporate currently undeveloped land south of the trees. These areas and the trees are shown in [Map 1](#).
