**Re: Geology Hazard Assessment**

Jefferson County Parcels 001034001, 001034002, 001034038, 001034039, 001034040  
and 00103041  
Discovery Road and San Juan Avenue  
Port Townsend, Washington

**Geology Hazard Assessment**

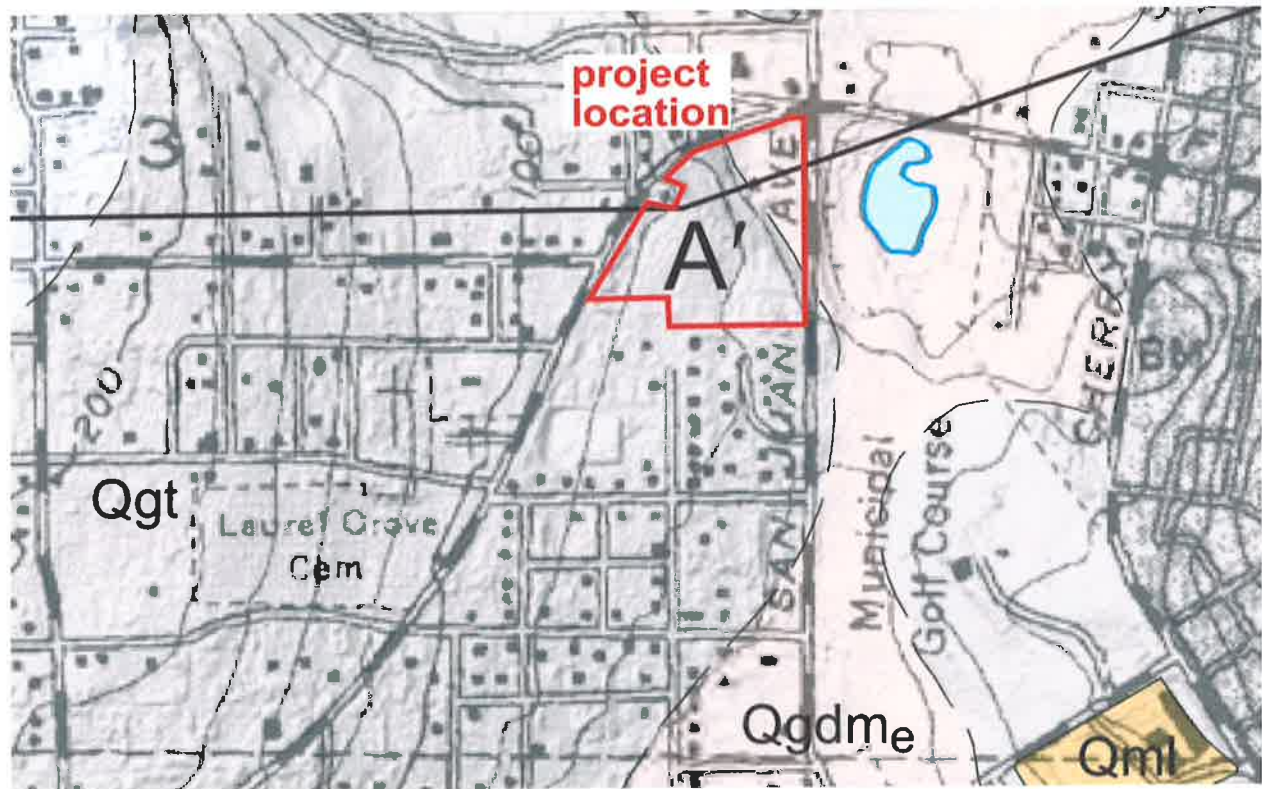
The *Geologic Map of the Port Townsend South and Part of the Port Townsend North 7.5-minute Quadrangles, Jefferson County, Washington* (Schasse and Slaughter, 2005) indicates that the subject property and vicinity are located in an area underlain by glacial till and glacial marine drift (Figure 1).

**Figure 1.** Annotated geologic map (Schasse and Slaughter, 2005) showing the subject property location. Qgt = Vashon till, Qgdm<sub>e</sub> = Everson Glaciomarine Drift, Qml = modified land.

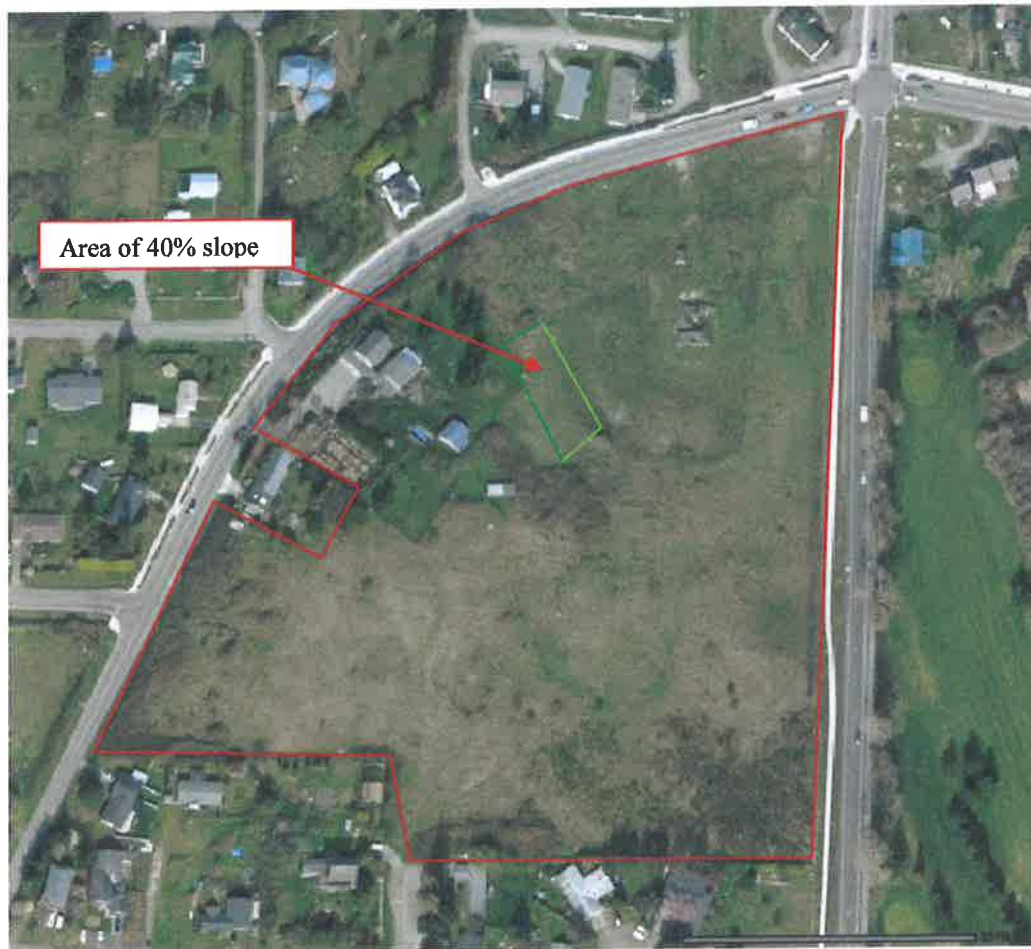
**Figure 2. Aerial view of site (Jefferson County GIS, 2012)**

Slopes on site are mostly gentle with moderate undulations. The steepest slope area is located on the north central portion of the site. This slope is approximately 40 percent with a height of approximately 8 feet. Based on the lidar imagery of the site, this slope appears to have been the result of some minor soil mining or grading. This observation is consistent with top soils in this area being very thin.

Property is outlined in red.

Green outline is area of 40 percent slope. Note 40 percent slope area is less than 10 feet in height.

A limited area of 40 percent slope is present on the north central portion of the site. However, this limited 40 percent slope area is less than 10 feet in height. Slopes were measured via clinometer, tape, and pace. Short areas of road cut by Discovery Road at the northwest edge of the site and San Juan at the southeast edge of the site are greater than 40 percent, but are less than 10 feet in height.
