# Northwest Maritime Center Coastal Geologic Report – Revised

Project Number: 20-001

Prepared for Miller Hull Partnership, LLP

August 21, 2023

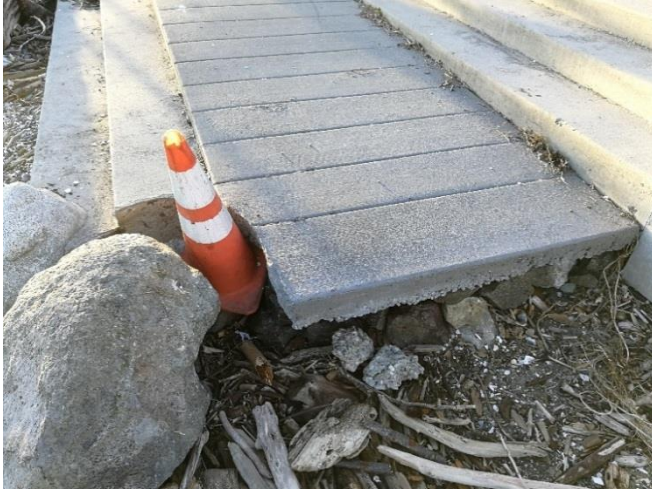
- ◆ Upper beach erosion and toe scour with exposure and loss of foundation base rocks at the northeast end of the concrete pathway at North Beach, which provides wheelchair beach access (Photo Page: photos A and B).
- ◆ Toe line scour and base exposure along the toe of the concrete stairway leading to the North Beach (Photo Page: C). Similar toe line scour at the South Beach leading to the paved concrete boat ramp.

A. Concrete pathway for wheelchair and beach access

- a. Excavate toe sand at the concrete foundation.
- b. Form a new concrete step/footing at the base of the existing footing.
- c. Deepen and widen the foundation toe line and fill the voids under the exposed parts of the concrete foundation with quarry spalls to avoid re-exposure of the foundation.

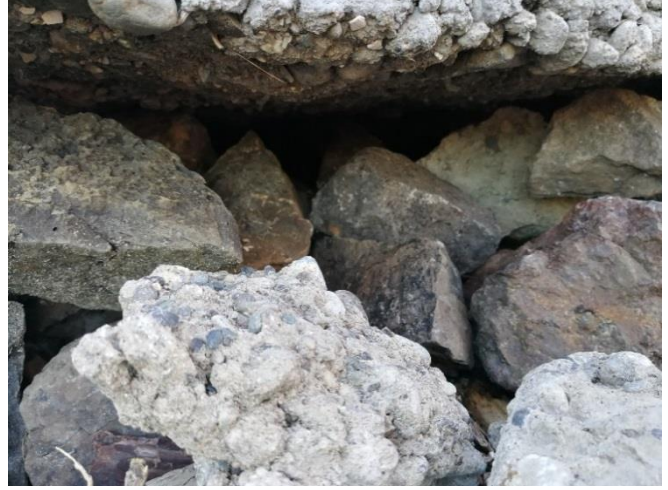
B. Foundation rocks underlying concrete pathway

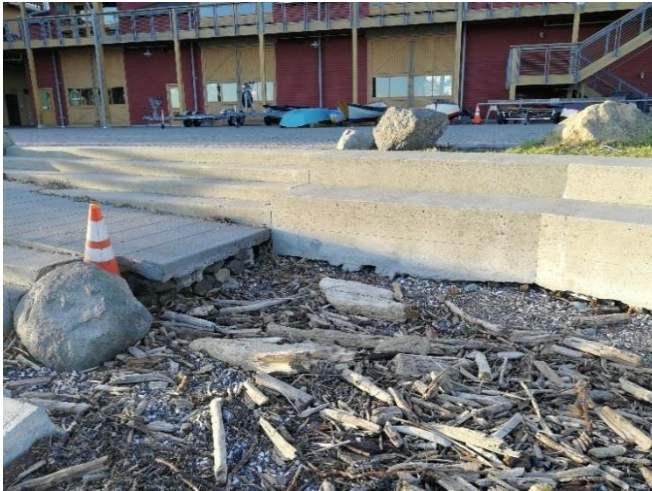
C. Scour and exposed base of concrete stairs

- a. Remove existing scattered boulders from the beach surface.
- b. Excavate sand at and the edge of the concrete.
- c. Add concrete footing below existing paving.

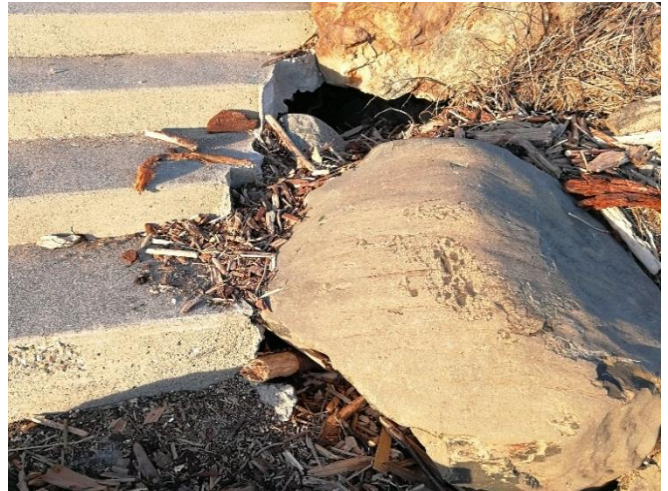
- ◆ Decorative landscaping boulders that had previously been integrated into the concrete structure were undermined and displaced due to toe scour beneath the boulders (Photo Page: D).

D. Displaced landscaping boulder and voids

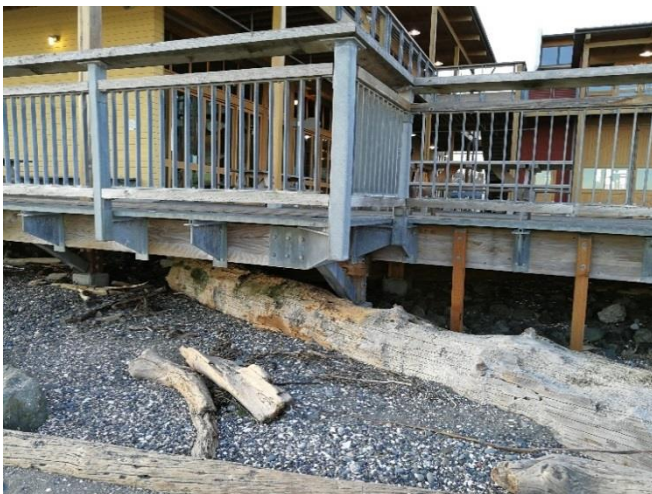
- ◆ At least one large log (we understand some were removed prior to 2018) that had been originally installed and anchored at the upper beach had been displaced. One approximately 40 FT-long log was found partially stuck under the porch deck. Evidence of impact and abrasion between the log and the metal truss (deck supporting member) was evident. Other large and small logs and wood pieces were scattered on the upper beach/backshore (Photo Page: E)

E. Displaced large logs from backshore beach

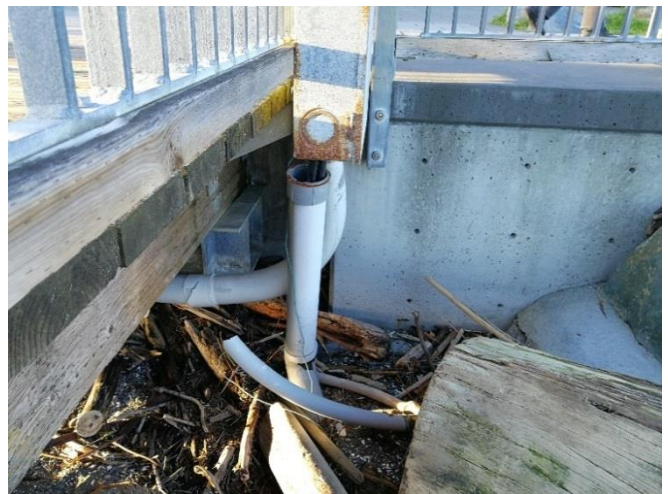
- ◆ The electric box and wire conduit (HDPE pipes) at the shore end of the pier on the North Beach side were broken and deformed, apparently damaged by debris impact during the storm (Photo Page: F).

F. Damaged electrical box and HDPE wire conduit

- a. Protect Utility (water) pipes and supporting structural members beneath the porch deck, as well as the electric wire conduits beneath the pier.
- b. Place quarry spall 9-21" below grade.
- c. Place large boulders scattered and in groups on beach grade.

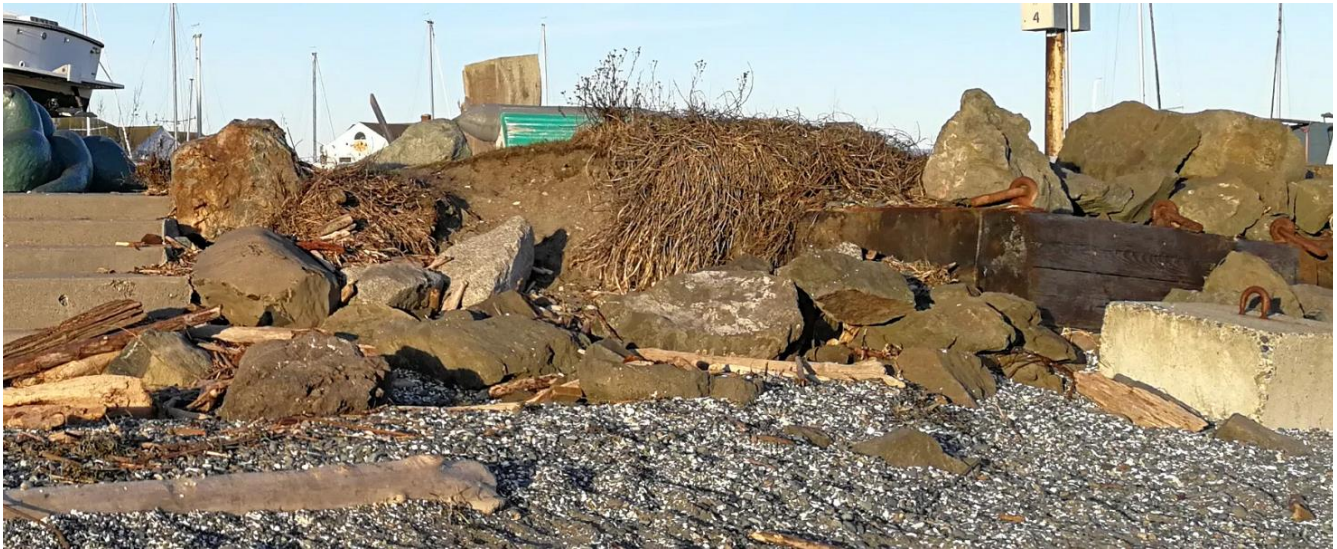
- ◆ The low elevation bank at the north end of the concrete stairway was under-protected. Earth material was exposed with signs of recent bank erosion and collapsing, requiring urgent rock repair/enhancement (Photo Page: G). Insufficient crest elevation of the existing revetment had reportedly resulted in a large volume of seawater overtopping during the storm.

G. Under-protected and eroded bank northeast of concrete stairway from 12/20/18 storm event at the project area.

- a. Place quarry spall 9-21" below grade.
- b. Place large boulders scattered and in groups on beach grade.

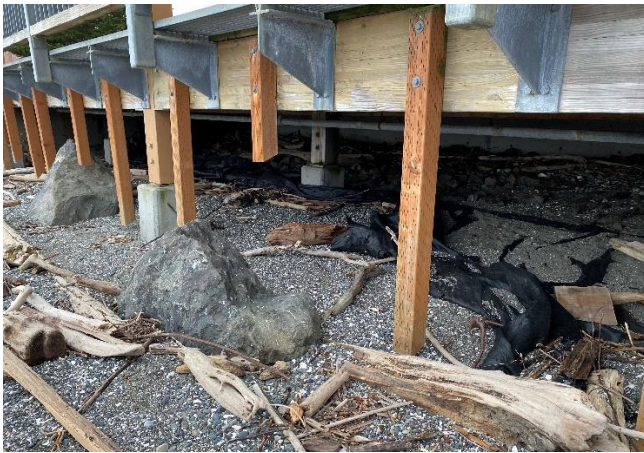
H. Damage and debris under deck after 1/13/21 storm.

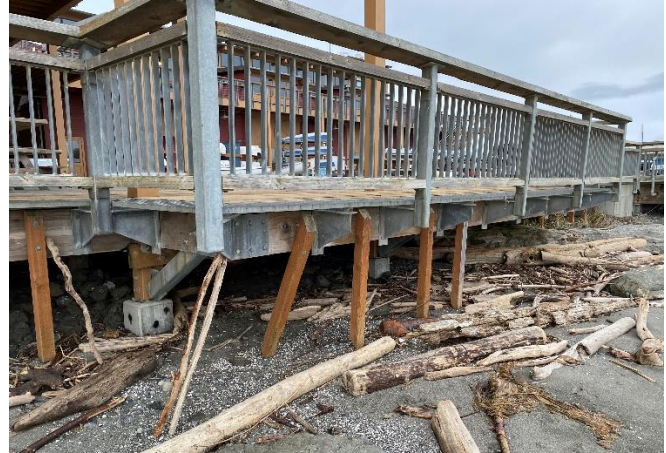
I. Damage and debris under deck after 1/13/21 storm.

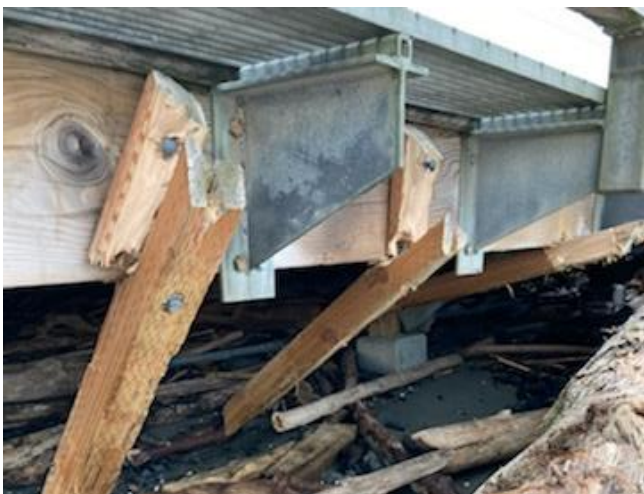
J. Damage and debris under deck after 1/7/22 storm.

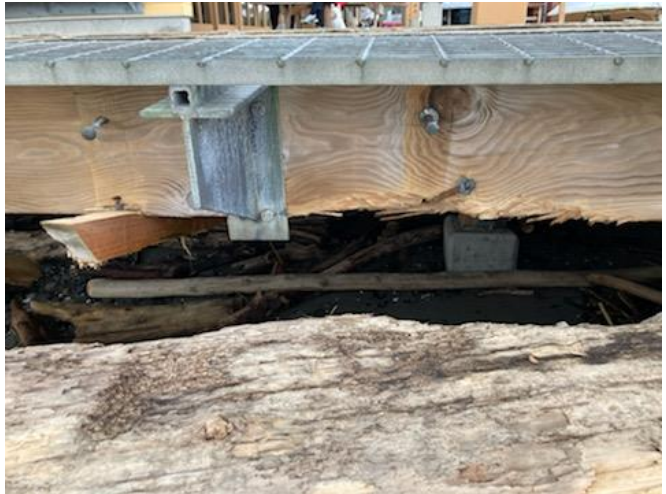
K. Damage and debris under deck after 1/7/22 storm.
