2020 Periodic Inspection Report

*Lords Lake North Dam and East Dam
Jefferson County, Washington*

August 2020

DSO Files JE17-0243 & JE17-0357

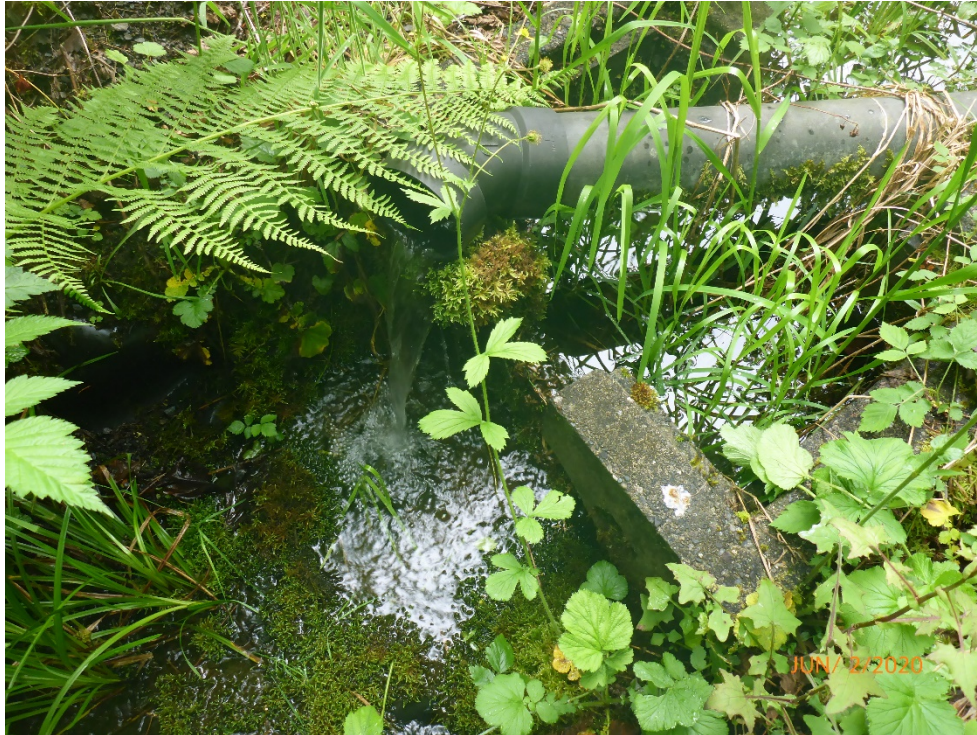
The toe drain outlet was visually inspected and the water appeared clear, with no sediment noted. Some minor amount of vegetation growth was observed around the toe drain and concrete weir box (see Photos 1 and compare to Photo 2). It is required to clear all vegetation from this area to ensure that the vegetation does not hamper inspection or operation of the drain and weir; remove sediment accumulated in the weir concrete box; and, similar to the toe drain, periodically monitor flow volume and characteristics on the weir.

Photo 1: Weir and drain pipe at downstream toe area of North Dam.

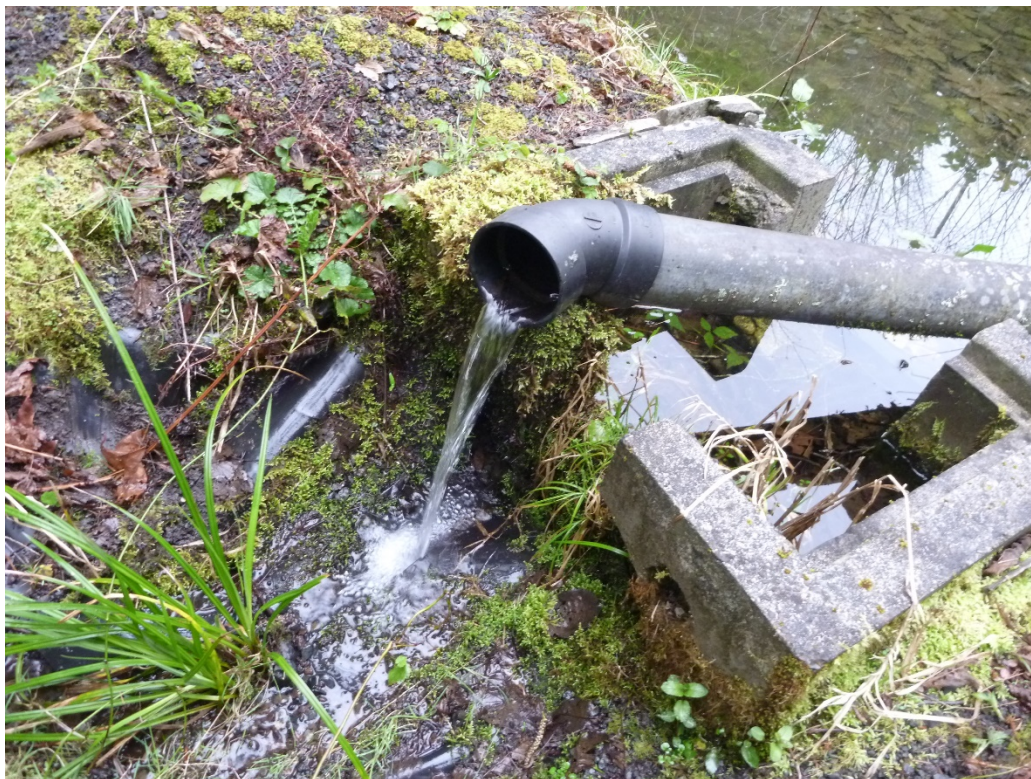
Photo 2: Weir and drain pipe at downstream toe area of North Dam during 2015 DSO inspection.

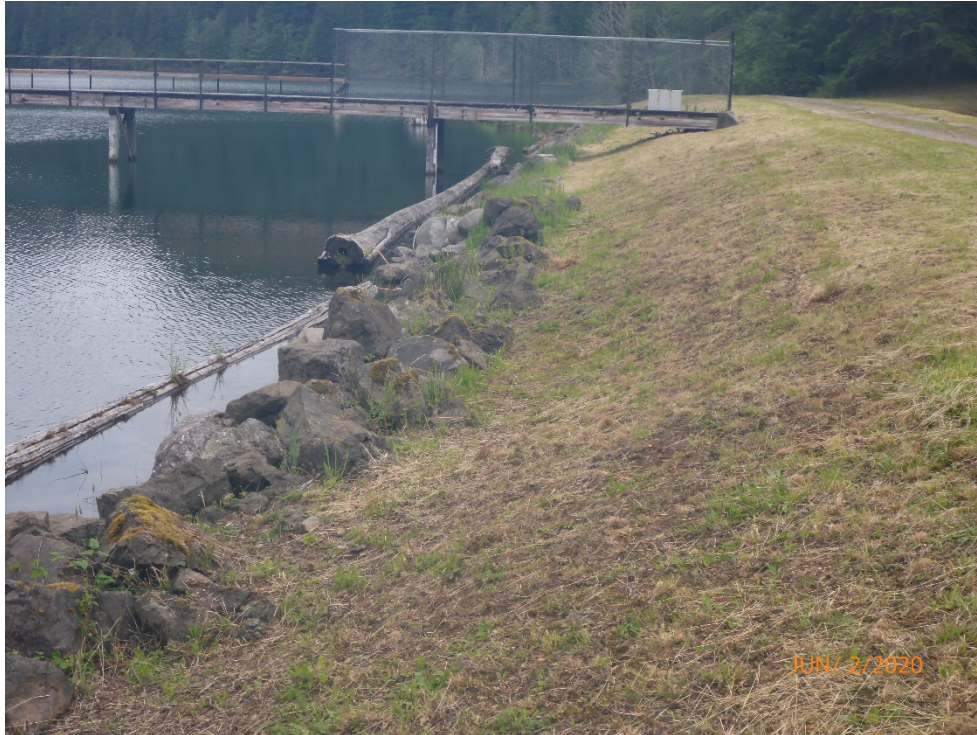
At the time of the inspection, the upper 6.5 feet of the upstream slope was above water. A layer of riprap appears to provide adequate erosion protection (see Photo 3). However, based on photos taken circa 1999 when the reservoir was lowered (see Photo 4), it appears that the riprap layer does not cover the entire upstream slope. No signs of slumping, cracks or uneven settlement were apparent along the section of the upstream slope above the water line.

Photo 3: Upstream slope at East Dam.

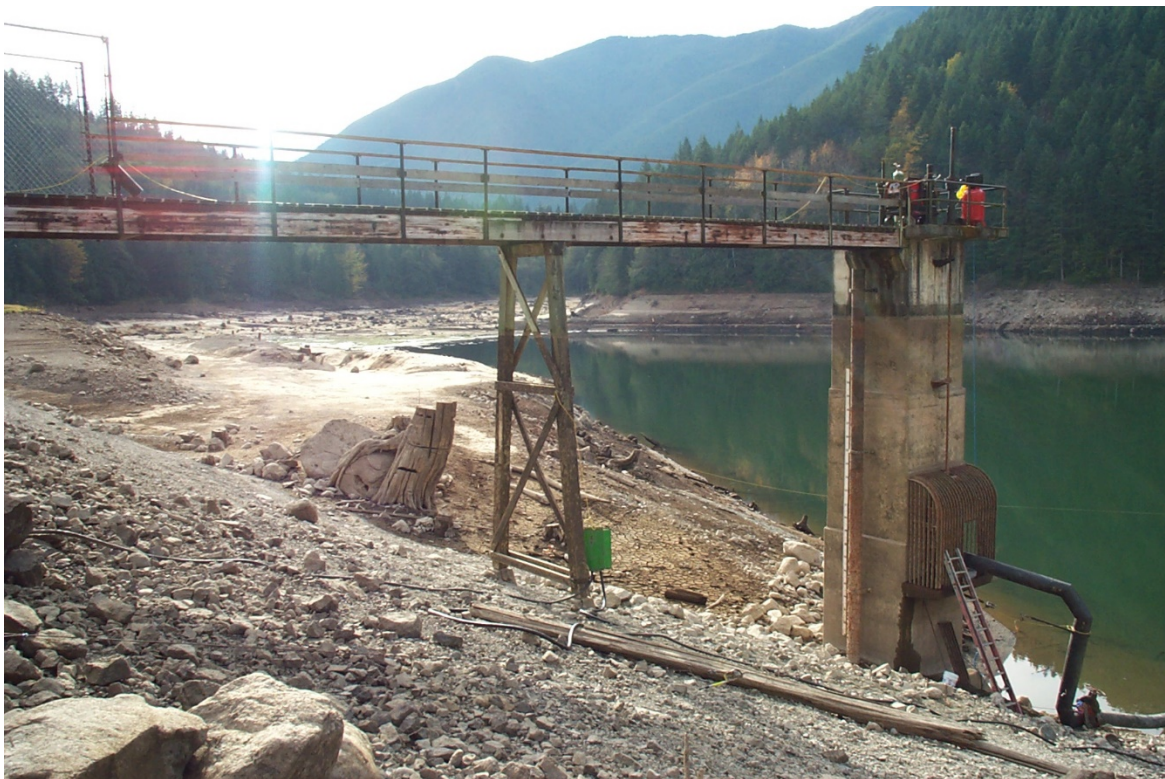
Photo 4: Upstream slope at East Dam (October 2002).

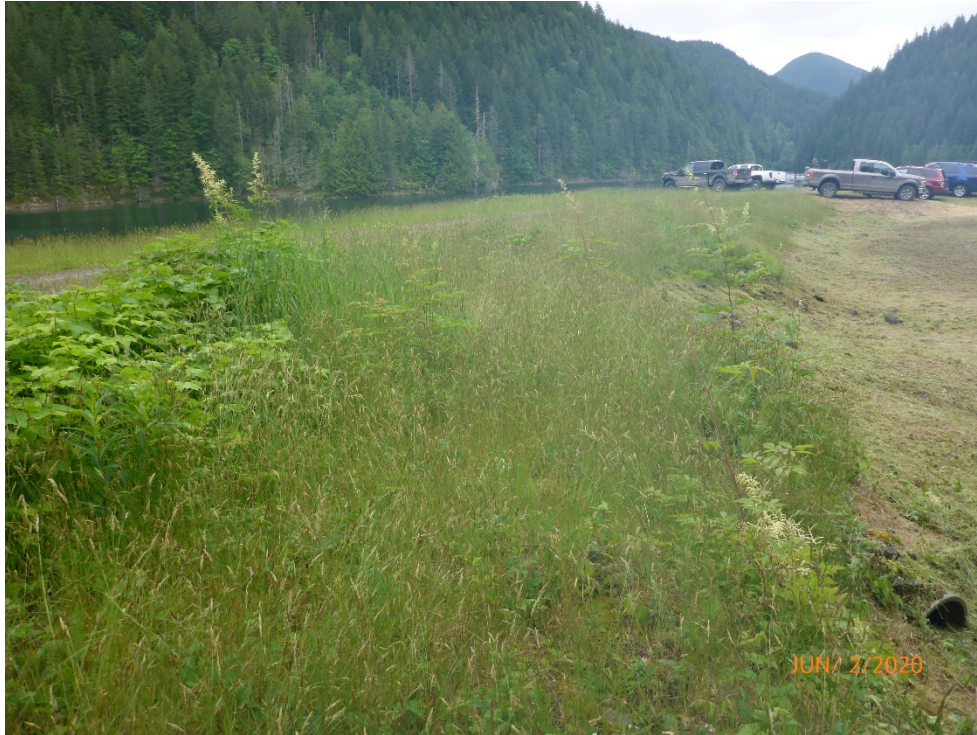
Our examination of the downstream slope revealed that there were no signs of slumping, settlement, cracking, or seepage. The only maintenance deficiency observed was some vegetation at the saddle embankment section (see Photo 5). However, this vegetation was promptly removed after the inspection (see Photo 6 provided by CPT).

Photo 5: Southern saddle section of East Dam.

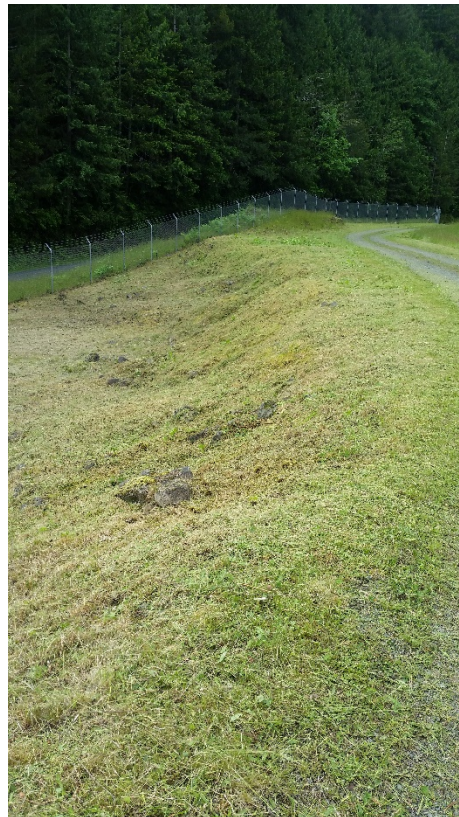
Photo 6: Southern saddle section of East Dam cleared of vegetation after inspection.

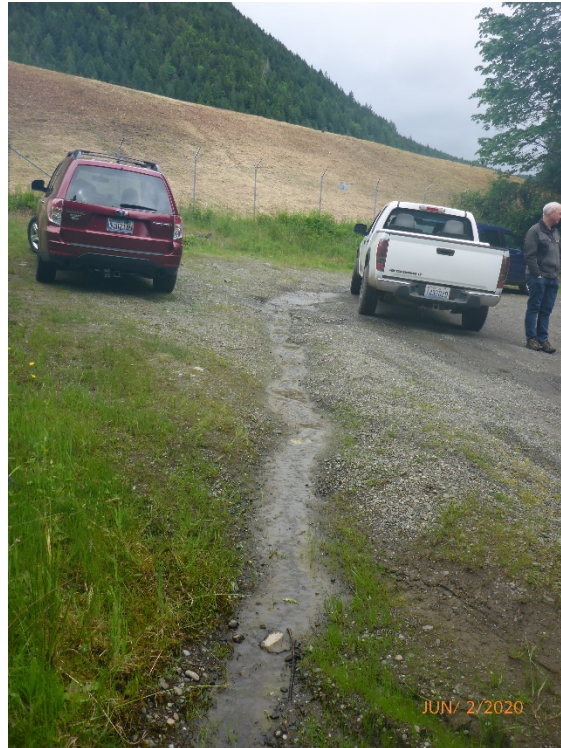
Similar to prior inspections of the dam, a seepage area was observed on the downstream toe foundation area of the East Dam (see Photo 7). The source of the water is probably from seepage through the dam and/or foundation soils. This area should be periodically monitored to determine if there are any significant changes on the amount of water and/or if signs of increased seepage such as bubbles or dirty water flow are present. In the event of any changes, the DSO should be notified as soon as possible to evaluate the situation.

Photo 7: Seepage area on downstream foundation area at East Dam.

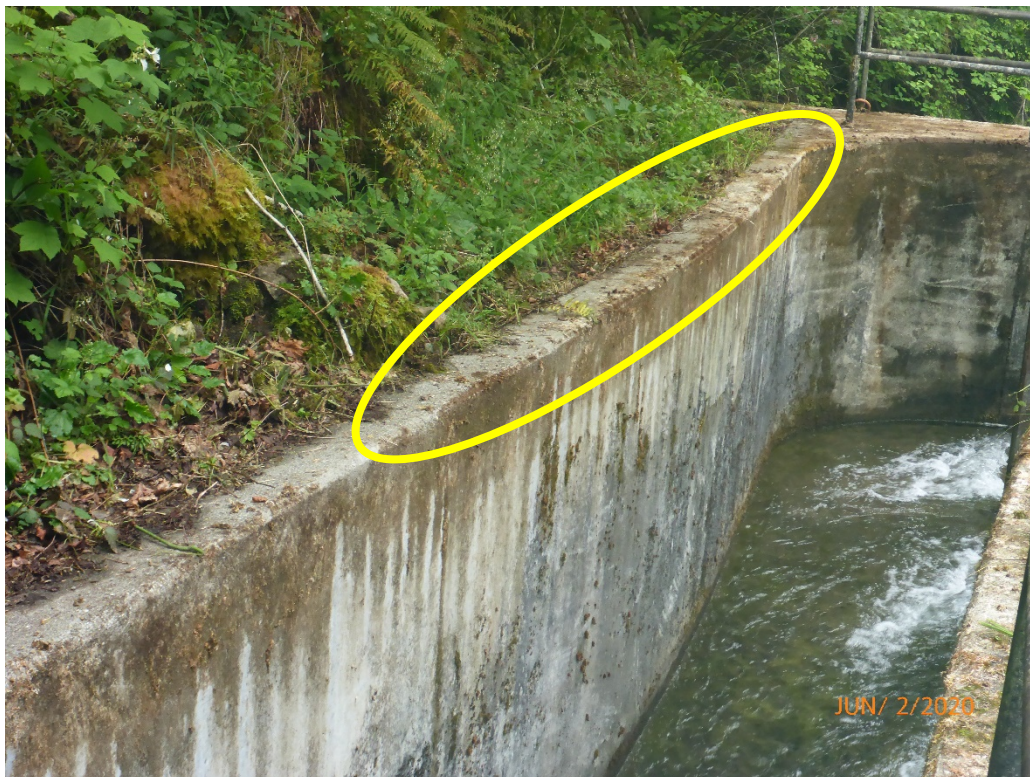
Removal of the moss layer allowed us to visually inspect the concrete sidewall along the eastern side (i.e., along the toe of the hillside) of the spillway channel. It was observed that the section of wall at the crest of the dam showed a slight curvature at its upper section (see Photo 8). The original plans show a straight alignment along the wall. However, there were no obvious signs of cracking on the wall that may indicate the wall has moved due to forces induced by the soils against it. Further, it is not known if the current shape of the wall is the as-built geometry.

Photo 8: View of spillway at entrance channel. Concave area highlighted.

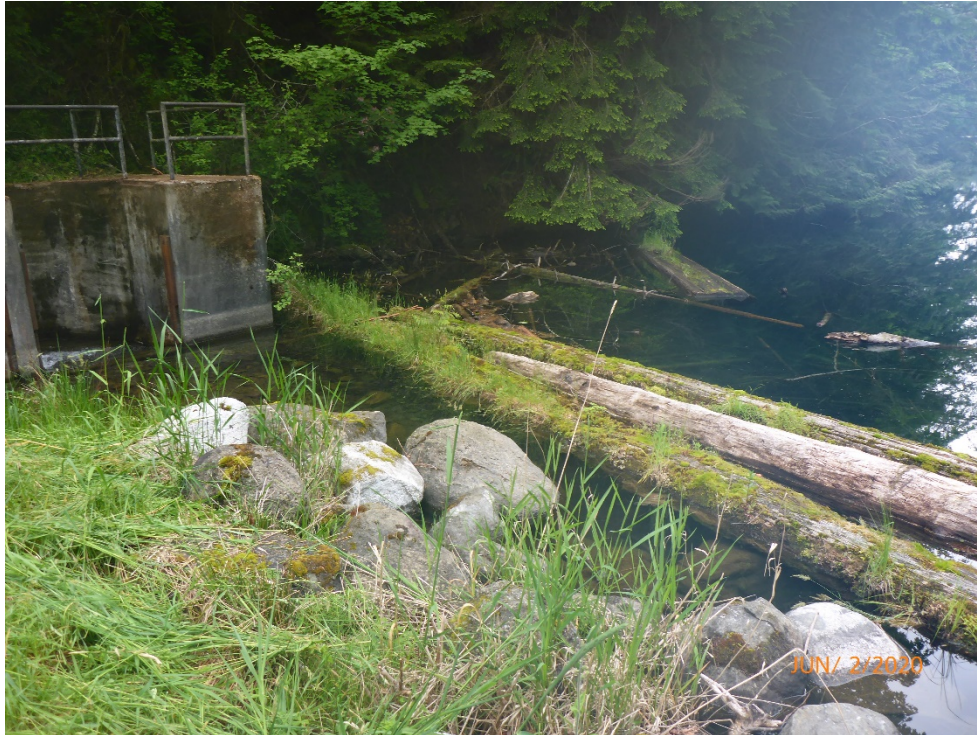
As noted during prior inspections of the dam, a small accumulation of floating debris against the log boom was observed (see Photo 9). It is required that any debris be periodically removed to ensure the spillway will perform as designed.

Photo 9: Spillway entrance channel at North Dam.

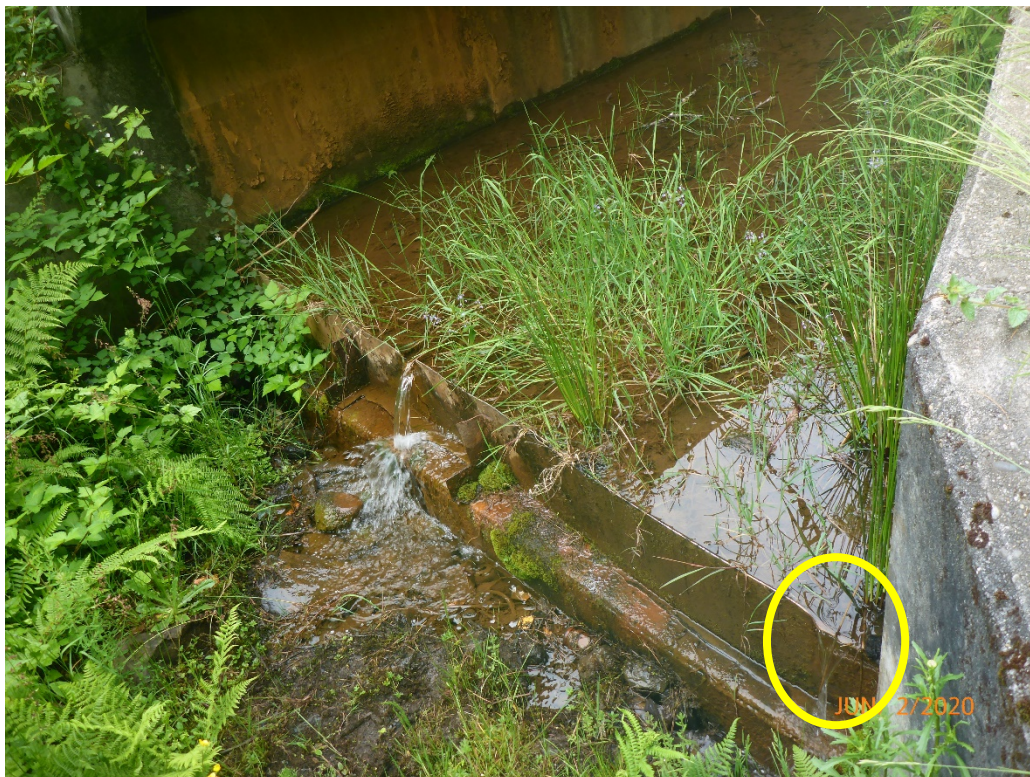
A visual inspection of the v-notch weir at the East Dam indicated that the flow appear clear, i.e., it did not appear to be carrying fines. It was observed that the weir has suffered some damage, likely from vandalism (see highlighted area on Photo 10). This damage should be repaired as soon as possible to ensure the entire seepage flow is measured.

Photo 10: V-notch weir at seepage measurement point number 1. Damage section highlighted.
