REPORT OF  
ENGINEERING CONTROL OF COMPACTED FILL  
TWO EARTH DAMS  
LORD'S LAKE DEVELOPMENT  
JEFFERSON COUNTY, WASHINGTON  
for the  
CROWN ZELLERBACH CORPORATION

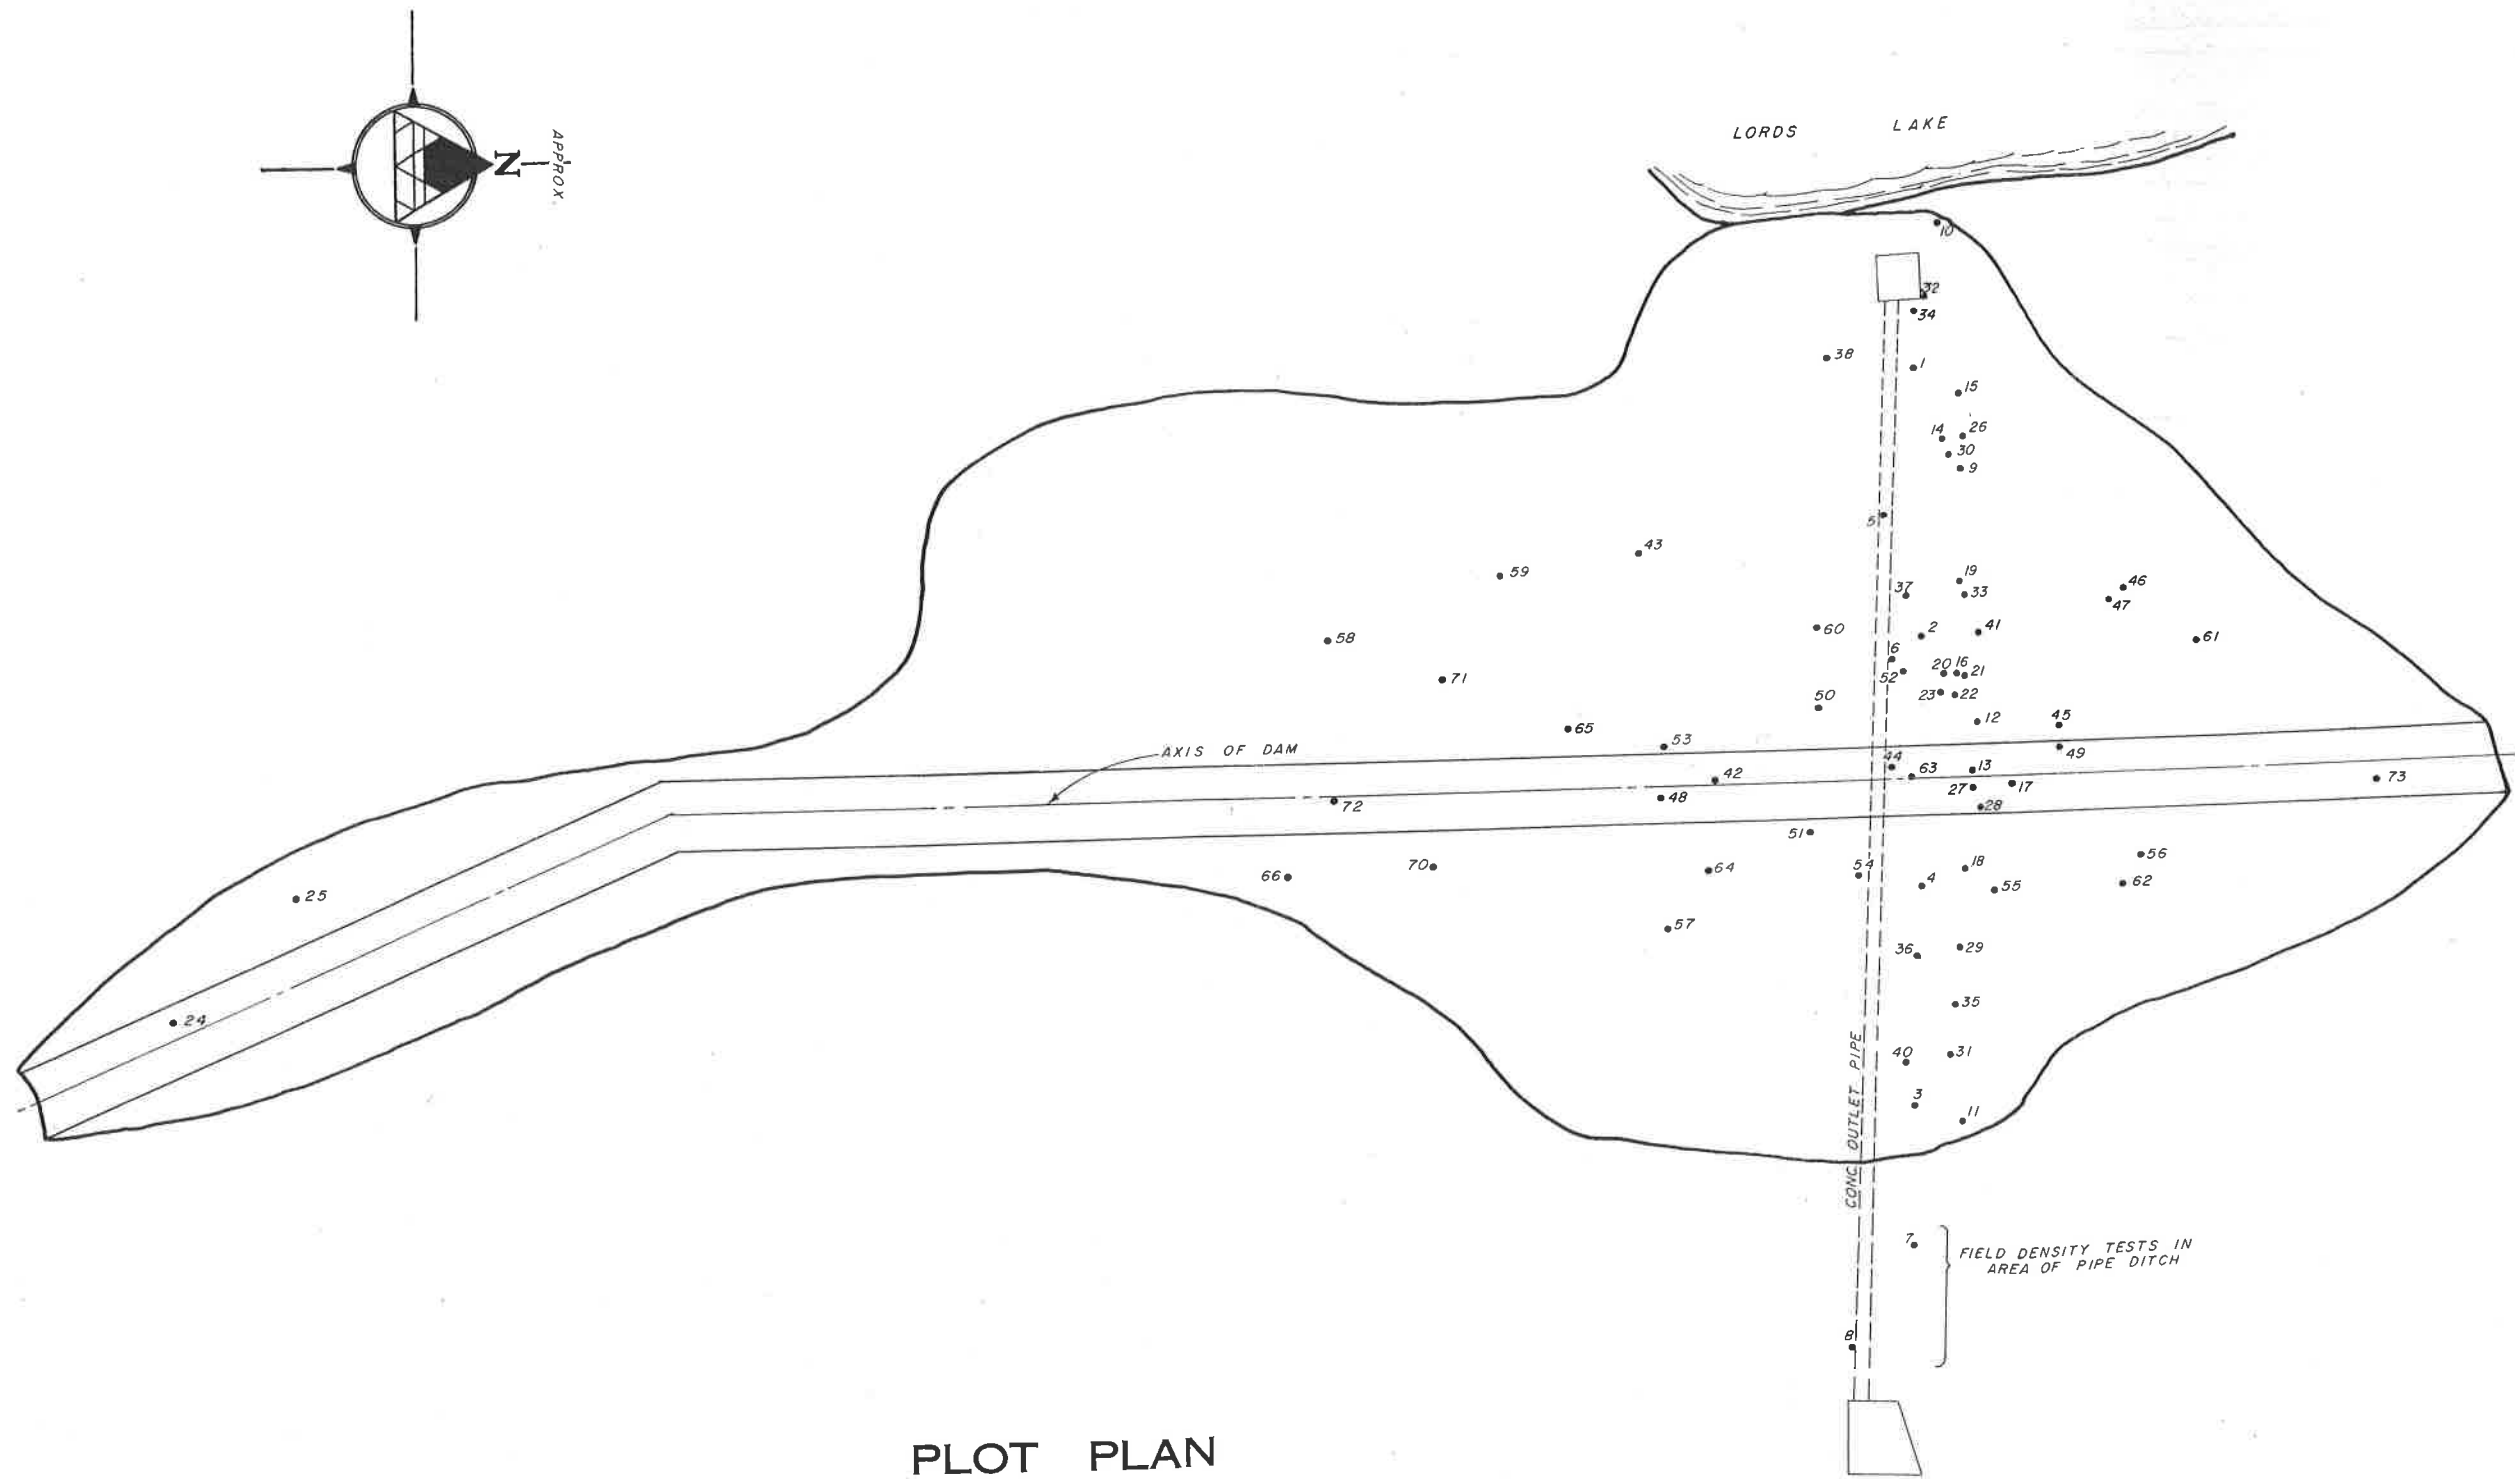
PLOT PLAN  
EAST DAM

During the placing of the compacted fill in the East Dam, 70 field density tests were performed to determine the moisture content and degree of compaction being obtained. The results of these tests are tabulated in Table II, Field Density Test Data, East Dam. The percent compaction obtained, based on a comparison of the dry density of the soil as determined by the field density test and the maximum dry density of the same soil as determined by the compaction test is shown on the table for each test. For those tests containing gravel, corrections were made to take into account the effect of the gravel

on the density. Where tests indicated compaction of less than 90 per cent of maximum dry density, the fill received additional compaction, or was removed and replaced with adequately compacted material.

Placement of the compacted fill for the East Dam was completed on approximately October 19, 1956. A final inspection of the fill was made on November 6, 1956. The results of the field density tests and observations by our field engineer indicate that the fill has been placed satisfactorily and in accordance with the specifications.

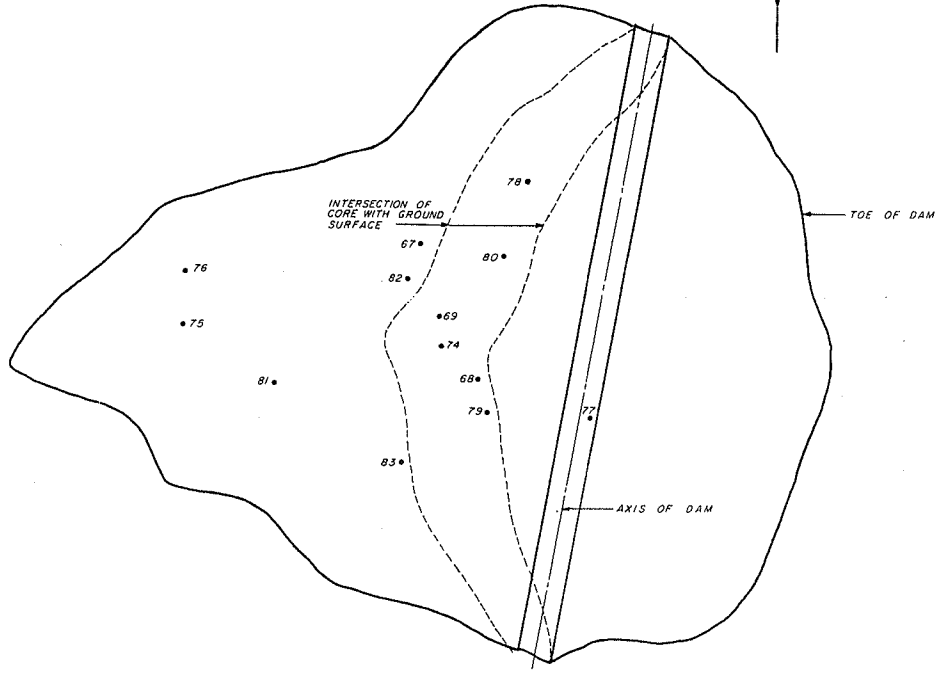
PLOT PLAN  
NORTH DAM

The first fill was placed in the North Dam on September 21, 1956. Fill was placed whenever weather conditions were satisfactory until November 8, 1956, when all work was halted for the remainder of the fall and winter season. During the placement of the fill in the North Dam, 13 field density tests were made to determine the degree of compaction being obtained. The results of the tests are tabulated in Table III, Field Density Test Data, North Dam. The data are presented in this table in the same manner as the data presented in Table II. Between September 21 and October 8 the fill was placed and compacted to meet a strength requirement based upon the results of direct shear tests performed on samples of compacted fill. The results of these tests were summarized on Plate B-1 in our "Report of Supplementary Consultation and Soils Investigation, North Dam, Lord's Lake Development, Jefferson County, Washington", dated October 31, 1956. Tests 67 through 69 and 74 through 79 were performed

during this period, and are denoted as being satisfactory or unsatisfactory based on a comparison between the dry density of the field tests and the average dry density of the laboratory shear test samples.
