Port Townsend Condition Assessment

Summary Report

September 11, 2019

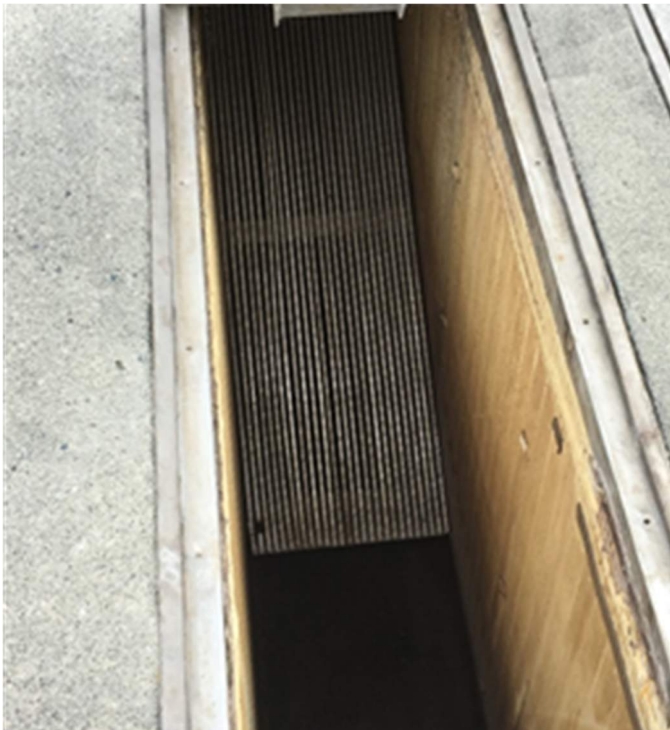
- **Capacity.** The bar screen is functioning well with no comments associated with high water levels upstream of the screen indicating possible capacity issues (Photos 2 and 3). There is a manual bar rack (Photo 4) that can be installed in a parallel channel if the installed screen fails. The Pistagrit vortex grit removal unit (Photo 5) is also functioning well with no significant accumulations of grit downstream to indicate that the unit is overloaded.

Photo 2: Bar Screen in Channel

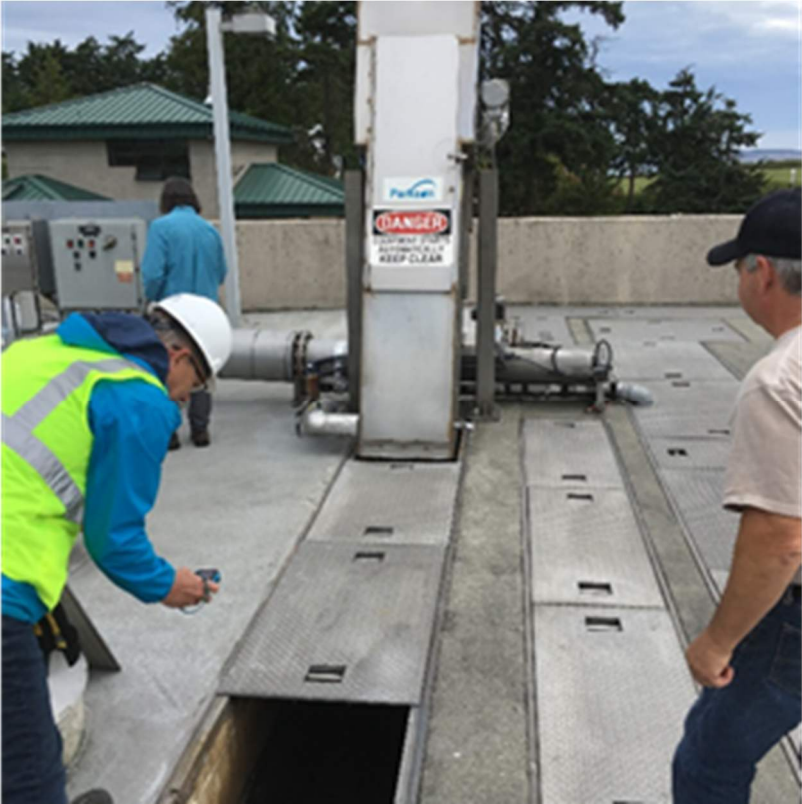
Photo 3: Bar Screen Enclosure and Compactor

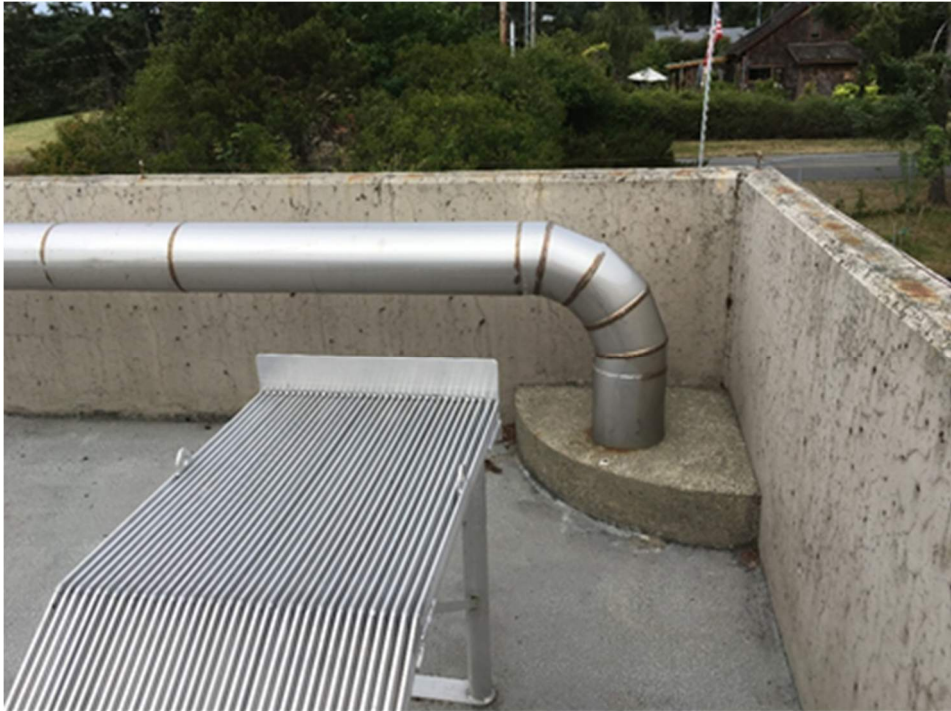
Photo 4: Manual Bar Rack

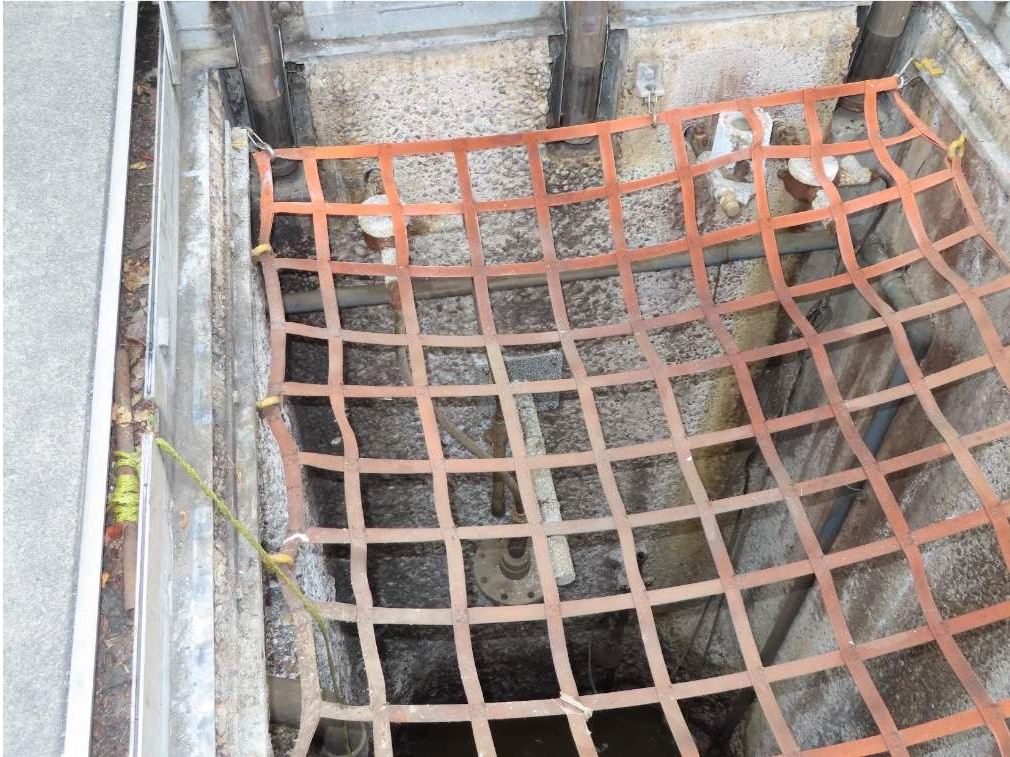
The instruments, conduit, and associated support elements inside of the influent structure need to be replaced due to corrosion. The area gas transmitter located inside the wet well shows extreme corrosion and the corresponding reading on the panel meter is off, indicating that it has failed (Photos 27, and 28).

Photo 27. Gas transmitter experiences extreme corrosion

- Replace the existing LE & LIT-210 Wet Well Level instrument with a single-sealed unit appropriate for these conditions. An appropriate unit would be Vega's VegaPULS WL61. This replacement would include, as a byproduct, a HART analog Intrinsic Safety Barrier which will allow remote connection and troubleshooting of this new unit.

- Replace the existing LSH & LSL-210 Wet Well low and high-level float switches with new float switches and Intrinsic Safety Barriers, including new 316L stainless steel mounting pole.
- Replace the existing AE & AIT-240 Wet Well Explosive Gas Sensor instrument with a new remote sensor that includes a sample draw system that returns the sample to the wet well. This is typical of current wet well design.
- Replace all conduit inside the wet well, and extending into the buried condition, as applicable, with a new system that includes a handhole outside the pump station where a sealed transition can be made to protected cables (suitable for the wet well environment).

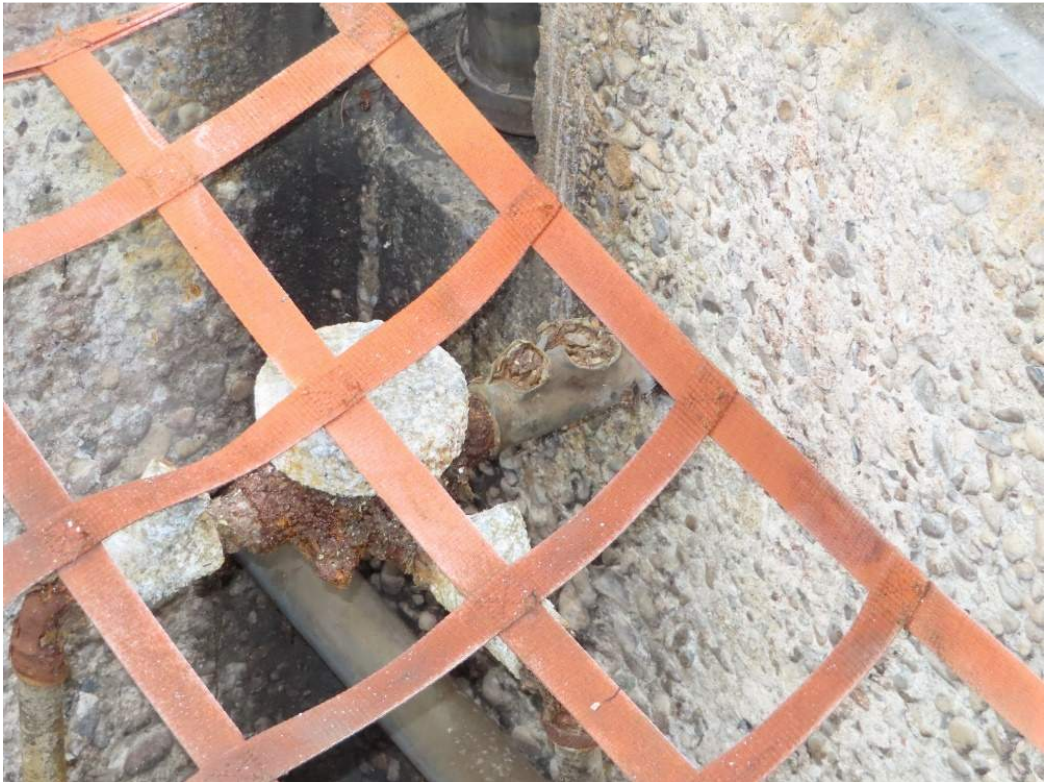
Photo 28. Gas transmitter experiences extreme corrosion

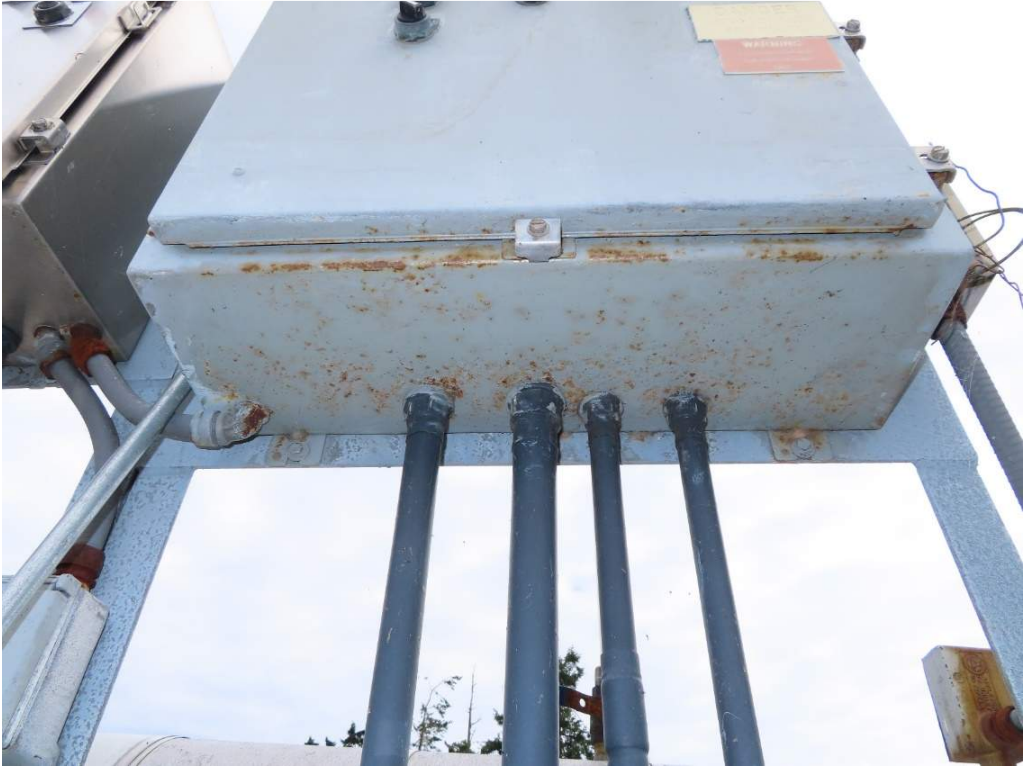
Photo 29. Corrosion of conduits and enclosures located outside

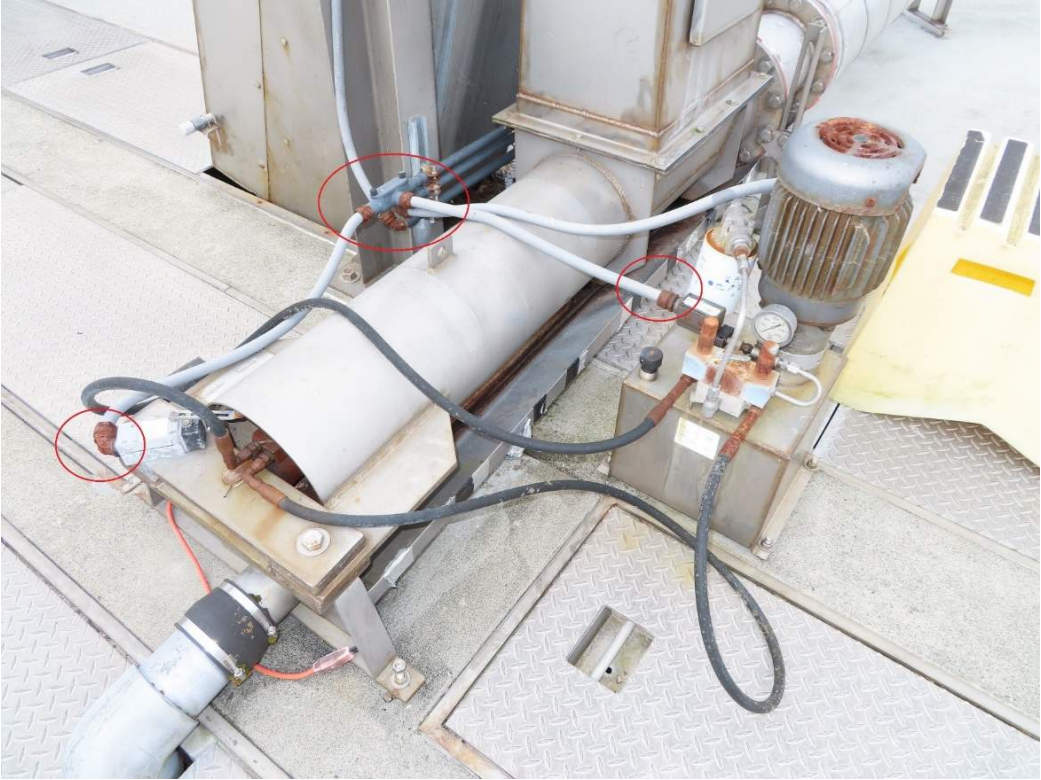
- Many of the flexible conduit connectors show rust, these should be coated with a rust protectant coating (Photo 30).
- Previous upgrade projects resulted in abandoning some components that are still in place. The network radio antenna's function has been replaced by a new network service to the facility (Photo 31). The new Sodium Hypochlorite tank uses a visual tank measurement, leaving the Milltronics transmitter located in the containment abandoned in place (Photo 32). The sodium bisulfite is metered with manual settings. A Strantrol Dechlor controller that was apparently previously used for metering is de-energized inside of CP1 (Photo 33). There may be other instruments that due to change in process needs have been abandoned in place.

Photo 30. Rusting of flexible conduit connectors

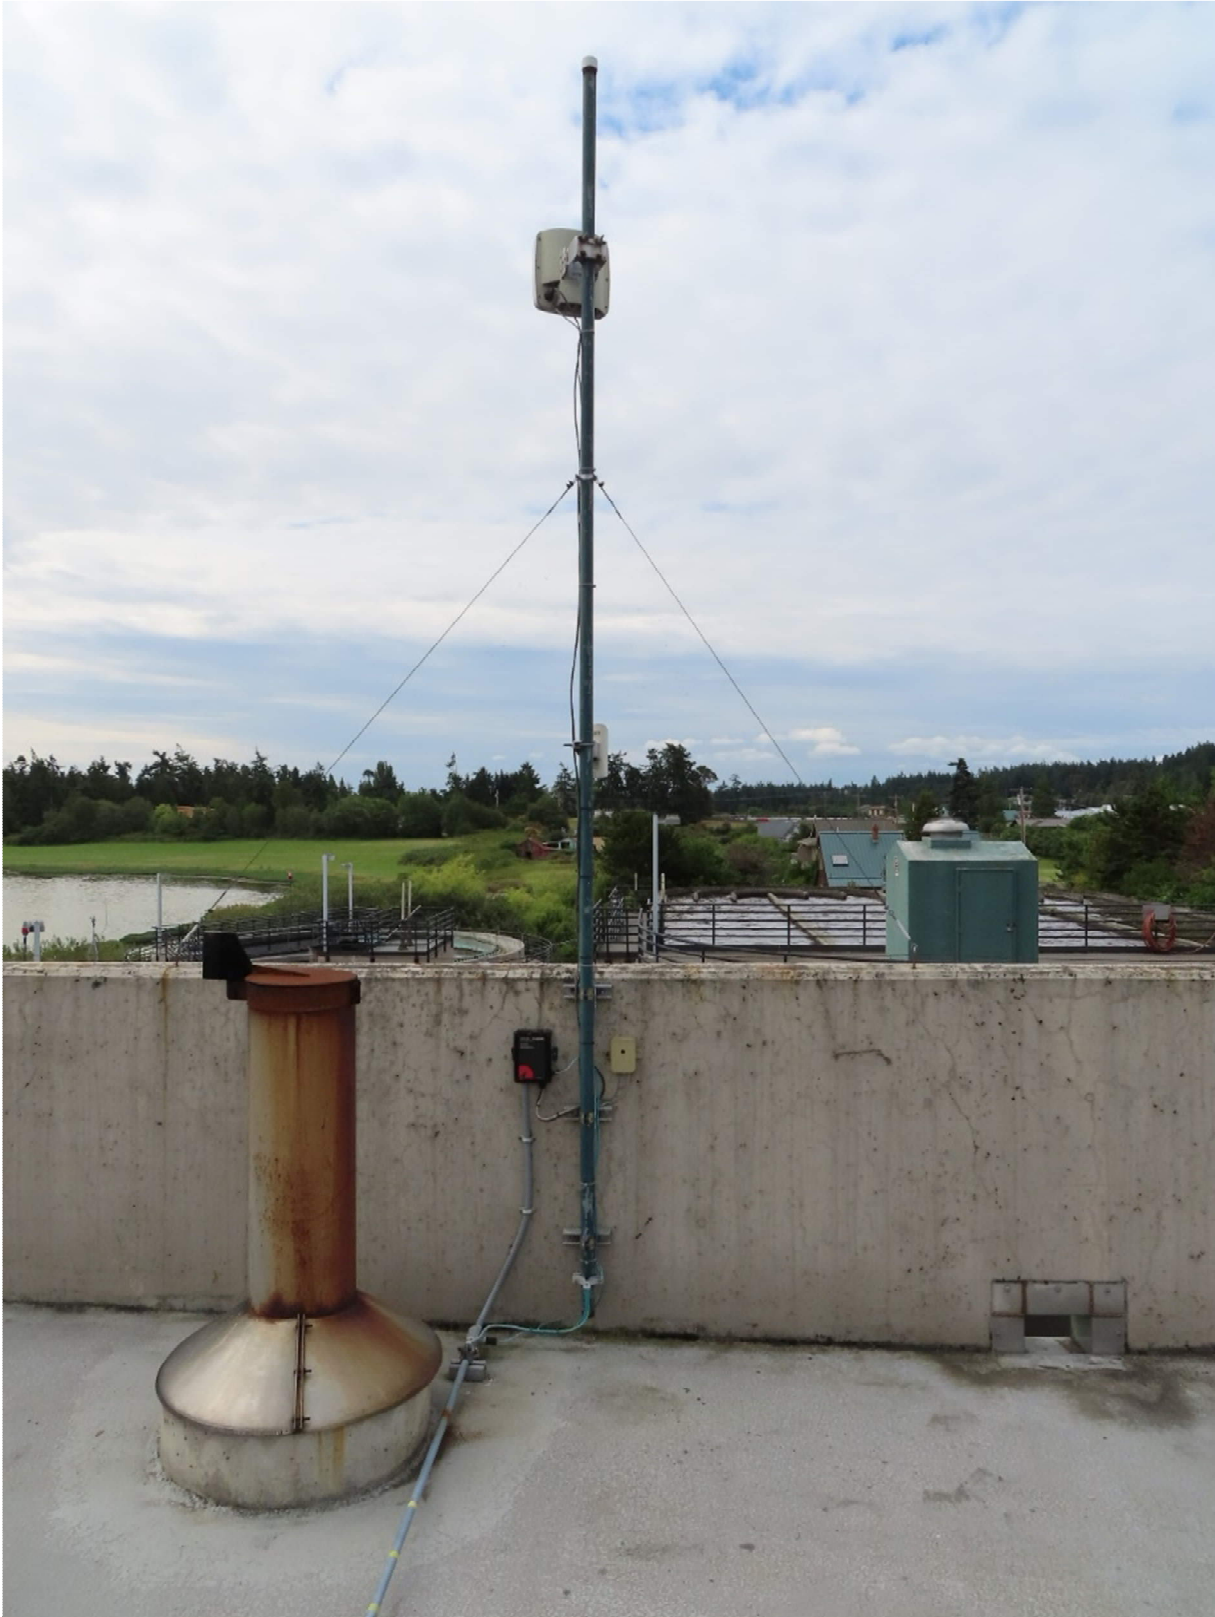
Photo 31. Abandoned network radio antenna

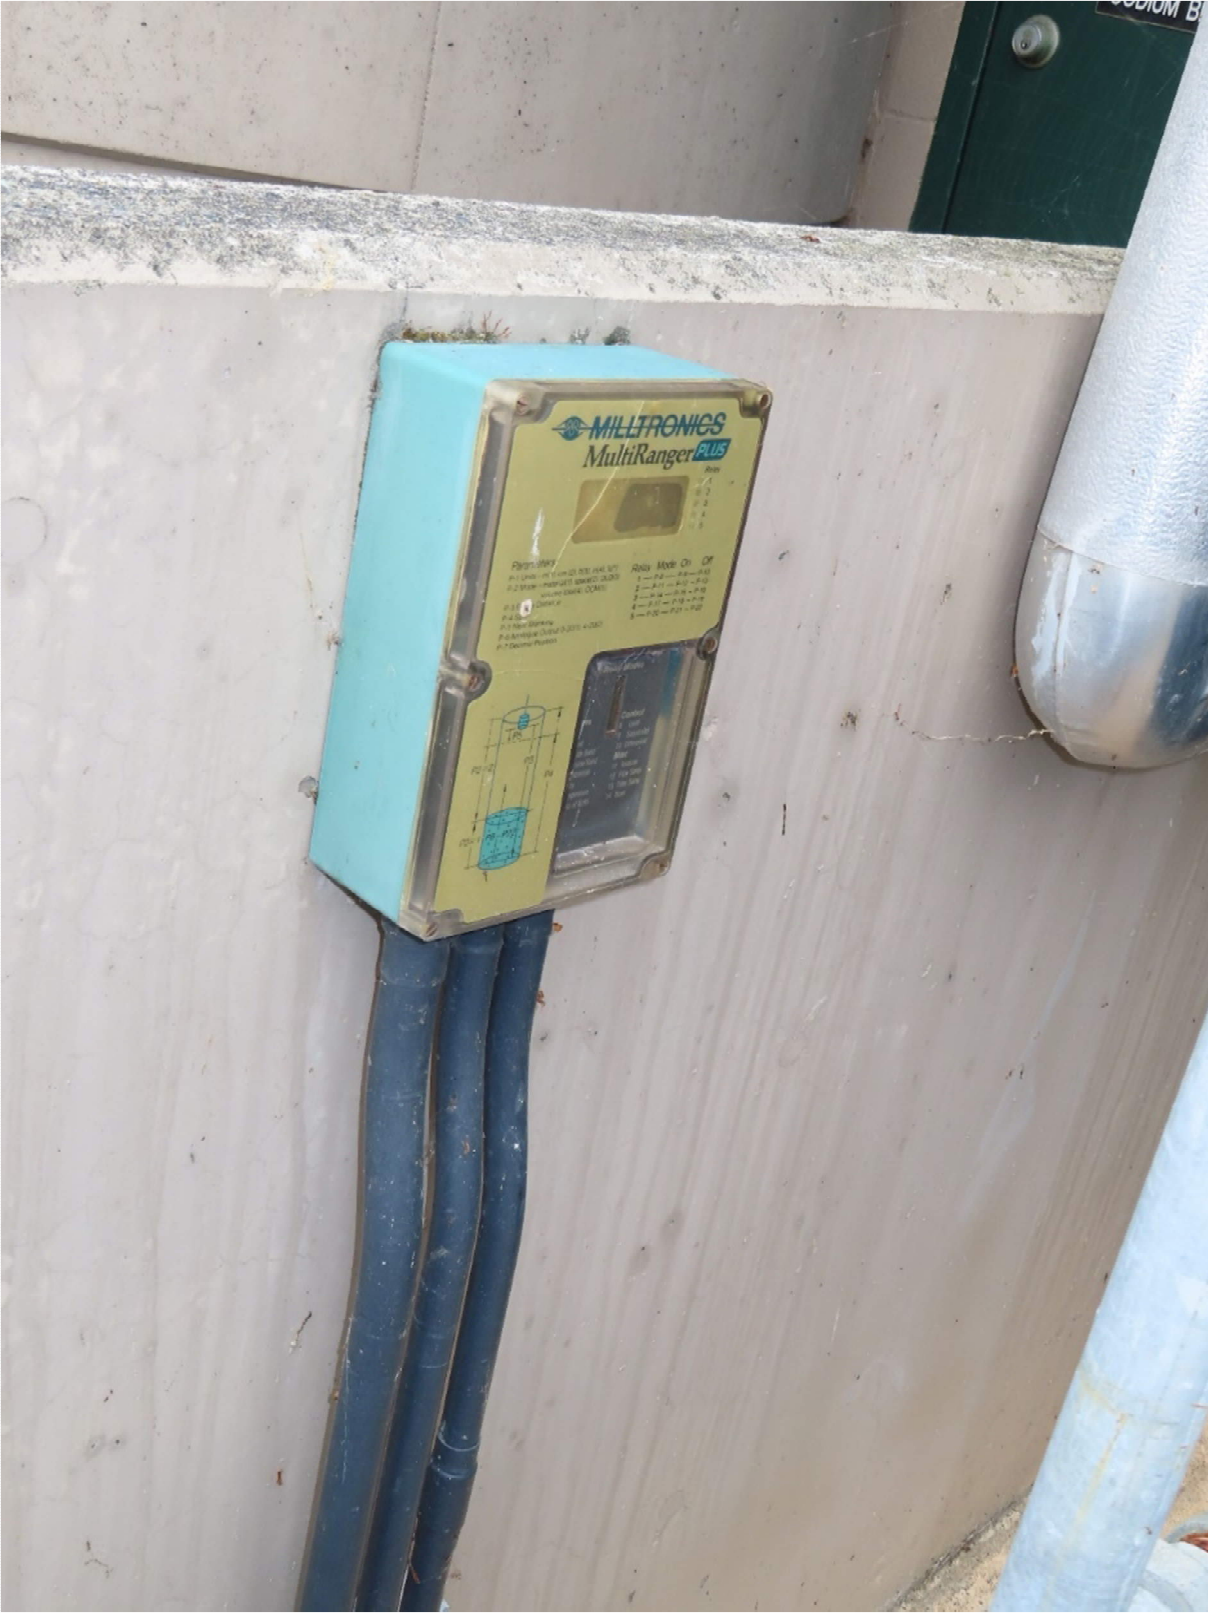
Photo 32. Abandoned the Milltronics transmitter

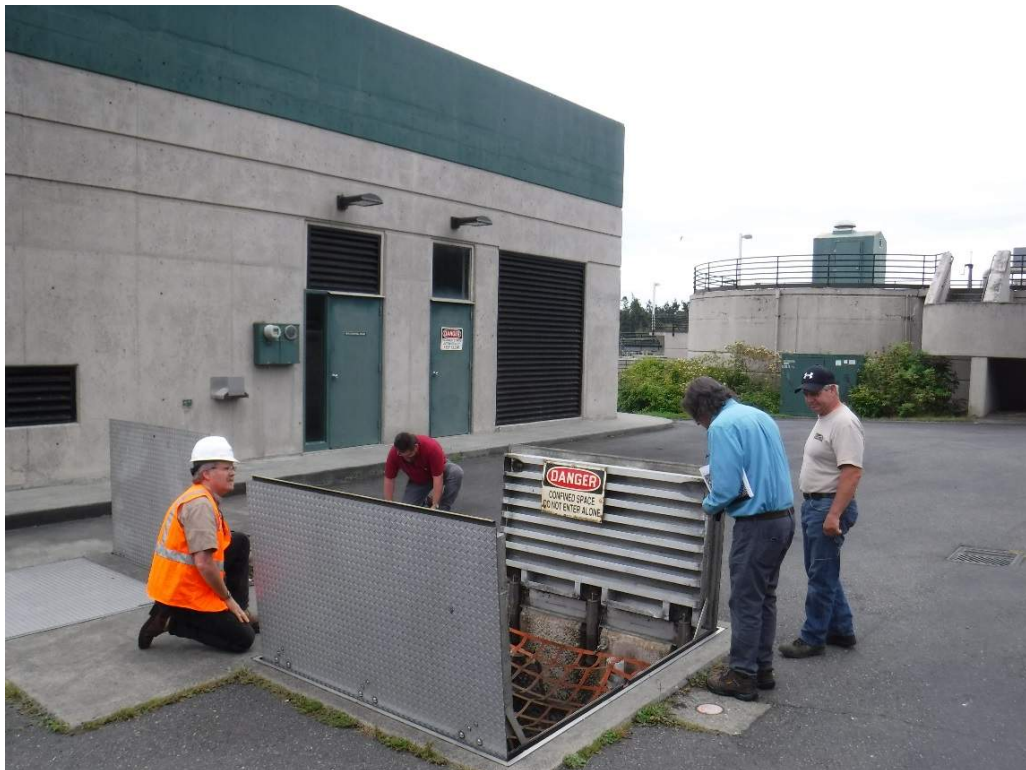
Photo 34. Influent Pump Station, Port Townsend wastewater treatment plant.

- Concrete. Corrosion of the concrete walls and ceiling has exposed the aggregate. It is estimated that the depth of concrete deterioration is ¾- to 1-inch. No exposed reinforcing steel was observed (Photos 34 and 35).
- Electrical. Electrical and I&C conduit and junction boxes appear to be PVC coated, but these are severely corroded where the PVC coating has deteriorated. These instruments, conduit, and ancillary equipment need to be replaced.
- Pump Guide Rails. The pump guide rails appear to be stainless steel. The rails are in good condition, with some discoloration and minor corrosion in the head space.
- Hatch Covers. The aluminum hatch covers are in good condition.

A protective coating is recommended for the interior walls and ceiling of the influent pump station. This protective coating is required to mitigate corrosion of the concrete due to hydrogen sulfide gas. A typical corrosion protection coating for this application would include:

- Dewatering and cleaning with high pressure water to remove surface contaminants and loose concrete.
- Abrasive blasting or high-pressure water wash to reach sound concrete.
- Application of cementitious surface restoration product to restore concrete thickness and provide a smooth surface for coating.
- Application of a high performance, high build epoxy coating designed for exposure corrosive conditions associated with hydrogen sulfide gas.

The concrete will continue to deteriorate under the current operating conditions. A protective coating project should be budgeted and scheduled for implementation within the next three to five years.

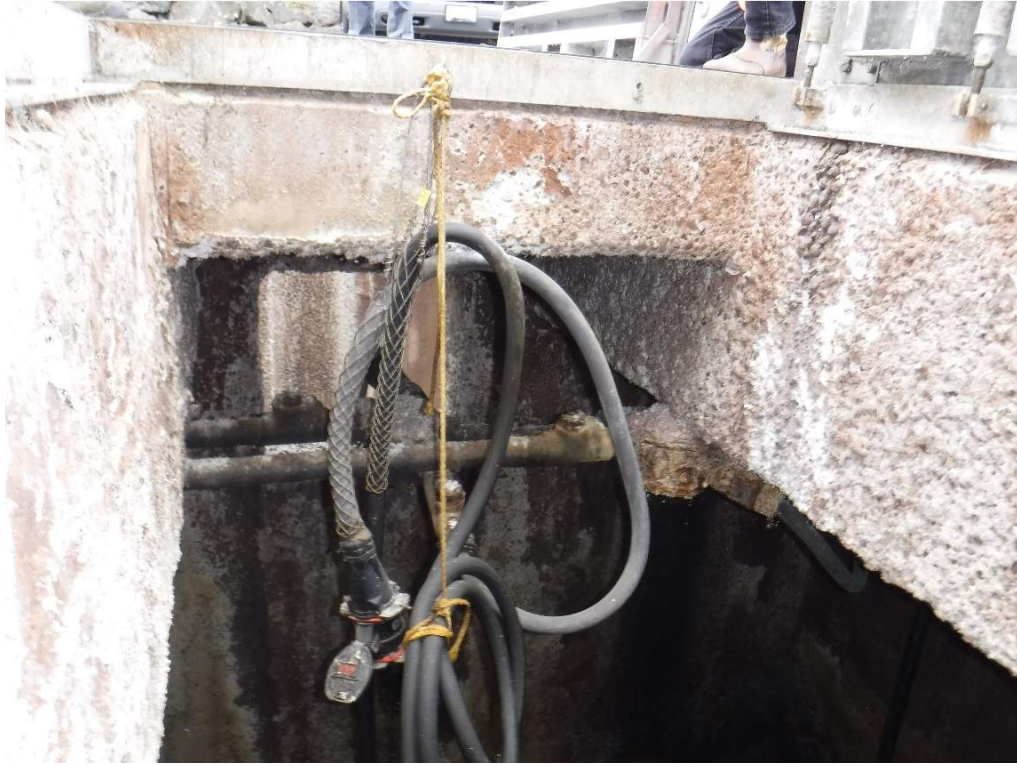
Photo 35. Deteriorated concrete and electrical components, influent wet well. Aluminum covers and stainless steel embeds are in good condition.

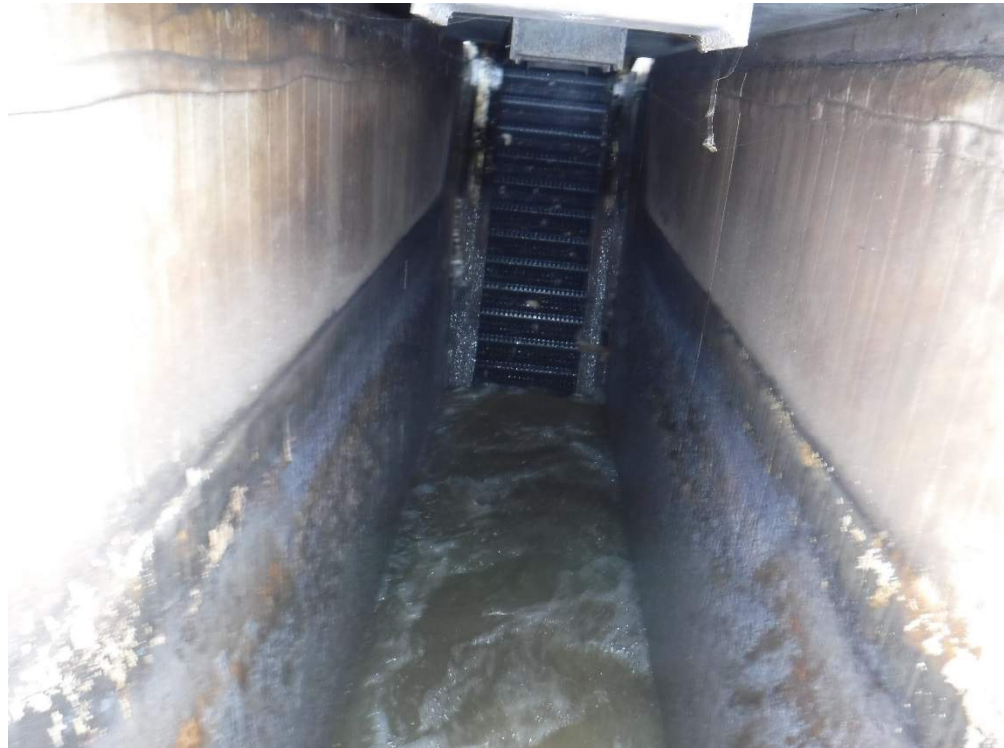
- Embedded Liner. The embedded liner is generally in good condition (Photo 36). There are several isolated locations in the channels where the liner has failed and concrete is corroding.

Photo 36. Traveling screen and embedded plastic liner in good condition.

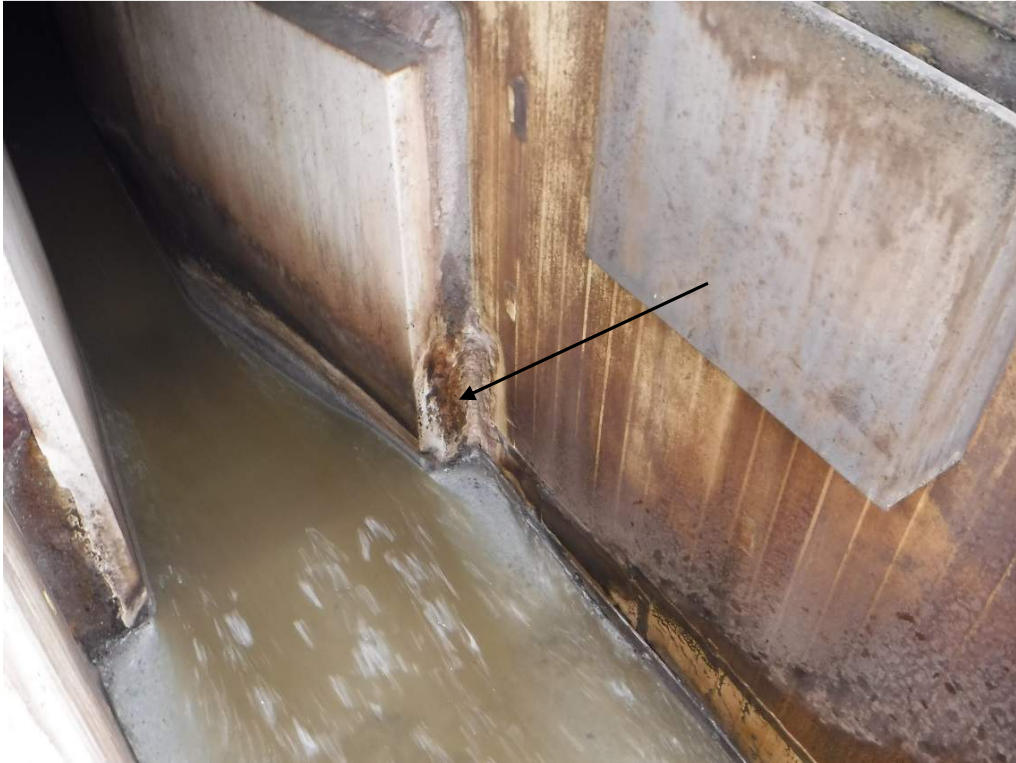
- ✓ Isolated failures were observed at the Parschall Flume (Photo 37).
 - ✓ The embedded liner has failed on a concrete support column in the RAS return basin. It appears that the liner was not completely installed over the cap of the column, and corrosion of the concrete has occurred from the top of the column down, allowing the embedded liner to peel away from the concrete at the corners (Photo 38). The process is turbulent in the RAS return basin, a condition that liberates hydrogen sulfide gas and creates a more corrosive condition.

Photo 37. Concrete is corroding at base of Parschall Flume where embedded liner is ineffective (arrow).

The embedded plastic liner needs to be repaired in several areas of the headworks facility. Significant corrosion of the concrete has occurred on the column in the RAS return basin (the last basin of the headworks). These repairs will need to be performed by a specialty contractor. Smaller repair areas on walls will need to be repaired with plastic liner material. The repairs to the column plastic liner can be repaired by restoring the concrete and replacement of the embedded liner or wrapped with carbon fiber.

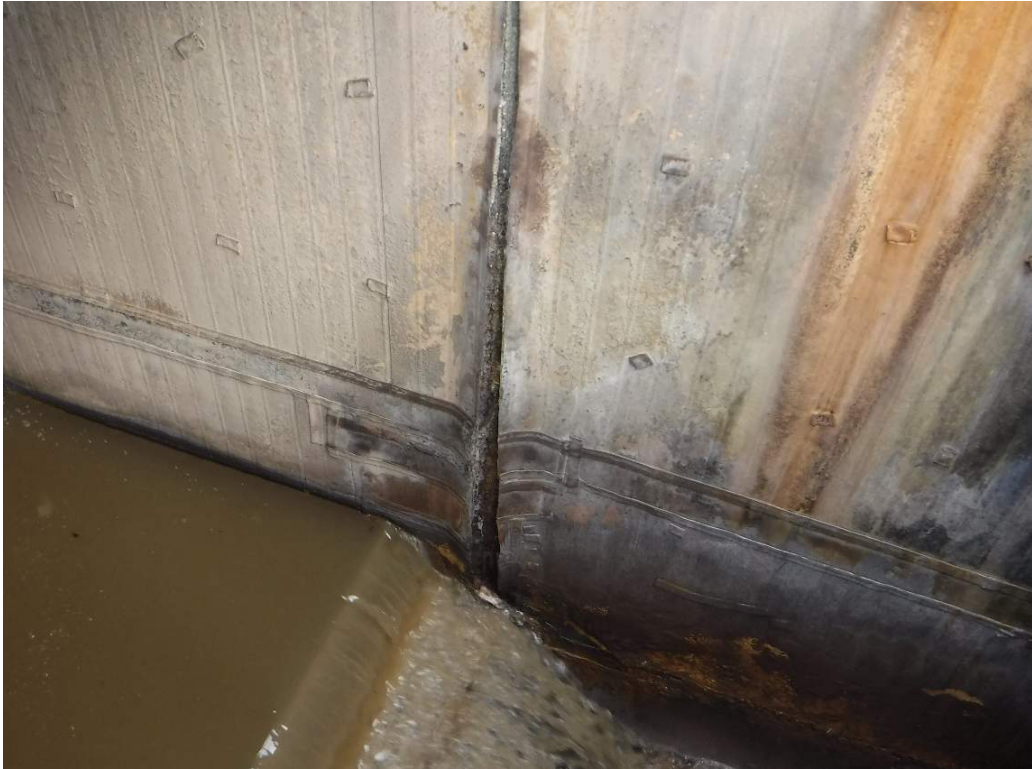
Photo 38. Embedded liner pulling from concrete at temporary gate groove, RAS return basin.

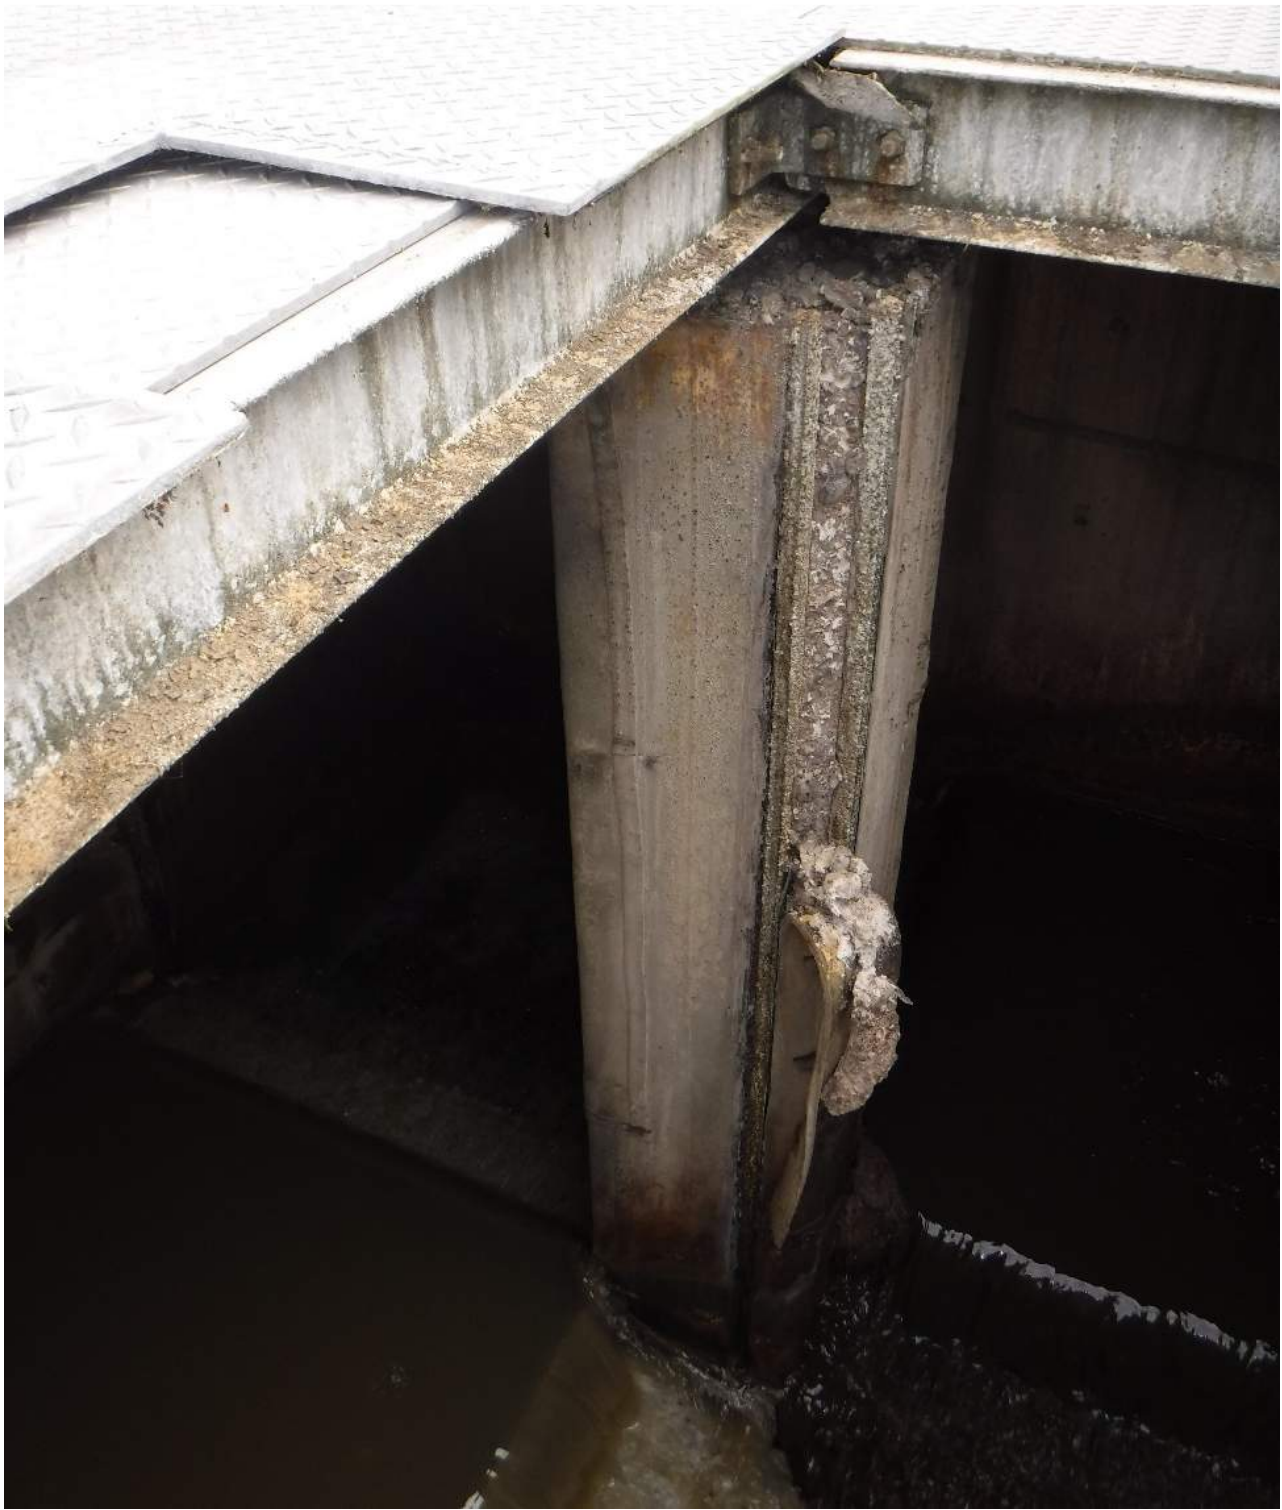
- ✓ Liner failure was also observed in the RAS return basin where the embedded liner was terminated next to stainless steel embeds for temporary gates (Photo 39).

Photo 39. Failure of embedded liner on corners of concrete support column, RAS return basin.

The repairs to the concrete column should be made within the next two years. It will be necessary to bypass the channels and RAS return basin to make these repairs.

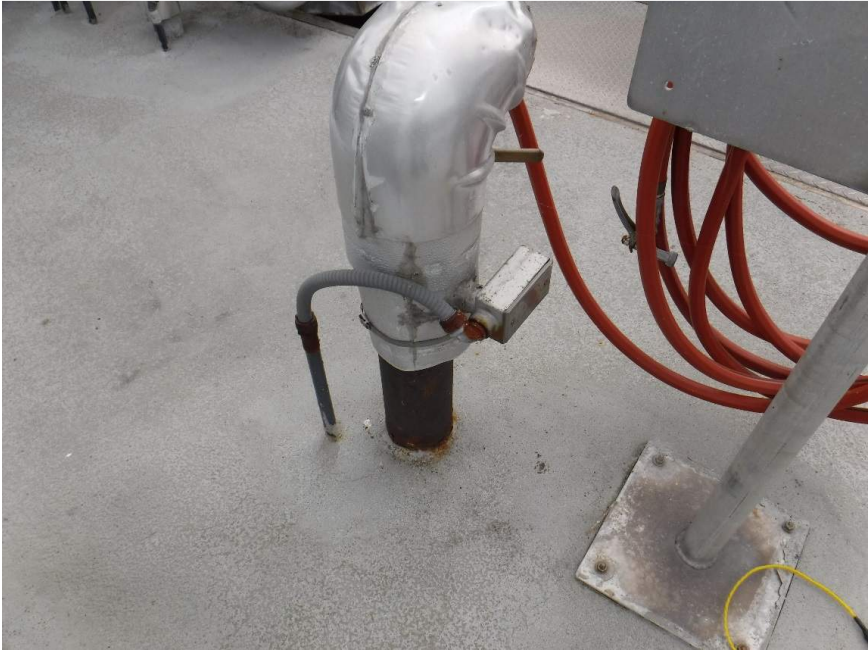
- Gate operator stems and brackets. These appeared to be in good condition.
- Above-Grade Materials, Miscellaneous.
 - ✓ A short section of ductile iron W3 pipe near the traveling screen is not painted (Photo 40).

- ✓ Moderate corrosion was observed where the pipe was not provided with thermal insulation.
 - ✓ Conduit fittings are corroding.
 - ✓ The painted air intakes for the MCC and generator rooms are in good condition.

Photo 40. W3 line corroding wher it is not insulated. Not corrosion on conduit fittings (typical)

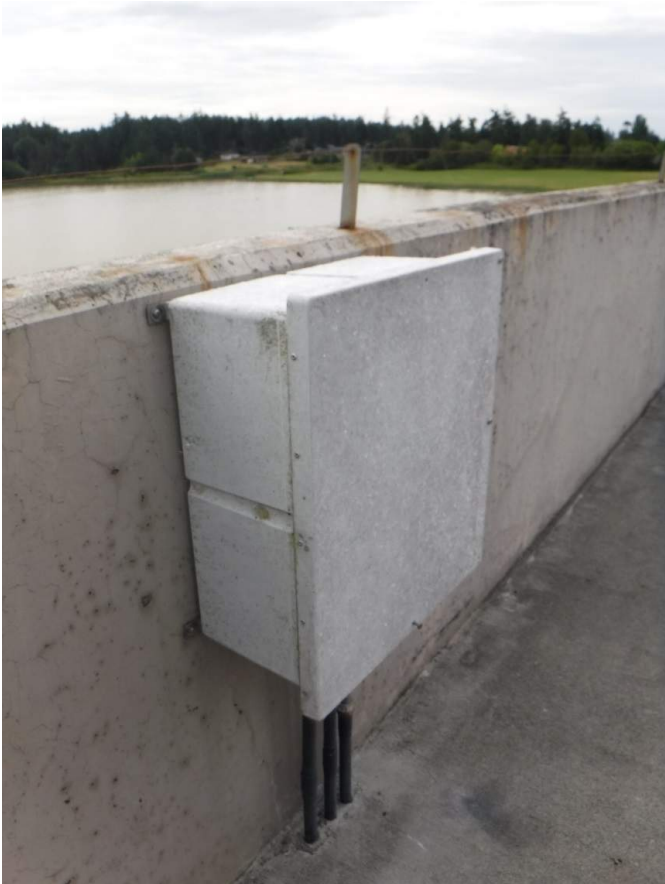
- ✓ A fiberglass box installed to house I&C equipment is starting to deteriorate from UV exposure (Photo 41).
 - ✓ The stainless steel and painted steel electrical enclosures appear to be in good condition.

Photo 41. Fiberglass box housing instrument panel, subject to UV deterioration (east side of headworks).

- Some fiberglass enclosures housing various I&C equipment are deteriorating due to UV exposure. The enclosures can be painted to reduce the rate of deterioration and exposure of glass fibers. The procedure would consist of cleaning with biodegradable detergent, light sanding to remove exposed fibers, and painting with two coats of a high-quality latex paint.
- The short section of W3 pipe on the headworks roof that is not insulated should be painted with epoxy.
- The aluminum light standards are in very good condition, but it was noted that screws on the electrical covers are either galvanized or carbon steel. They should be replaced with stainless steel.

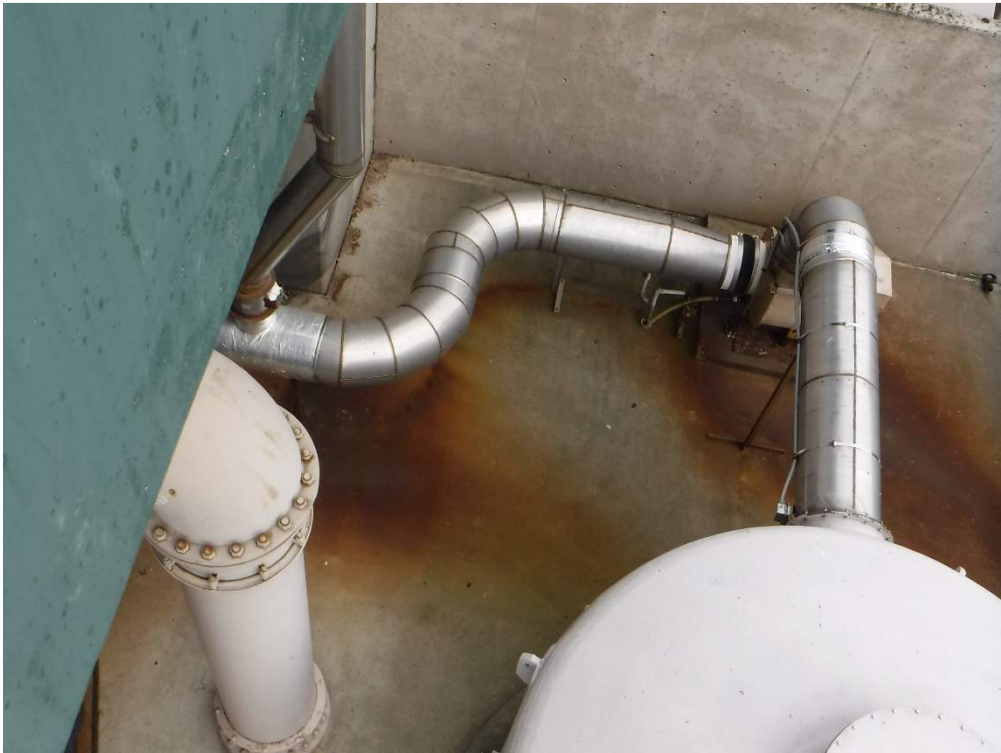
- Odor Control Duct.
 - ✓ The stainless steel odor control duct on the top of the headworks appears to be in good condition.
 - ✓ The vertical stainless steel odor control duct has some external staining, and may have some small wall penetrations at a weld due to internal corrosion.
 - ✓ The horizontal stainless steel odor control duct at grade level has numerous pipe wall penetrations due to internal corrosion (Photos 42 and 43). Most, but not all, of the penetrations are at the bottom of the duct.
- Fan. Some surface corrosion was observed on the fan housing.
- Fiberglass Filter Tank. No corrosion issues were observed.

Photo 42. Rust staining on concrete floor under stainless steel odor control duct with penetrations caused by internal corrosion.

In addition to modifying the odor control capacity, the odor control duct from the top of the headworks to the filter tank has been penetrated by corrosion and will need to be replaced. At this point, the holes are small. However, they will become larger as corrosion inside the duct continues. The duct should be scheduled for replacement within one to two years. Polymer-lined, stainless steel duct has been used successfully on several recent wastewater treatment plant projects and would be a suitable option for this installation.

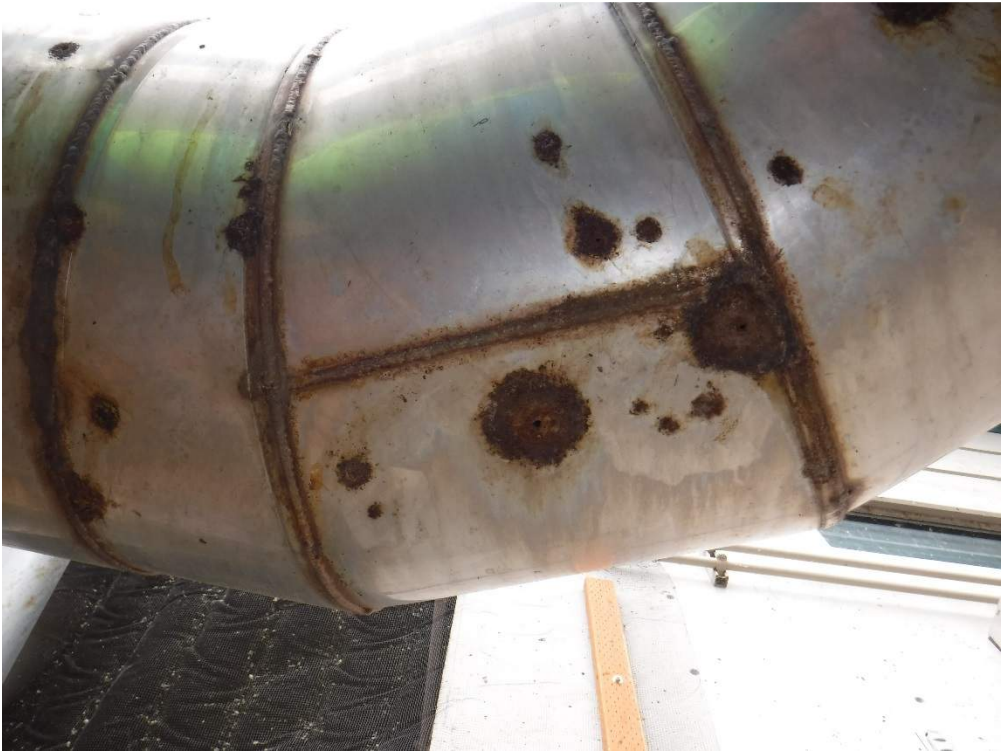
Photo 43. Typical penetrations in stainless steel odor control duct caused by internal corrosion.

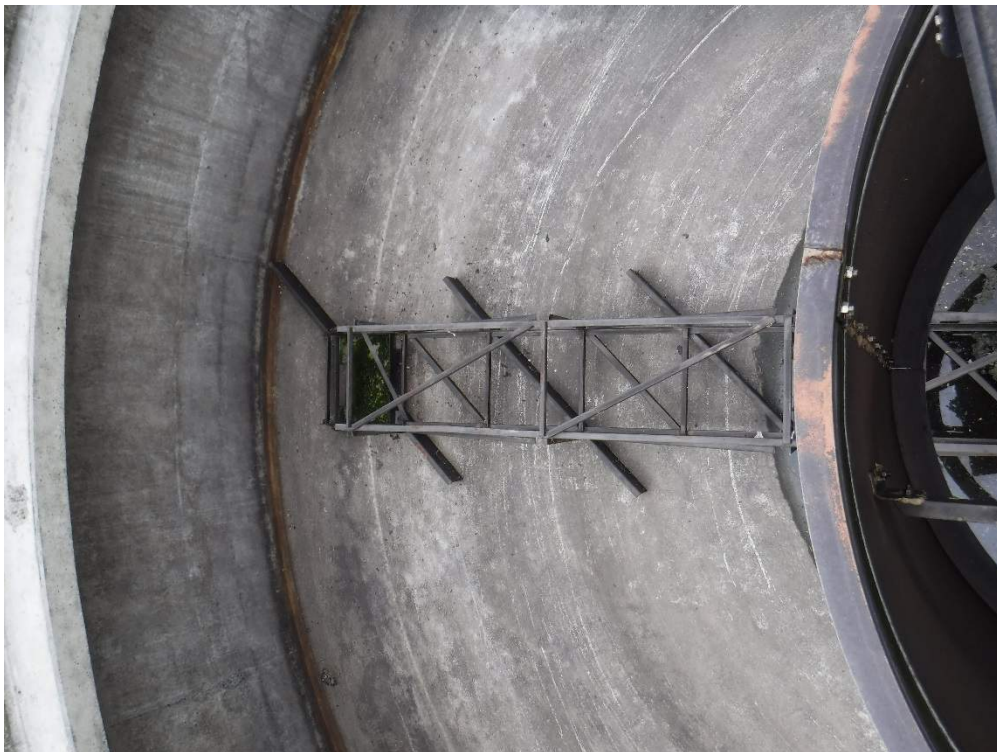
- Clarifier Mechanism.
 - ✓ The paint on the secondary clarifier mechanism is maintained on a regular basis by plant staff. There are some areas where minor corrosion is occurring at coating defects (Photo 45). Overall, the paint system is in good condition considering its age.

Photo 45. Clarifier mechanism rake arm and well. Note coating deterioration on top of well angle (red primer is showing). Some corrosion is occurring on rake arms where coating has failed.

- The coating on the secondary clarifier mechanisms is over 25 years old. It appears to be in relatively good condition, but epoxy coatings on steel in this environment generally have a service life of 20 to 25 years. Budget for recoating should be set aside for a project to be implemented in the next 5 to 10 years for both of these mechanisms. The actual date for repainting can be determined based on periodic observation of the mechanisms by City staff. There is no need to undertake the recoating until it is determined to be necessary. This project would require outside consulting services to develop a bidding document to procure a contractor to do this work.

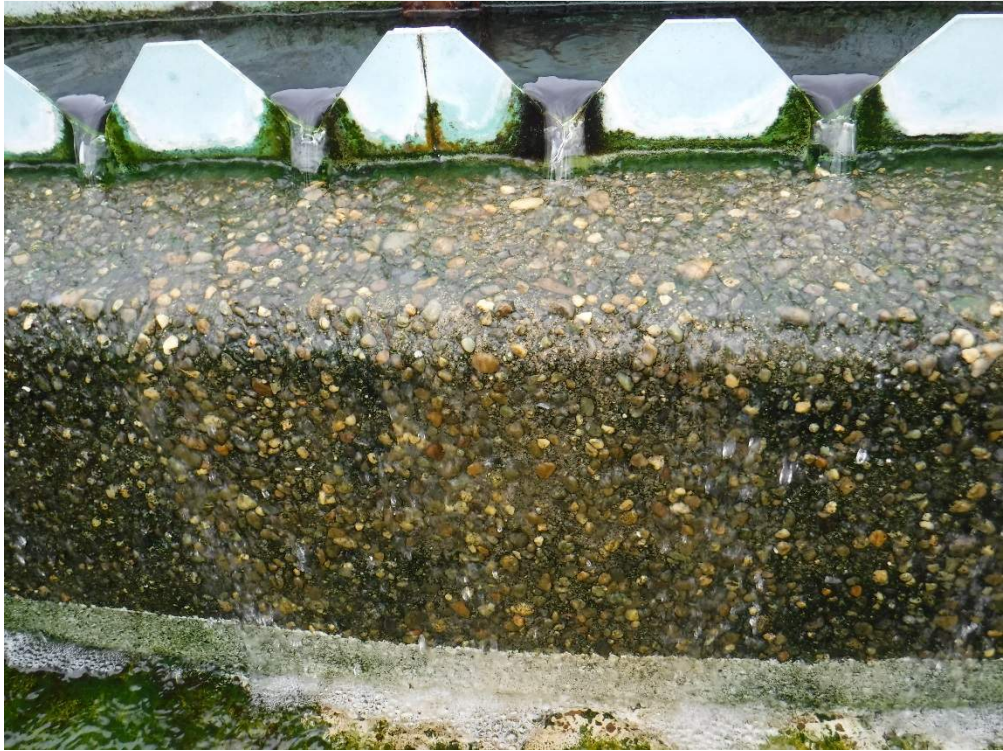
Photo 46. Exposed aggregate in launder, north secondary clarifier.

- Leaching has occurred on the concrete launders for each of the two secondary clarifiers. It is possible to coat these items with epoxy coating, but it will introduce potential coating maintenance for plant staff. The amount of concrete leaching currently does not warrant installation of a protective coating. However, WWTP staff should monitor and document the pace of corrosion and consider coating the launders in the future if concrete deterioration significantly increases. This project would require outside consulting services to develop a bidding document to procure a contractor to do this work.

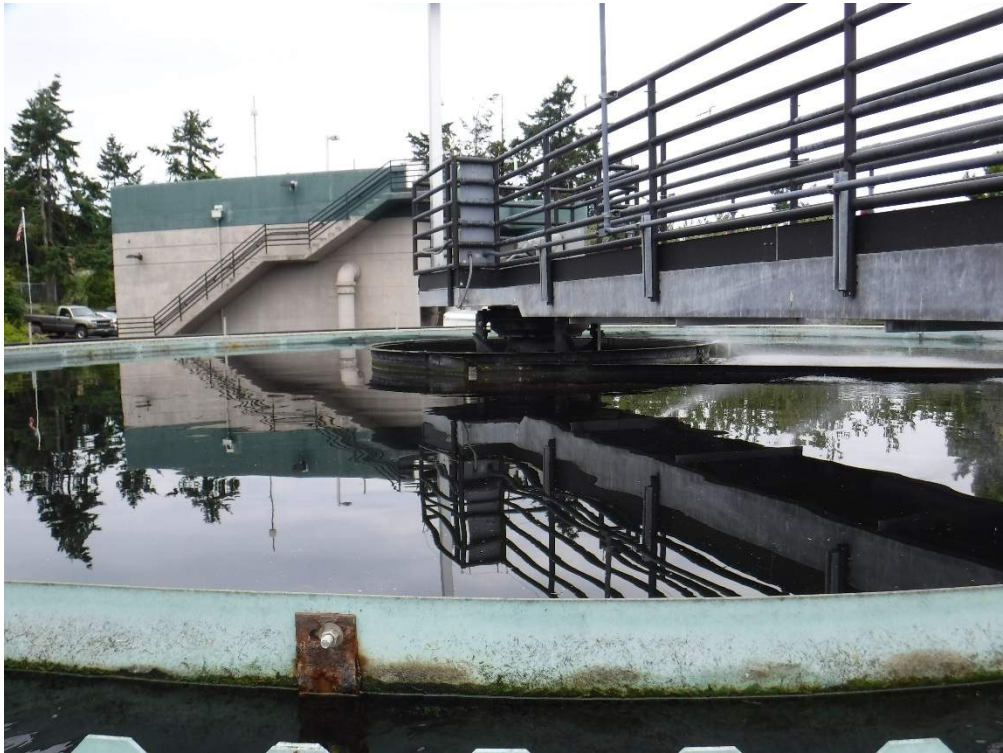
- ✓ The fiberglass weirs and baffles are in good condition.
 - ✓ Stainless steel hardware is in good condition.
 - ✓ Carbon steel support brackets are corroding (Photo 47).

Photo 47. Corroding carbon steel baffle support bracket, north secondary clarifier.

- The carbon steel weir support brackets should be replaced with stainless steel. The brackets do not appear to be in imminent risk of failure, so this activity could be scheduled to occur with a mechanism repainting project – in the next 5 to 10 years. This work could be done by City staff.
