Port Townsend Condition Assessment

Summary Report

September 11, 2019

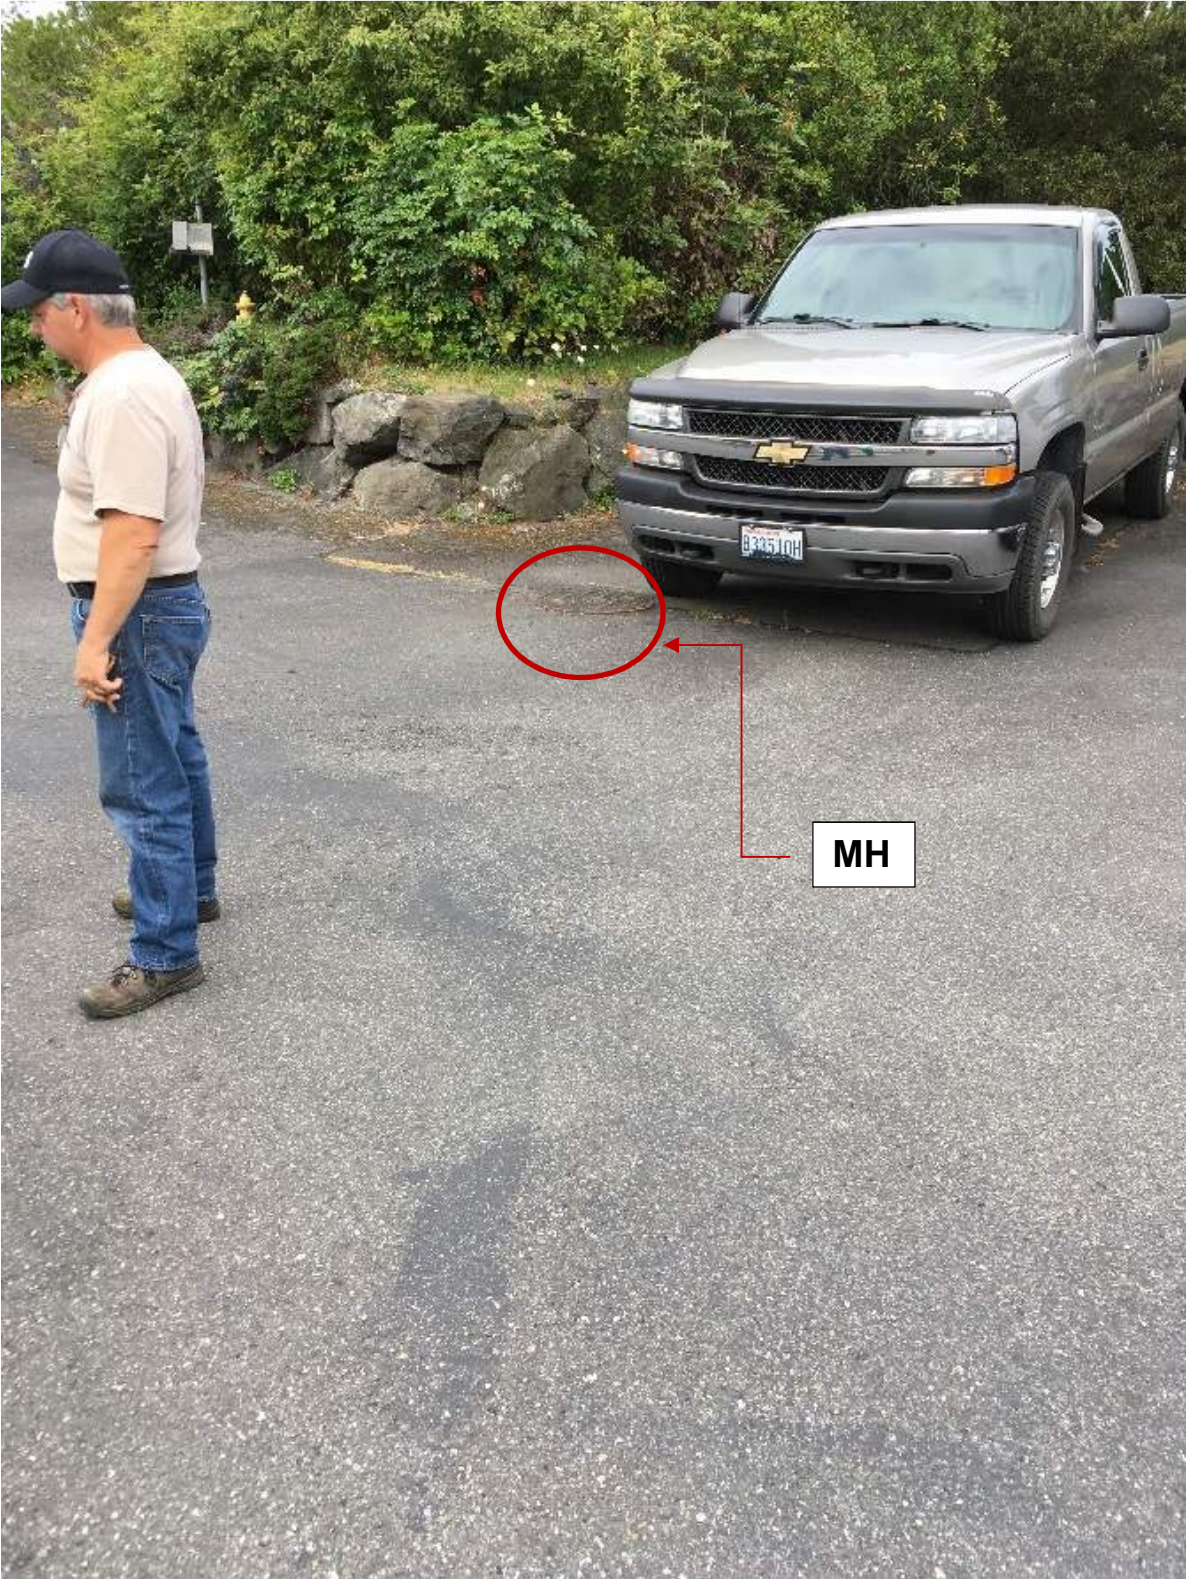
Photo 48: Potential Influent Pump Station Pump Around Manhole

In order to accomplish the bypass pumping around this influent pump station, there will have to be a pump around set up for the wetwell. There is a manhole across the drive from the pump station where temporary pumps could draw suction. (Photo 48). The pumps could discharge thru a hose across the drive and then into a rigid pipe to carry the sewage up to the Headworks Building roof, discharging into a headworks open channel. (Photos 49 and 50). This pump around could last for one month in order to accomplish the coatings prep, concrete repair and new coatings process. During this time, access to the plant offices and lab, sludge cake loadout, and the screenings and grit dumpster would have to be maintained. Possibly a lightweight truss bridge could be constructed to carry the temporary pump discharge above truck height across the drive.
