Port Townsend Condition Assessment

Summary Report

September 11, 2019

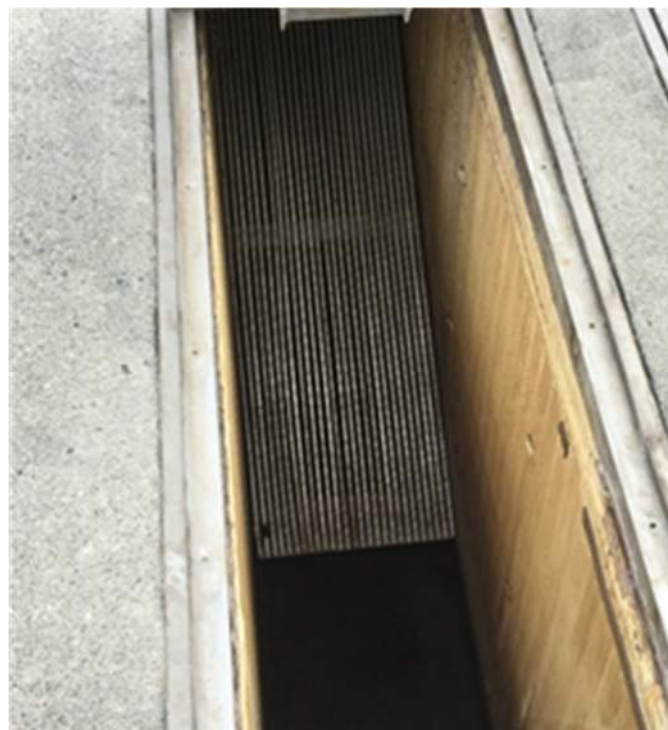
Photo 2: Bar Screen in Channel

- Capacity. The bar screen is functioning well with no comments associated with high water levels upstream of the screen indicating possible capacity issues (Photos 2 and 3). There is a manual bar rack (Photo 4) that can be installed in a parallel channel if the installed screen fails. The Pistagrit vortex grit removal unit (Photo 5) is also functioning well with no significant accumulations of grit downstream to indicate that the unit is overloaded.

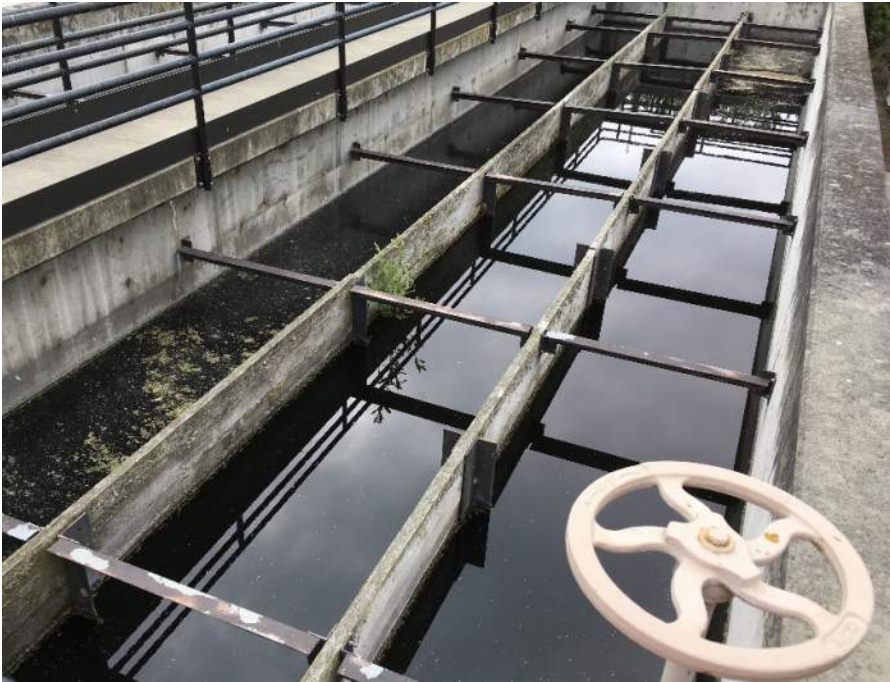
Photo 15: Chlorine Contact Basin

Secondary clarifier effluent enters the Chlorine Contact Basins, has hypochlorite solution diffused into the stream, passes thru the serpentine flow path that is designed to achieve a design contact time and then discharges to the outfall. There is the wide spot just prior to outfall discharge that provides a wet well for vertical turbine, W3 pumps to pull suction. There are no capacity, functionality, or condition issues with this process or equipment (Photos 15 and 16).

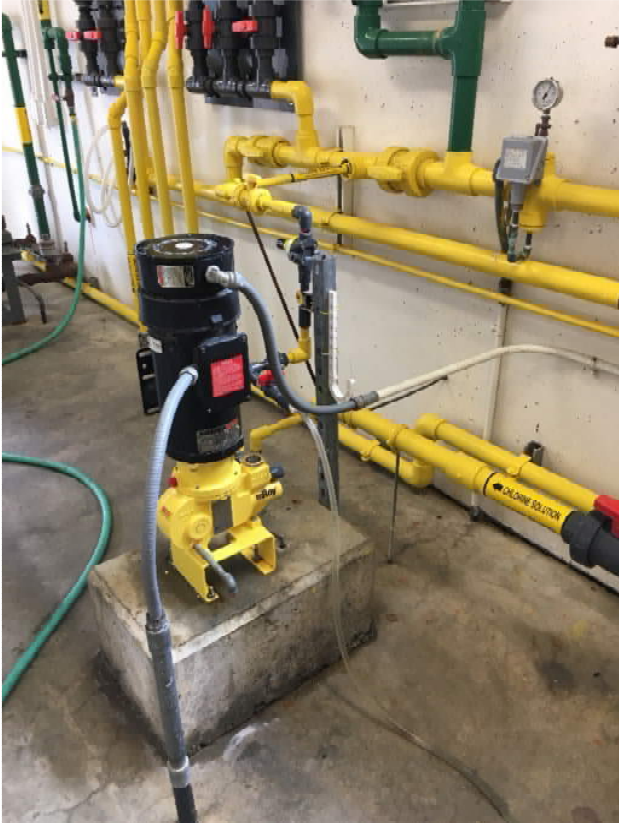
Photo 17: Hypochlorite Metering Pump

Hypochlorite is delivered in 12% concentration and stored in a new 6,200 HDPE tank. This is a black tank. The black tank (increased temperature of the hypochlorite) could possibly be contributing to an increase observed in off-gassing and vapor locking of the hypochlorite metering pumps (Photo 17) from prior operations. It also may have nothing to do with it.

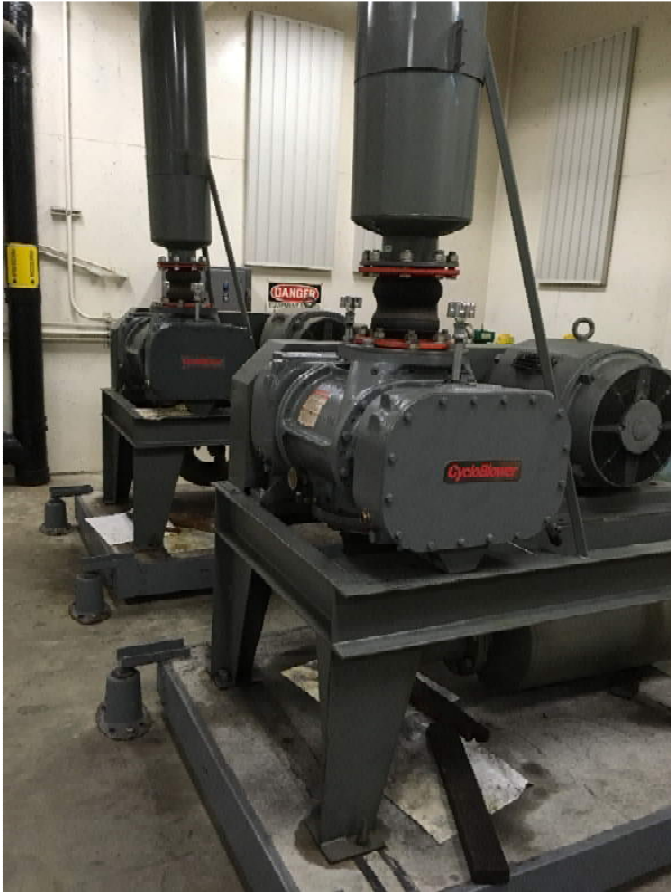
Photo 20: Aerobic Digester Blowers

Air is delivered to the aerobic digesters (waste activated sludge [WAS]) via a pair of rotary lobe blowers located in the lower level of the Operations building. They have 60-horsepower motors and produce about 1,200 cfm of air (Photo 20). They operate around 19 hours per day with additional run time in the summer. These blowers are in good condition and have adequate capacity. However, rotary lobe blowers are not particularly efficient from a power-usage standpoint. This could be a consideration with respect to upgrading these blowers, as is discussed in Section 3.

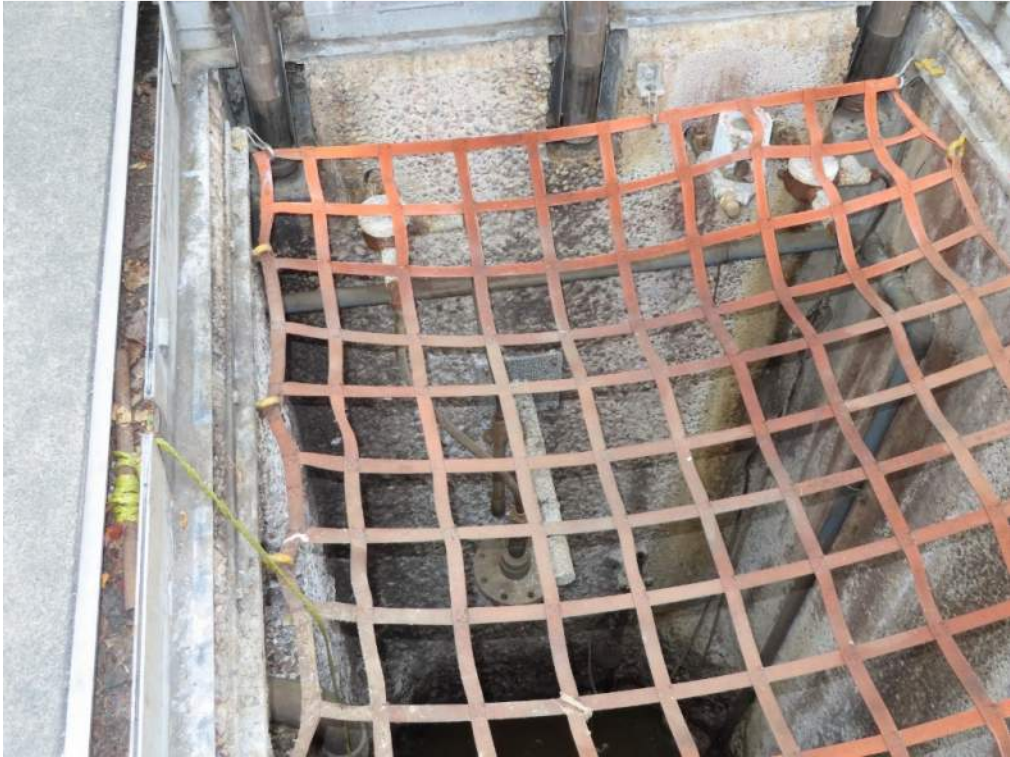
The instruments, conduit, and associated support elements inside of the influent structure need to be replaced due to corrosion. The area gas transmitter located inside the wet well shows extreme corrosion and the corresponding reading on the panel meter is off, indicating that it has failed (Photos 27, and 28).

Photo 27. Gas transmitter experiences extreme corrosion

Coordinated with the work to recondition the influent wet well, several instruments need to be replaced because of their corroded condition. These include:

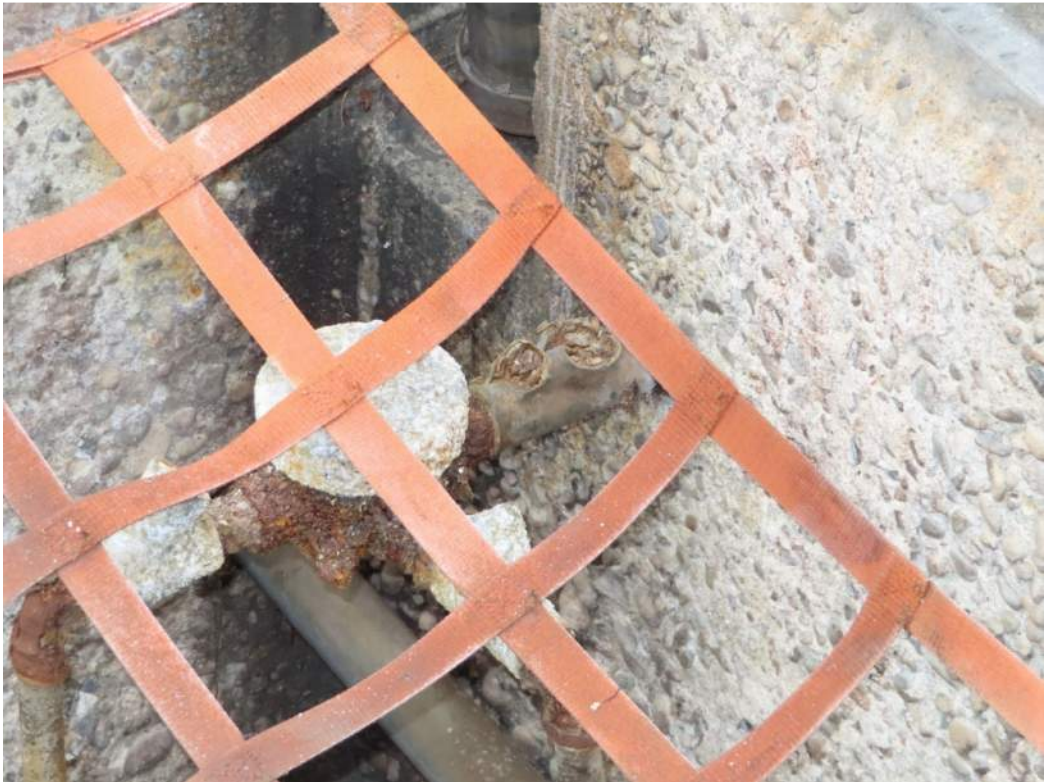
Photo 28. Gas transmitter experiences extreme corrosion

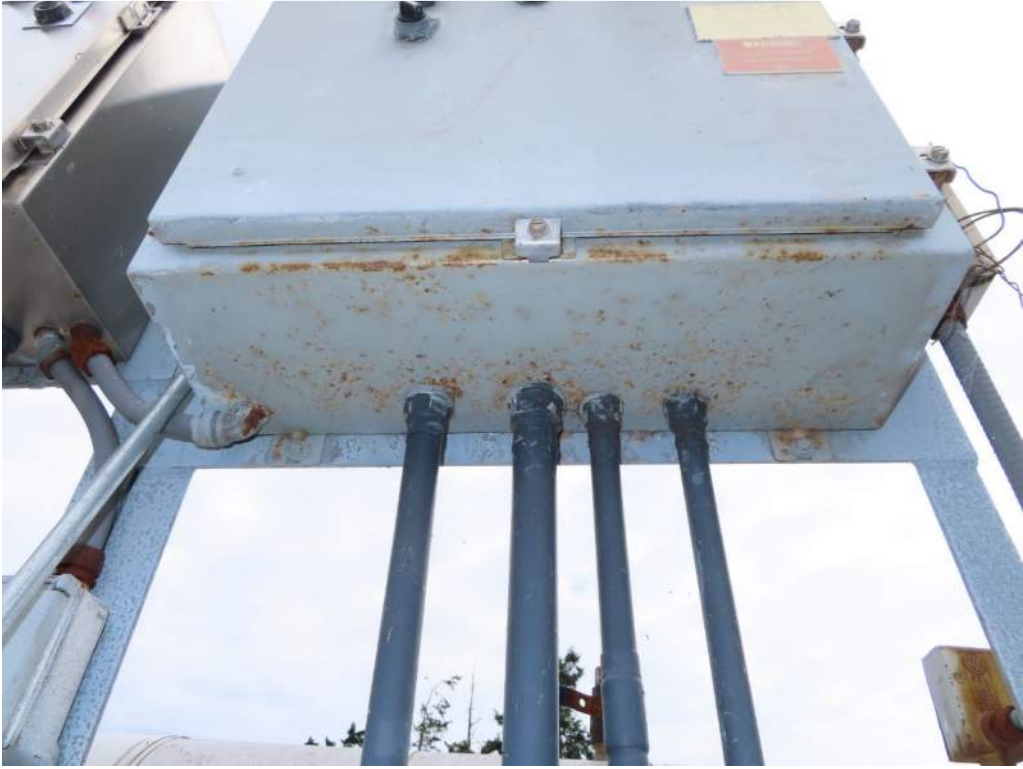
Photo 29. Corrosion of conduits and enclosures located outside

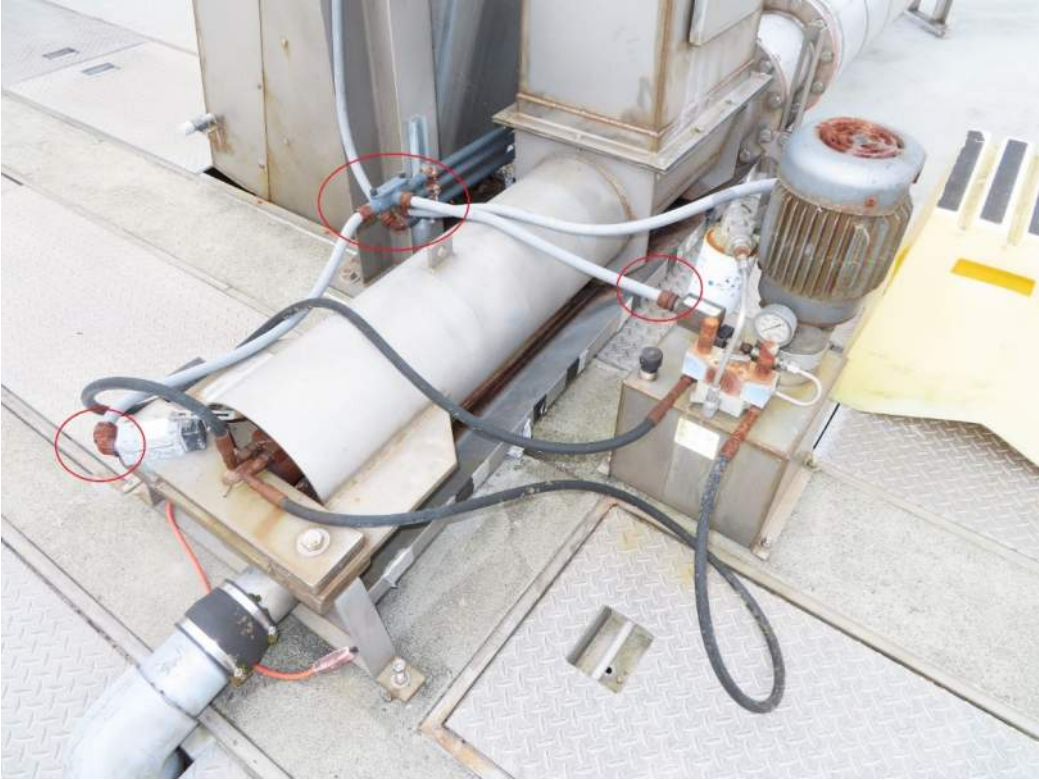
- Many of the flexible conduit connectors show rust, these should be coated with a rust protectant coating (Photo 30).
- Previous upgrade projects resulted in abandoning some components that are still in place. The network radio antenna's function has been replaced by a new network service to the facility (Photo 31). The new Sodium Hypochlorite tank uses a visual tank measurement, leaving the Milltronics transmitter located in the containment abandoned in place (Photo 32). The sodium bisulfite is metered with manual settings. A Strantrol Dechlor controller that was apparently previously used for metering is de-energized inside of CP1 (Photo 33). There may be other instruments that due to change in process needs have been abandoned in place.

Photo 30. Rusting of flexible conduit connectors

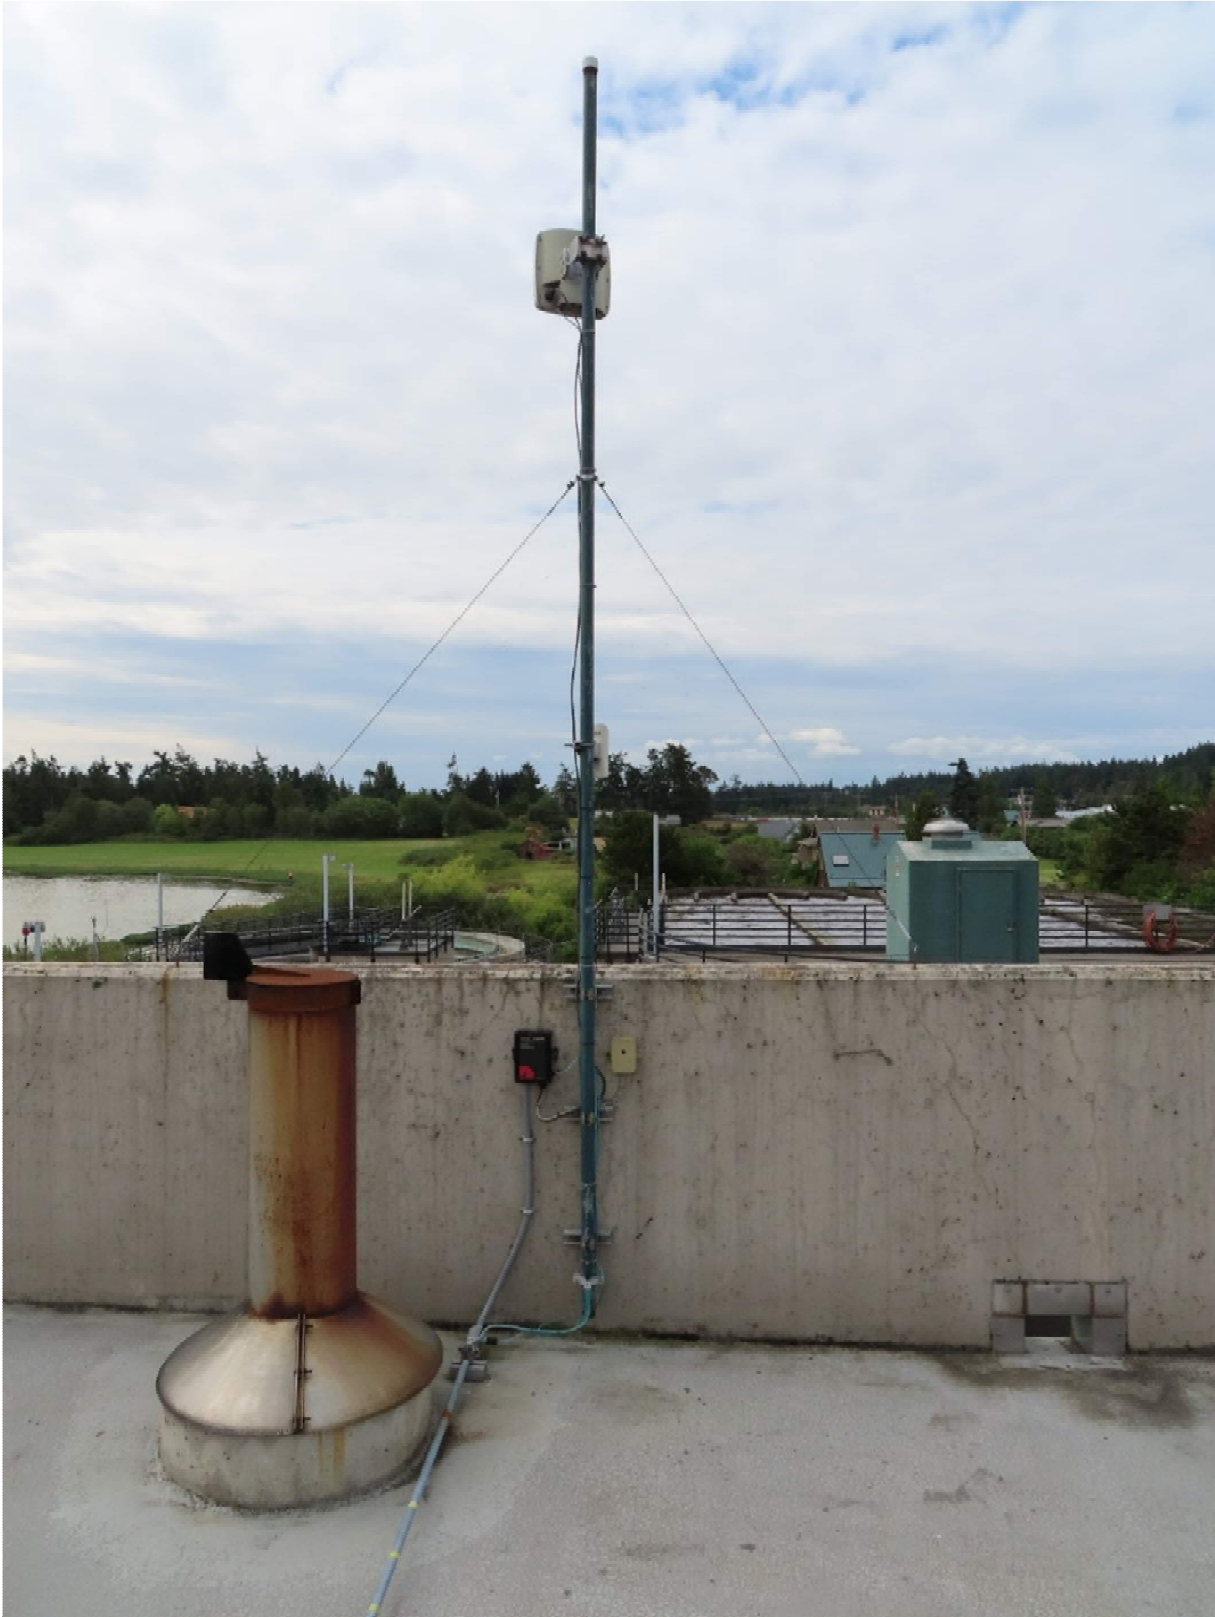
Photo 31. Abandoned network radio antenna

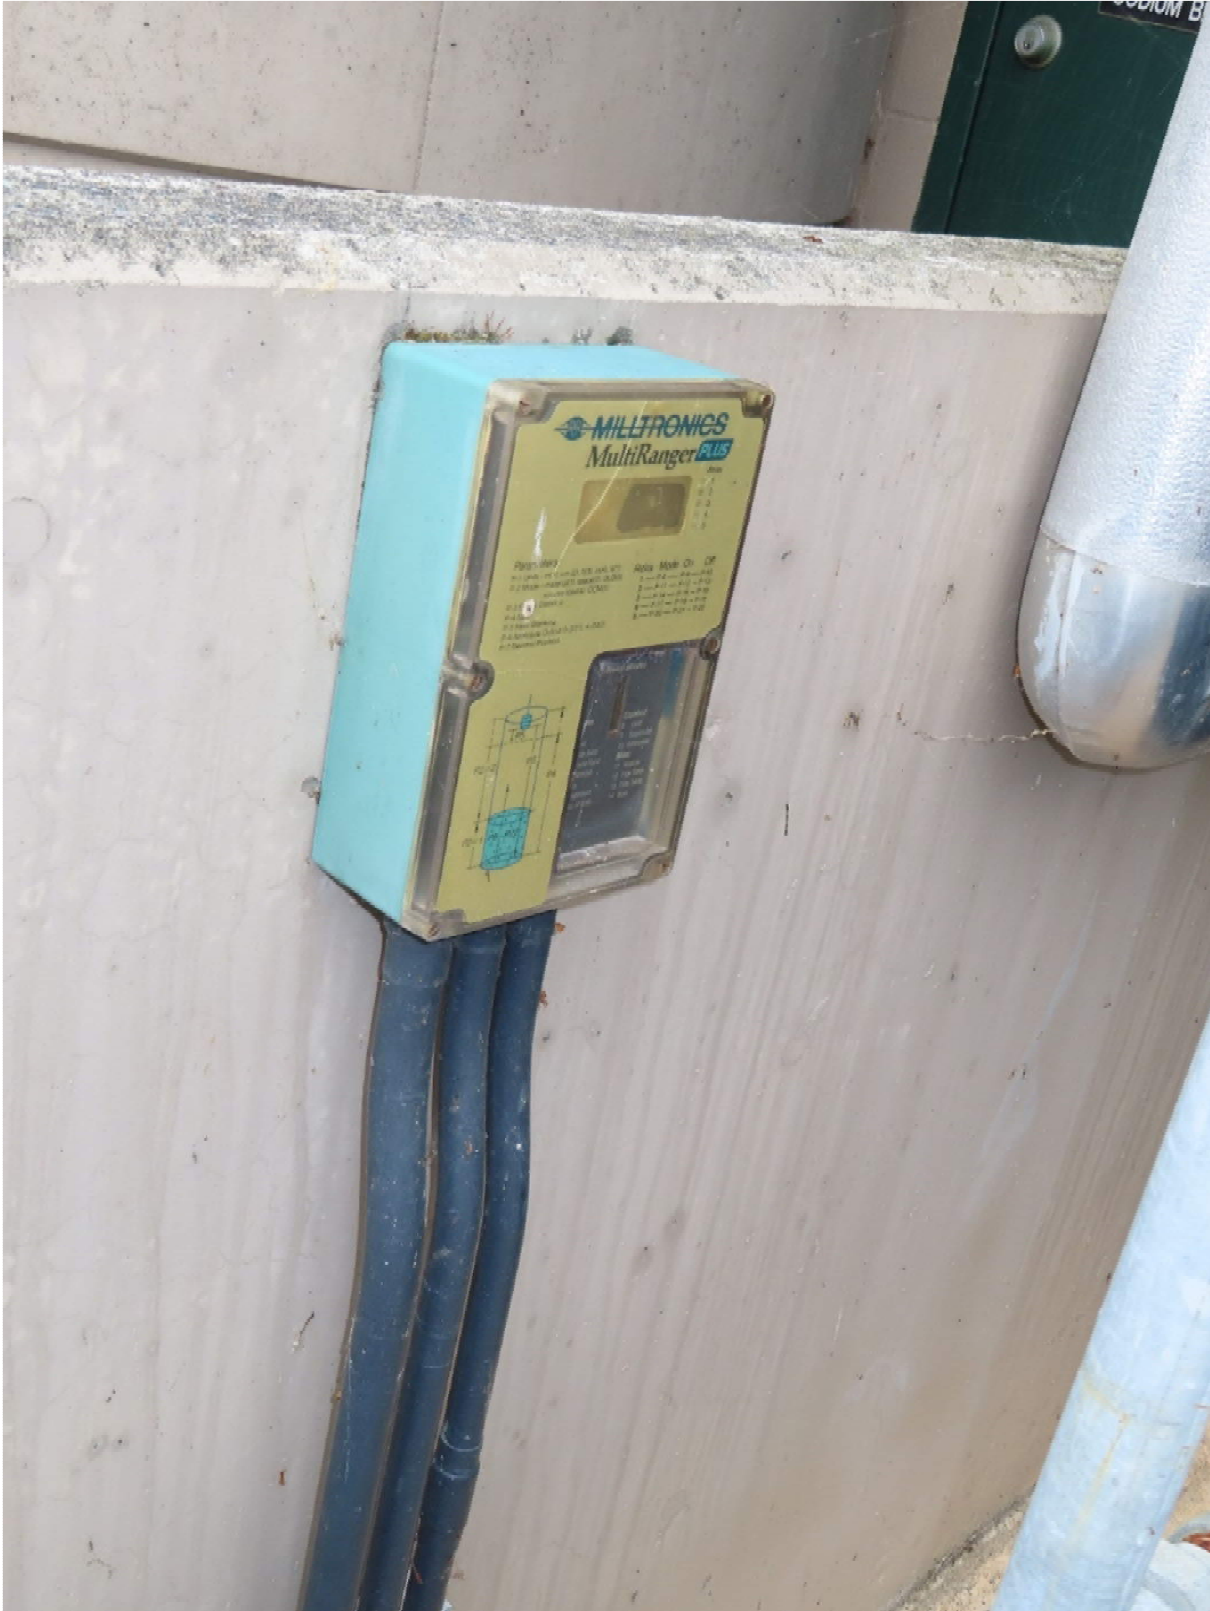
Photo 32. Abandoned the Milltronics transmitter

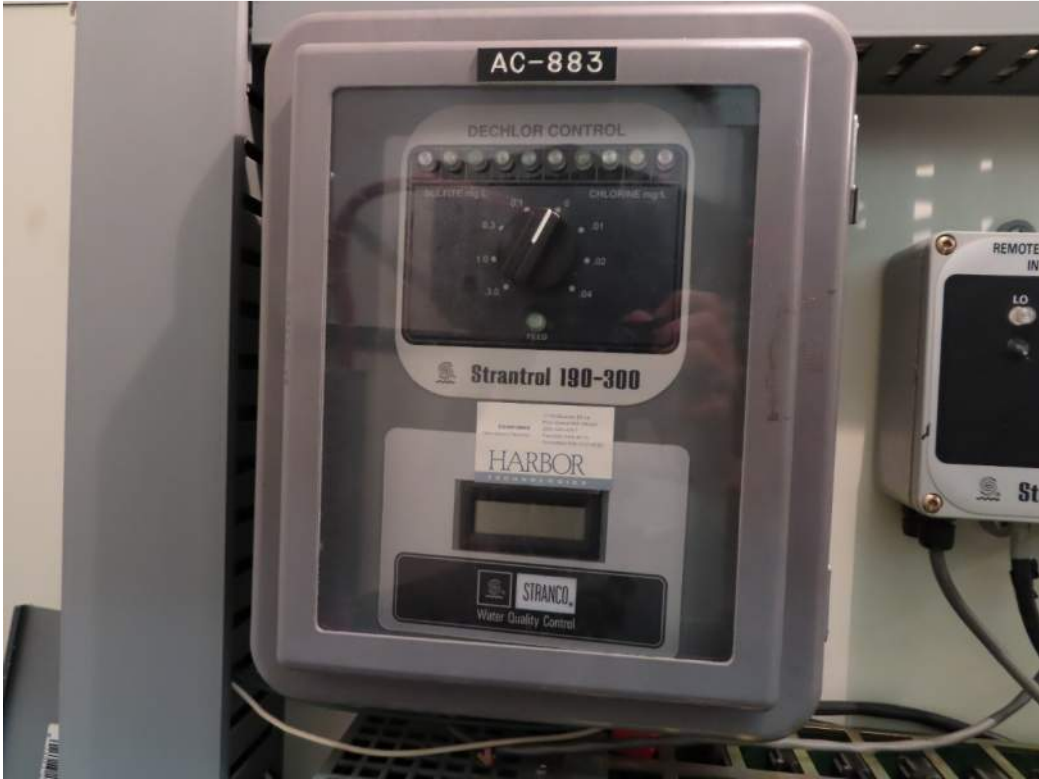
Photo 33. Deenergized Strantrol Dechlor controller

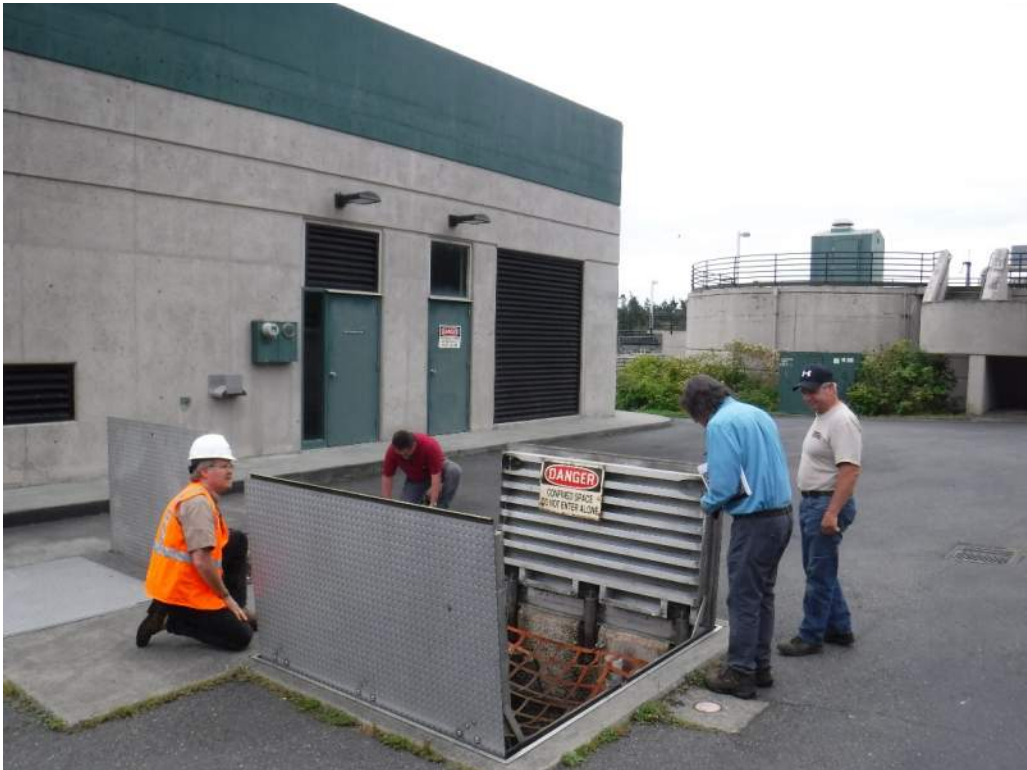
Photo 34. Influent Pump Station, Port Townsend wastewater treatment plant.

- Concrete. Corrosion of the concrete walls and ceiling has exposed the aggregate. It is estimated that the depth of concrete deterioration is ¾- to 1-inch. No exposed reinforcing steel was observed (Photos 34 and 35).
- Electrical. Electrical and I&C conduit and junction boxes appear to be PVC coated, but these are severely corroded where the PVC coating has deteriorated. These instruments, conduit, and ancillary equipment need to be replaced.
- Pump Guide Rails. The pump guide rails appear to be stainless steel. The rails are in good condition, with some discoloration and minor corrosion in the head space.
- Hatch Covers. The aluminum hatch covers are in good condition.

A protective coating is recommended for the interior walls and ceiling of the influent pump station. This protective coating is required to mitigate corrosion of the concrete due to hydrogen sulfide gas. A typical corrosion protection coating for this application would include:

The concrete will continue to deteriorate under the current operating conditions. A protective coating project should be budgeted and scheduled for implementation within the next three to five years.

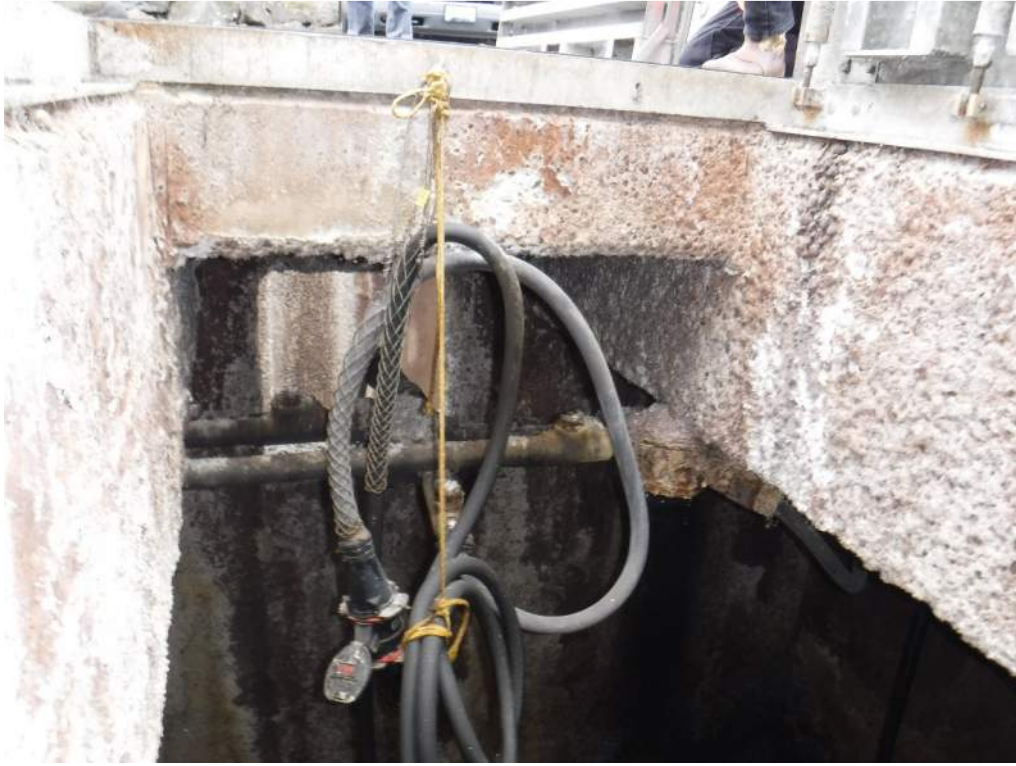
Photo 35. Deteriorated concrete and electrical components, influent wet well. Aluminum covers and stainless steel embeds are in good condition.

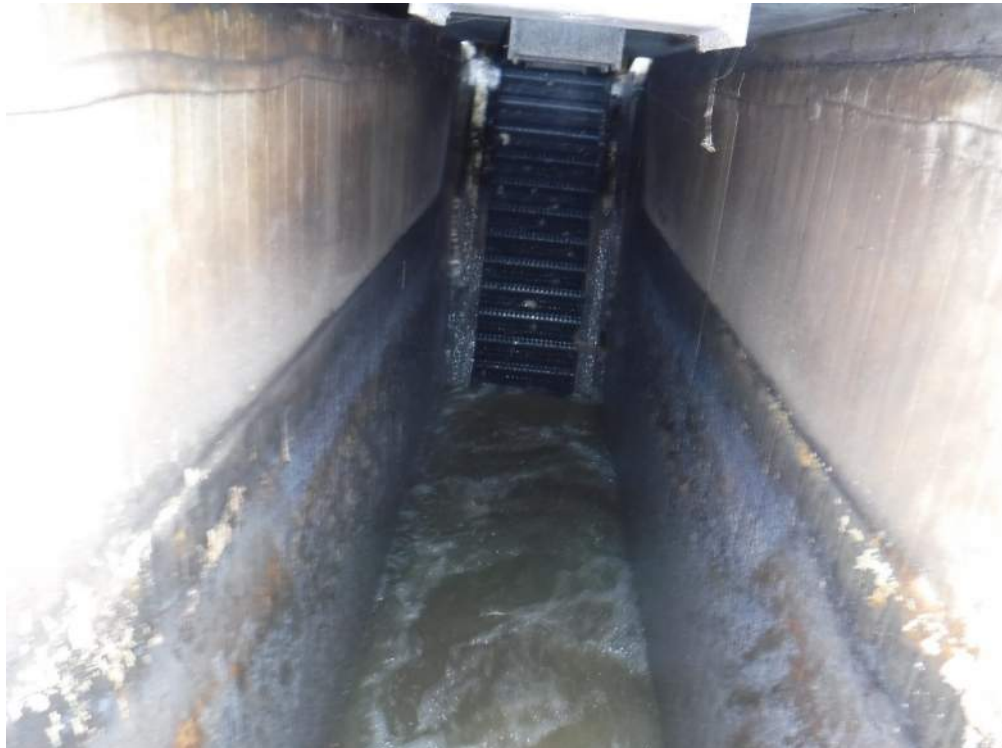
- Embedded Liner. The embedded liner is generally in good condition (Photo 36). There are several isolated locations in the channels where the liner has failed and concrete is corroding.

Photo 36. Traveling screen and embedded plastic liner in good condition.

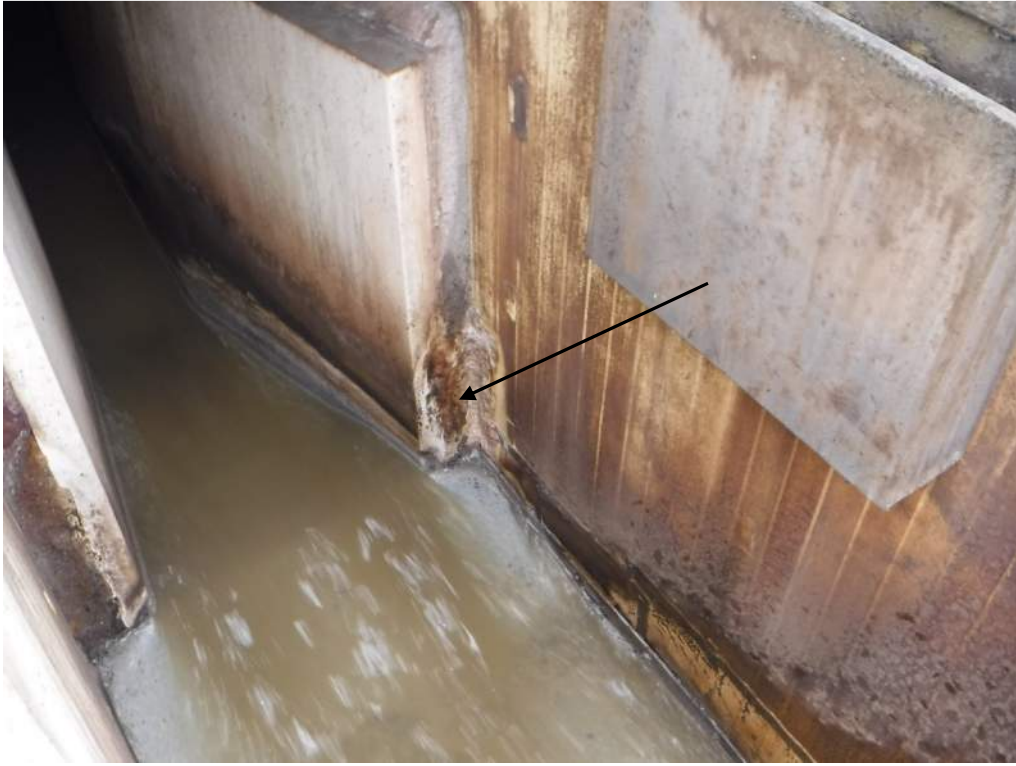
- ✓ Isolated failures were observed at the Parschall Flume (Photo 37).
 - ✓ The embedded liner has failed on a concrete support column in the RAS return basin. It appears that the liner was not completely installed over the cap of the column, and corrosion of the concrete has occurred from the top of the column down, allowing the embedded liner to peel away from the concrete at the corners (Photo 38). The process is turbulent in the RAS return basin, a condition that liberates hydrogen sulfide gas and creates a more corrosive condition.

Photo 37. Concrete is corroding at base of Parschall Flume where embedded liner is ineffective (arrow).

The embedded plastic liner needs to be repaired in several areas of the headworks facility. Significant corrosion of the concrete has occurred on the column in the RAS return basin (the last basin of the headworks). These repairs will need to be performed by a specialty contractor. Smaller repair areas on walls will need to be repaired with plastic liner material. The repairs to the column plastic liner can be repaired by restoring the concrete and replacement of the embedded liner or wrapped with carbon fiber.

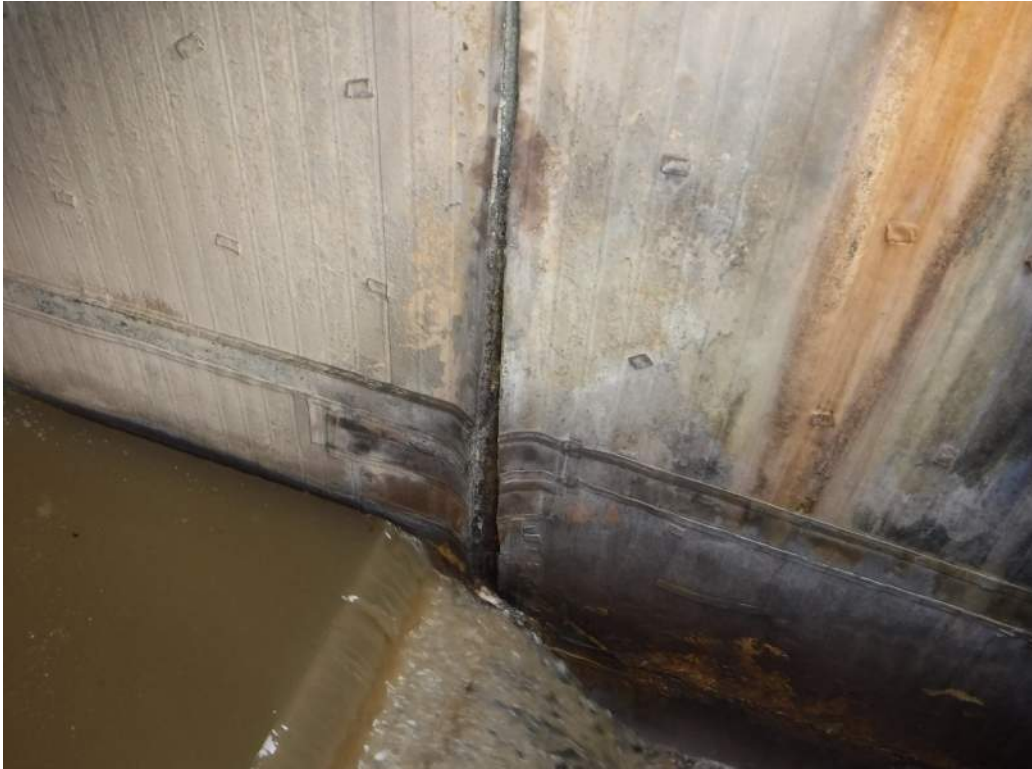
Photo 38. Embedded liner pulling from concrete at temporary gate groove, RAS return basin.

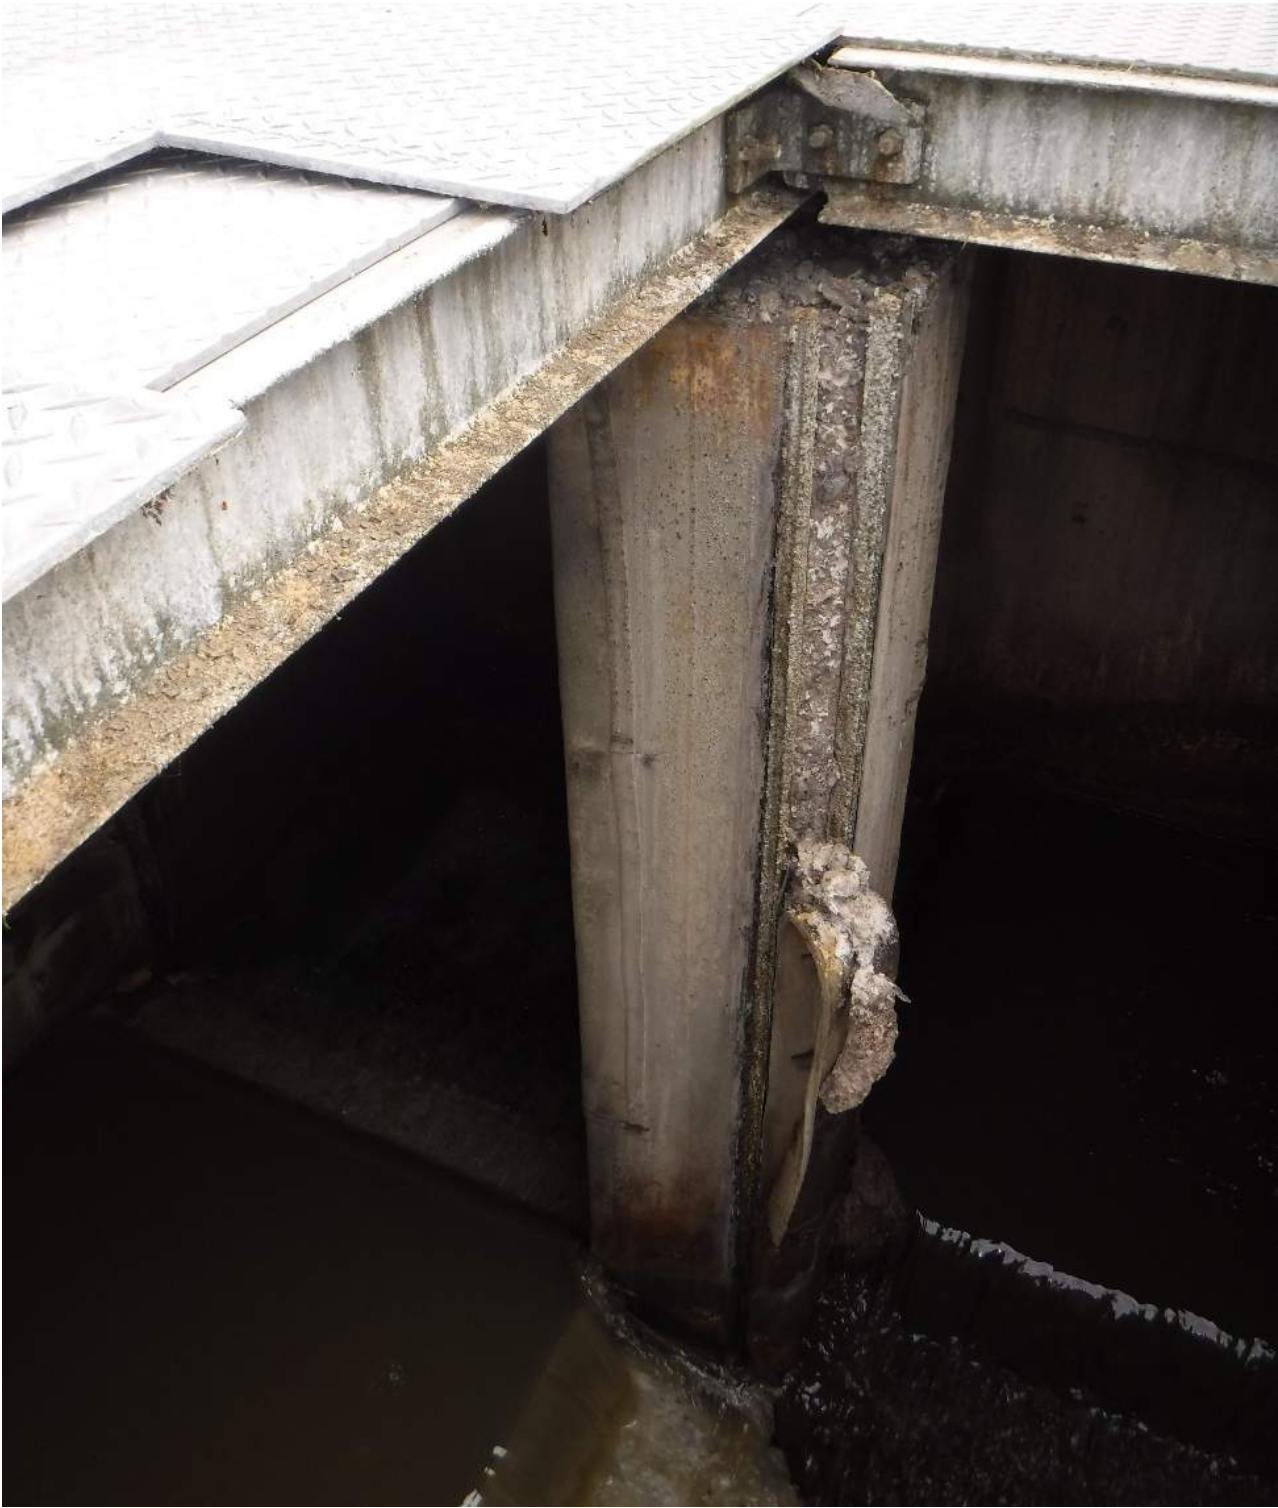
- ✓ Liner failure was also observed in the RAS return basin where the embedded liner was terminated next to stainless steel embeds for temporary gates (Photo 39).

Photo 39. Failure of embedded liner on corners of concrete support column, RAS return basin.

The repairs to the concrete column should be made within the next two years. It will be necessary to bypass the channels and RAS return basin to make these repairs.

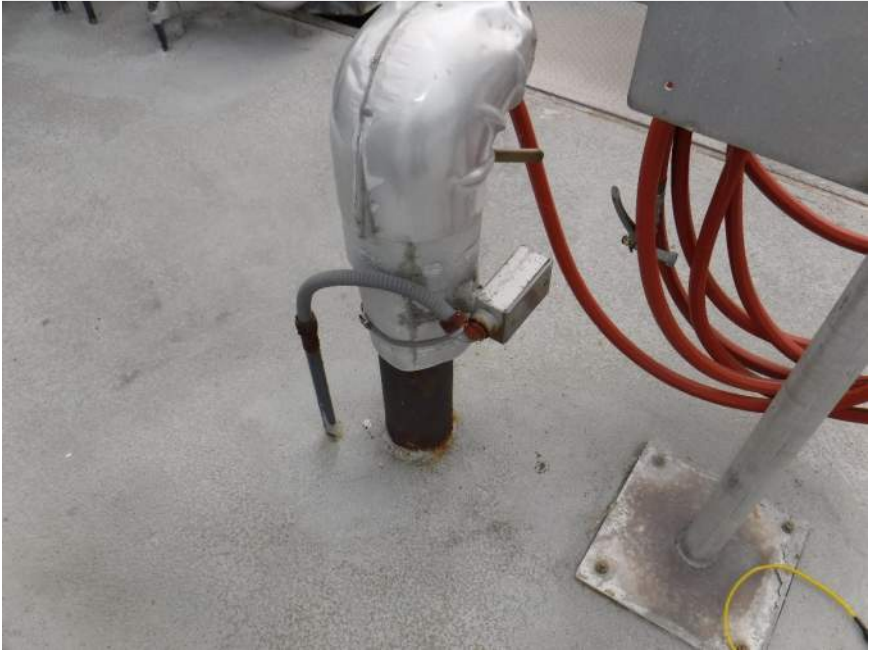
- Gate operator stems and brackets. These appeared to be in good condition.
- Above-Grade Materials, Miscellaneous.
 - ✓ A short section of ductile iron W3 pipe near the traveling screen is not painted (Photo 40).

- ✓ Moderate corrosion was observed where the pipe was not provided with thermal insulation.
 - ✓ Conduit fittings are corroding.
 - ✓ The painted air intakes for the MCC and generator rooms are in good condition.

Photo 40. W3 line corroding wher it is not insulated. Not corrosion on conduit fittings (typical)

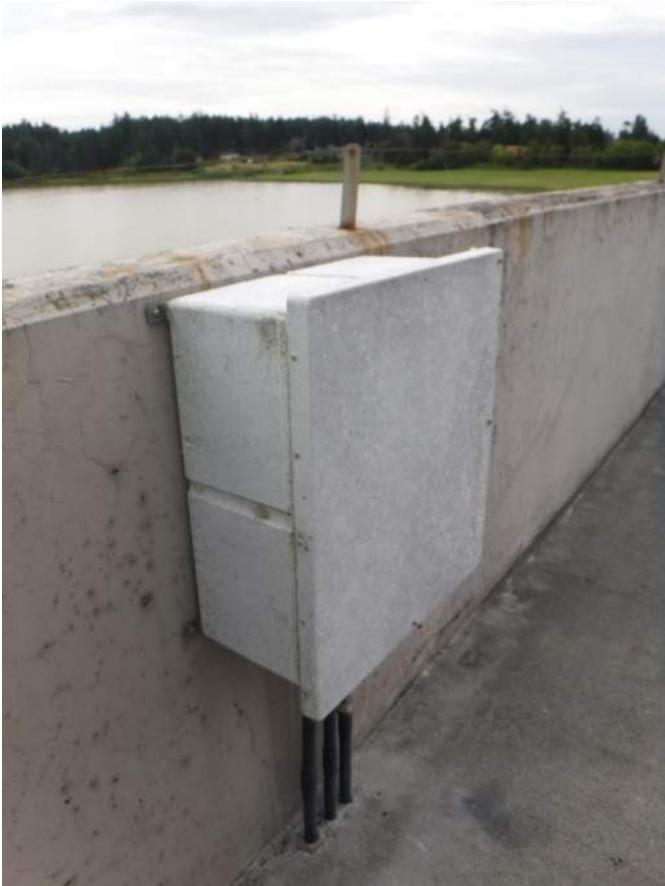
- ✓ A fiberglass box installed to house I&C equipment is starting to deteriorate from UV exposure (Photo 41).
 - ✓ The stainless steel and painted steel electrical enclosures appear to be in good condition.

Photo 41. Fiberglass box housing instrument panel, subject to UV deterioration (east side of headworks).

- Some fiberglass enclosures housing various I&C equipment are deteriorating due to UV exposure. The enclosures can be painted to reduce the rate of deterioration and exposure of glass fibers. The procedure would consist of cleaning with biodegradable detergent, light sanding to remove exposed fibers, and painting with two coats of a high-quality latex paint.
- The short section of W3 pipe on the headworks roof that is not insulated should be painted with epoxy.
- The aluminum light standards are in very good condition, but it was noted that screws on the electrical covers are either galvanized or carbon steel. They should be replaced with stainless steel.

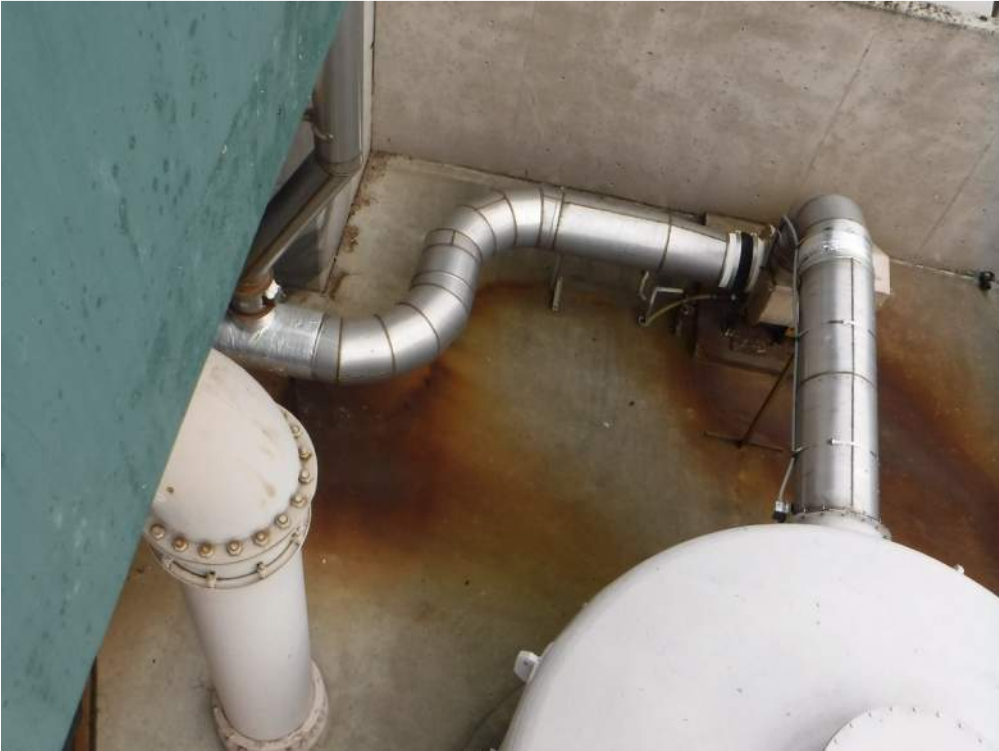
- Odor Control Duct.
 - ✓ The stainless steel odor control duct on the top of the headworks appears to be in good condition.
 - ✓ The vertical stainless steel odor control duct has some external staining, and may have some small wall penetrations at a weld due to internal corrosion.
 - ✓ The horizontal stainless steel odor control duct at grade level has numerous pipe wall penetrations due to internal corrosion (Photos 42 and 43). Most, but not all, of the penetrations are at the bottom of the duct.
- Fan. Some surface corrosion was observed on the fan housing.
- Fiberglass Filter Tank. No corrosion issues were observed.

Photo 42. Rust staining on concrete floor under stainless steel odor control duct with penetrations caused by internal corrosion.

In addition to modifying the odor control capacity, the odor control duct from the top of the headworks to the filter tank has been penetrated by corrosion and will need to be replaced. At this point, the holes are small. However, they will become larger as corrosion inside the duct continues. The duct should be scheduled for replacement within one to two years. Polymer-lined, stainless steel duct has been used successfully on several recent wastewater treatment plant projects and would be a suitable option for this installation.

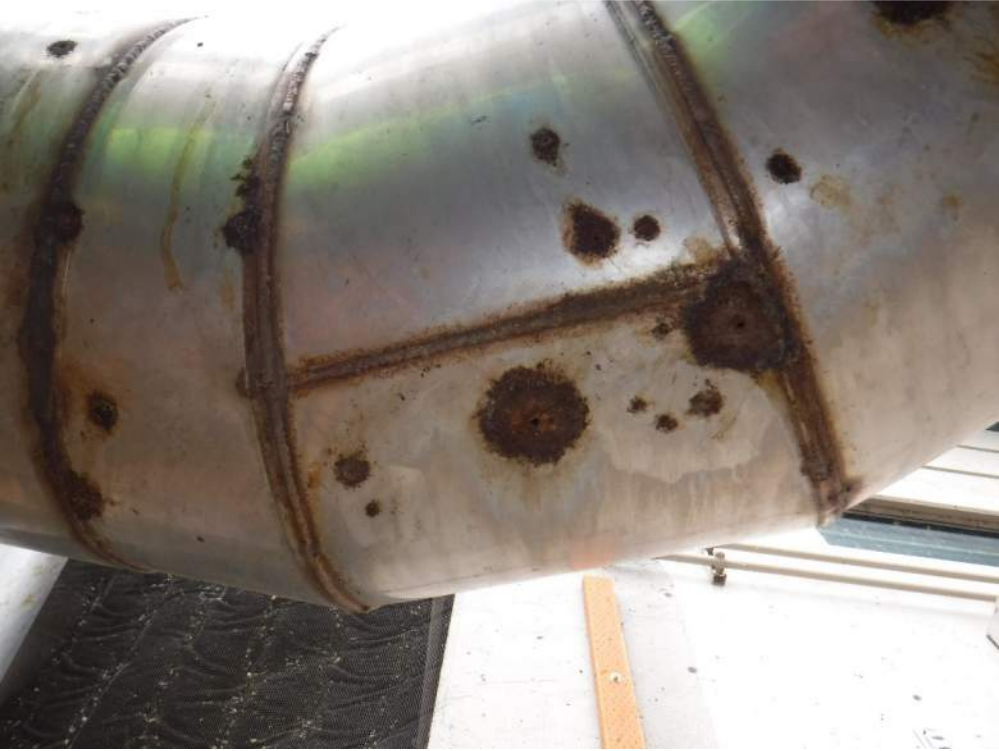
Photo 43. Typical penetrations in stainless steel odor control duct caused by internal corrosion.

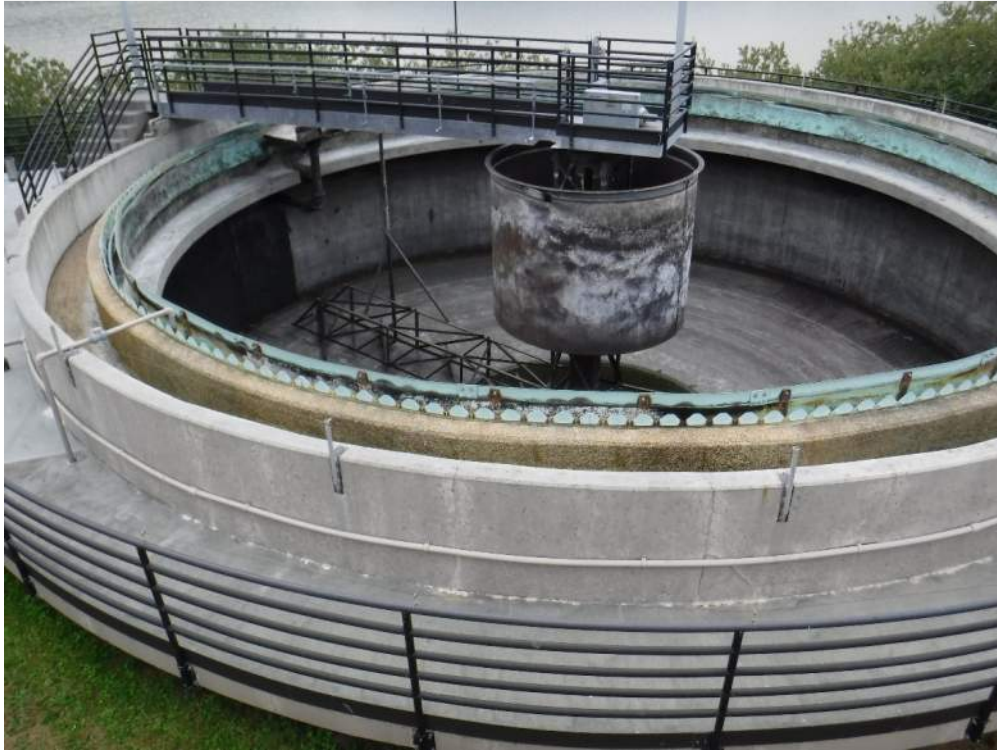
- The south secondary clarifier was drained and available for visual observation (Photo 44).
- Clarifier Mechanism.
 - ✓ The paint on the secondary clarifier mechanism is maintained on a regular basis by plant staff. There are some areas where minor corrosion is occurring at coating defects (Photo 45). Overall, the paint system is in good condition considering its age.

Photo 44. South secondary clarifier, empty at the time of inspection.
