Port Townsend Condition Assessment

Summary Report

September 11, 2019

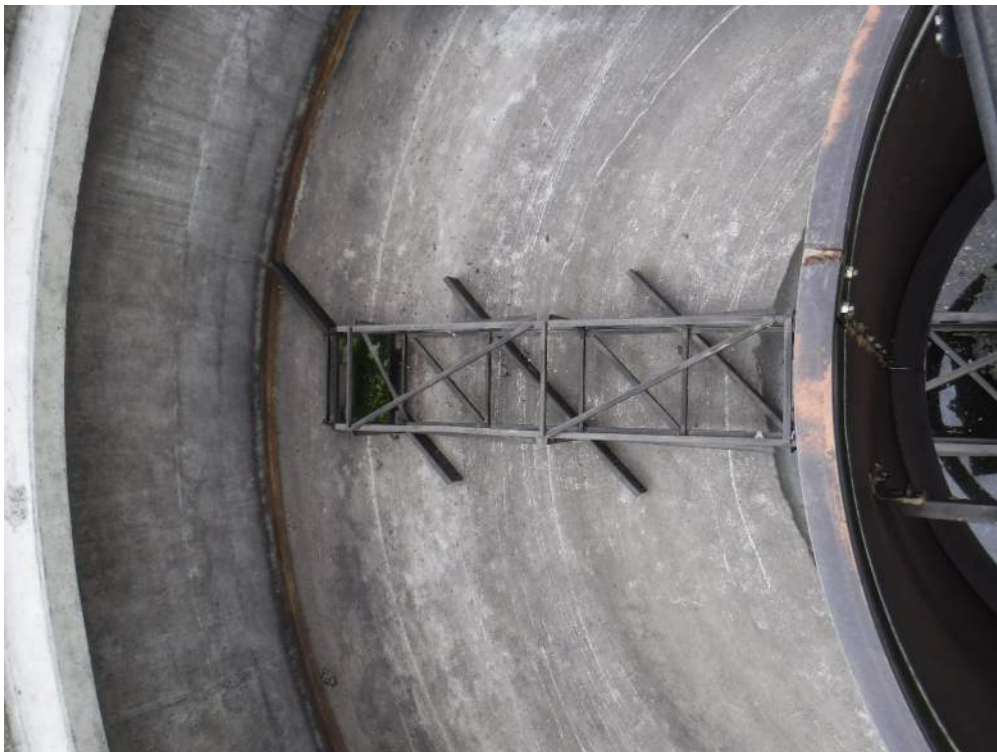
- The south secondary clarifier was drained and available for visual observation (Photo 44).
- Clarifier Mechanism.
 - ✓ The paint on the secondary clarifier mechanism is maintained on a regular basis by plant staff. There are some areas where minor corrosion is occurring at coating defects (Photo 45). Overall, the paint system is in good condition considering its age.

Photo 45. Clarifier mechanism rake arm and well. Note coating deterioration on top of well angle (red primer is showing). Some corrosion is occurring on rake arms where coating has failed.

- The coating on the secondary clarifier mechanisms is over 25 years old. It appears to be in relatively good condition, but epoxy coatings on steel in this environment generally have a service life of 20 to 25 years. Budget for recoating should be set aside for a project to be implemented in the next 5 to 10 years for both of these mechanisms. The actual date for repainting can be determined based on periodic observation of the mechanisms by City staff. There is no need to undertake the recoating until it is determined to be necessary. This project would require outside consulting services to develop a bidding document to procure a contractor to do this work.

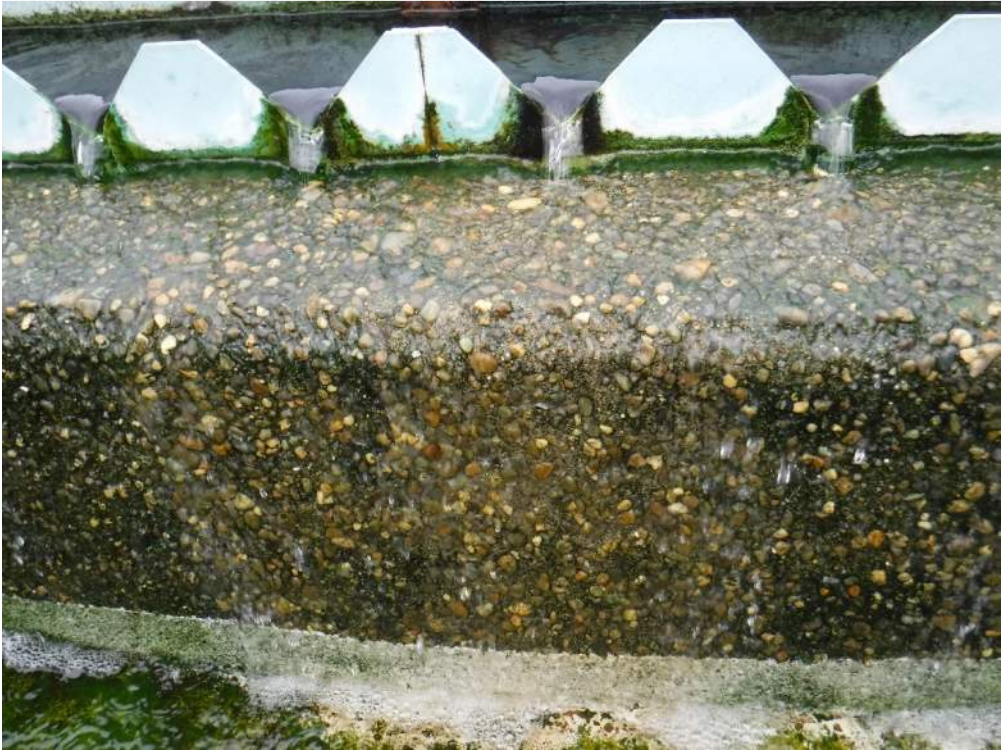
Photo 46. Exposed aggregate in launder, north secondary clarifier.

- Leaching has occurred on the concrete launders for each of the two secondary clarifiers. It is possible to coat these items with epoxy coating, but it will introduce potential coating maintenance for plant staff. The amount of concrete leaching currently does not warrant installation of a protective coating. However, WWTP staff should monitor and document the pace of corrosion and consider coating the launders in the future if concrete deterioration significantly increases. This project would require outside consulting services to develop a bidding document to procure a contractor to do this work.

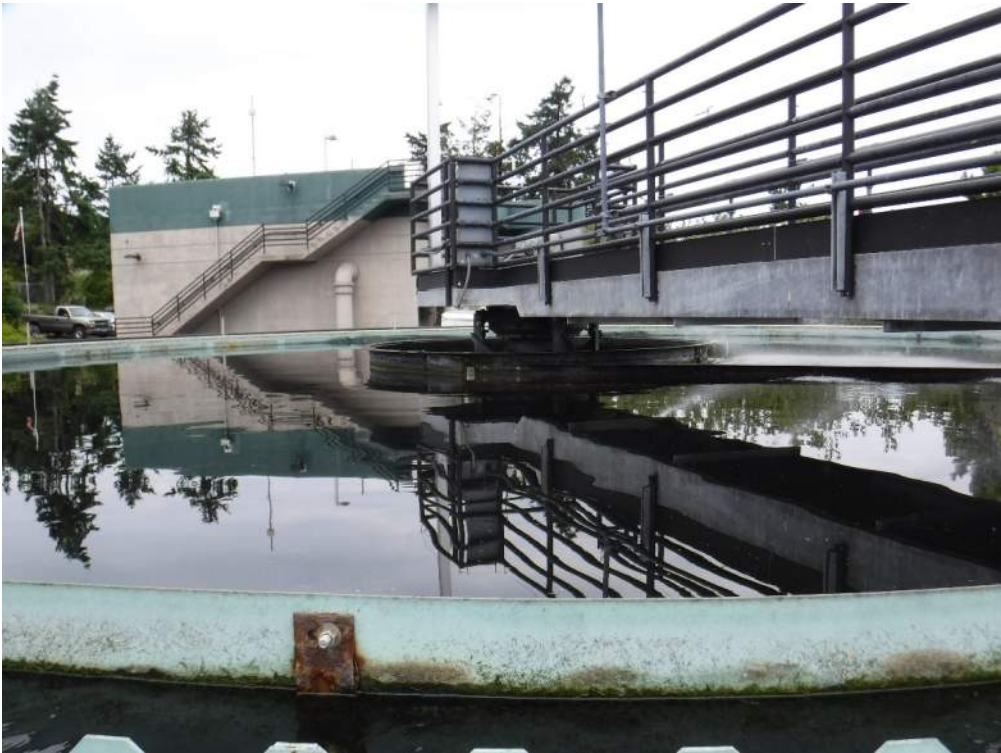
- ✓ The fiberglass weirs and baffles are in good condition.
 - ✓ Stainless steel hardware is in good condition.
 - ✓ Carbon steel support brackets are corroding (Photo 47).

Photo 47. Corroding carbon steel baffle support bracket, north secondary clarifier.

- The carbon steel weir support brackets should be replaced with stainless steel. The brackets do not appear to be in imminent risk of failure, so this activity could be scheduled to occur with a mechanism repainting project – in the next 5 to 10 years. This work could be done by City staff.
