# Tree Preservation Plan- Landmark Live Oak 1520 Lawrence Street

Richard R Hefley

Consulting Arborist – TRAQ Certified – ISA# PN784A

**Draft Date :** 03/13/2026

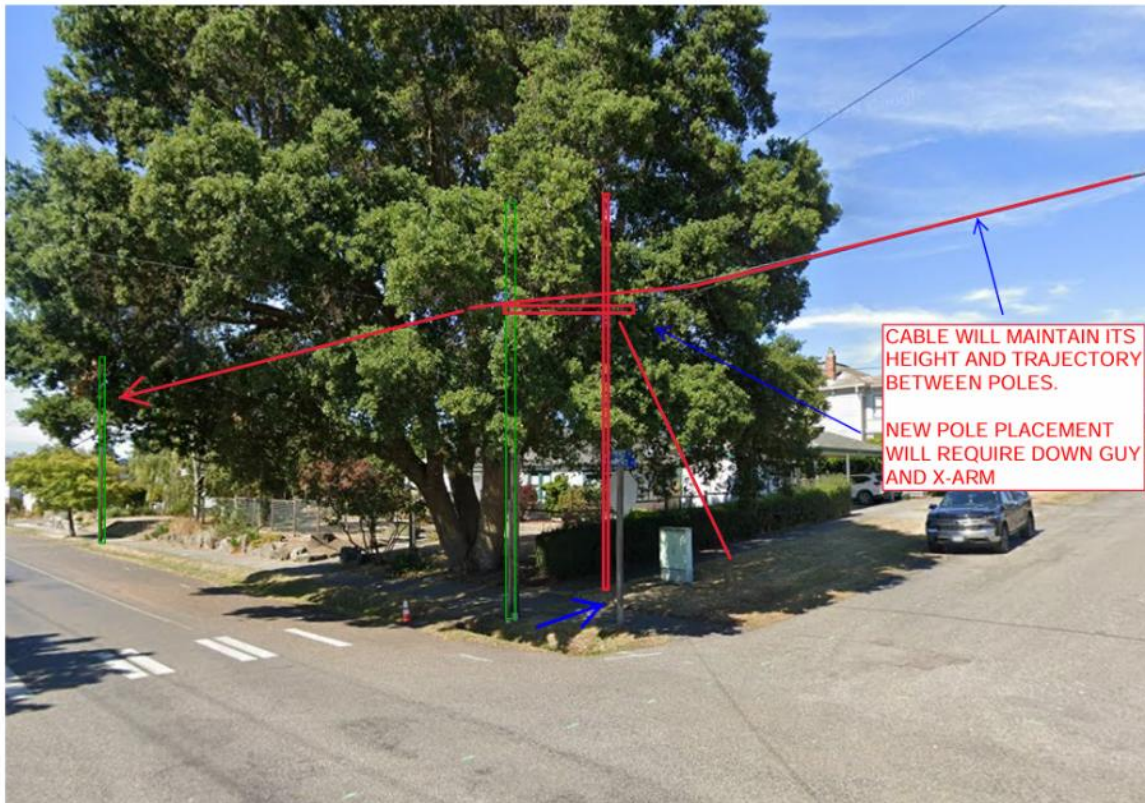
The aboveground utility lines are not indicated to be altered. These lines are in contact with a few of the lower limbs of the Oak. If limbs are required to be pruned these actions should be done under the direction of a certified arborist and in accordance with ANSI A300 pruning specifications. The limbs in contact with the utility lines comprise a small fraction of the canopy volume of this tree and should have no measurable impact if pruning is required. (No pruning is best, but if it must be done it should not measurably affect the health of this tree)

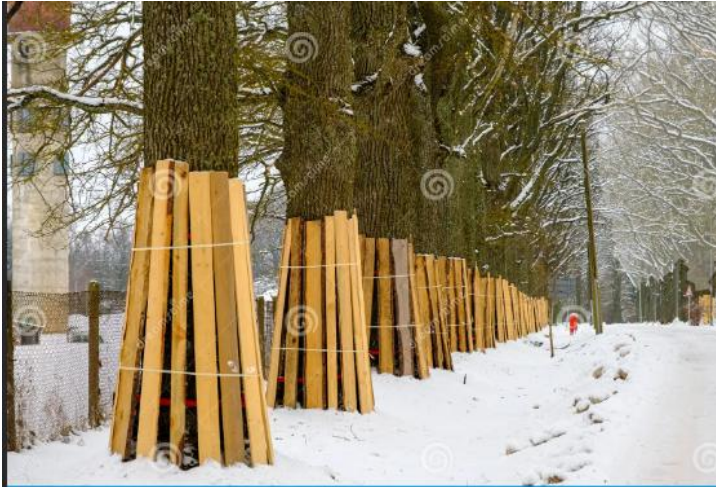
Left -  
simple trunk padding to prevent metal from contacting soft trunk wood. There are many varieties of trunk padding, but it must be sturdy enough to withstand some machinery contact but not abrasive that the contact will transfer damages to the trunk (use wood, not rebar).

----- Protect the trunk from contact with machinery.

Padding the trunk with a thick material to prevent metal contacting the wood can be as simple as vertical 2x4s attached to the trunk at close enough intervals to prevent machinery from contact.

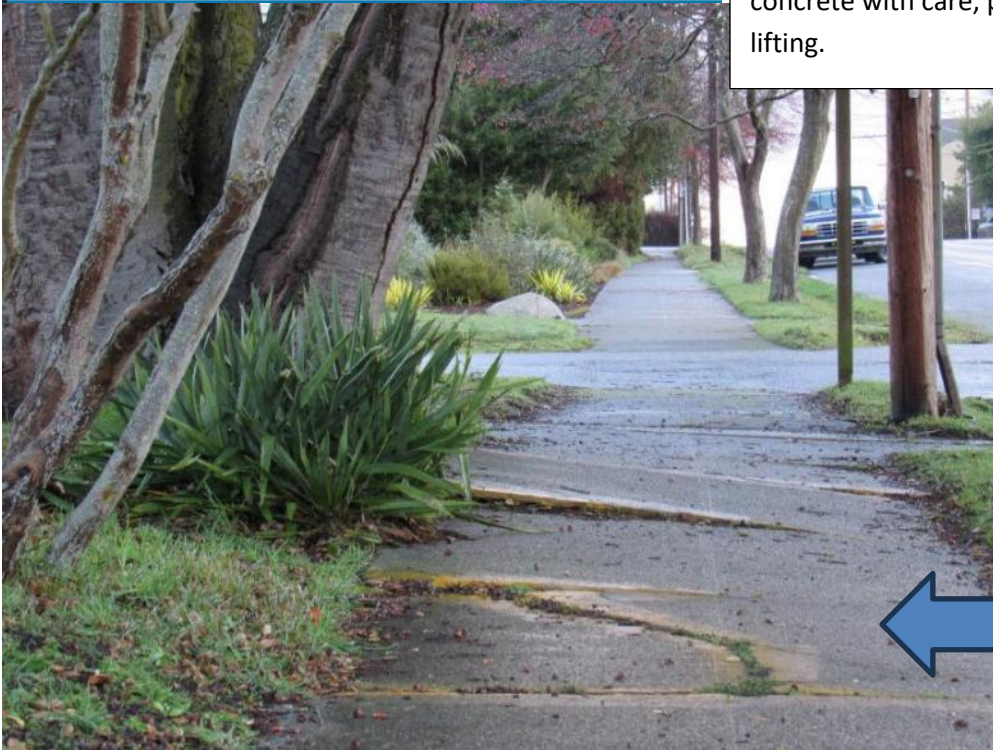
As noted in the following photo, the **existing sidewalk** is very close to the trunk of this Landmark Live Oak, resulting in fractures and heaving of the concrete due to the increasing diameter of large roots beneath the pavement.

Below – large buttress roots are located beneath this concrete. Remove the concrete with care, preferably by lifting.

*\*While working near the trunk, lift concrete sections with care to avoid damage to large roots likely located just below the bottom of the concrete. If pavement fractures, remove by hand. Otherwise a bucket with a thumb may be more practical. Avoid dragging the concrete sections as that may cause significant root damage to shallow large roots.*

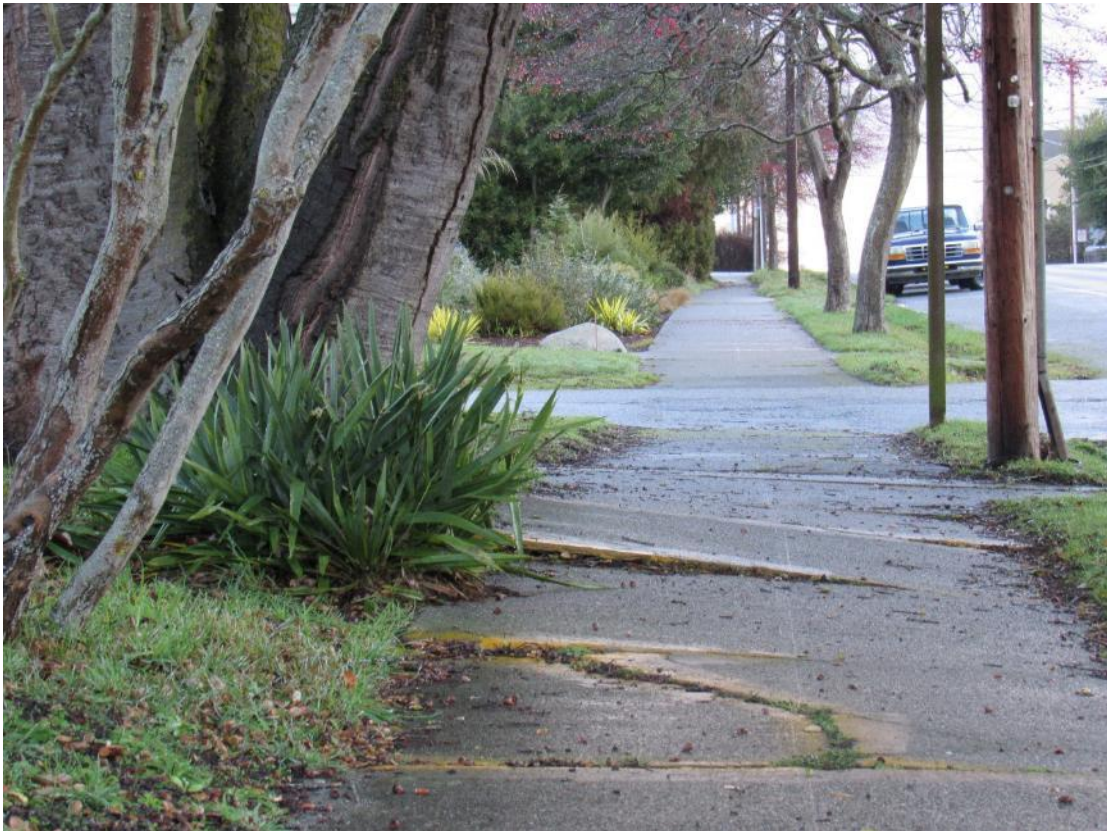
Large shallow roots are likely near the surface below this section of sidewalk. Extreme care should be taken to not damage roots with equipment. Hand removals are best. Having an arborist on site to mitigate potential root damage would be wise.

- 6. Use special care when removing the sections of sidewalk pavement parallel to Lawrence Street. There are likely large buttress roots immediately below the pavement which should not be damaged by equipment, dragging, or dropping concrete sections onto exposed roots. It is recommended that an arborist be on site during this portion of the project.**
