GEOTECHNICAL REPORT
Madrona Ridge Residential Development
Rainier Street
Port Townsend, Washington
Prepared for: Montebanc Management, LLC

Project No. 210338 • August 11, 2021 FINAL

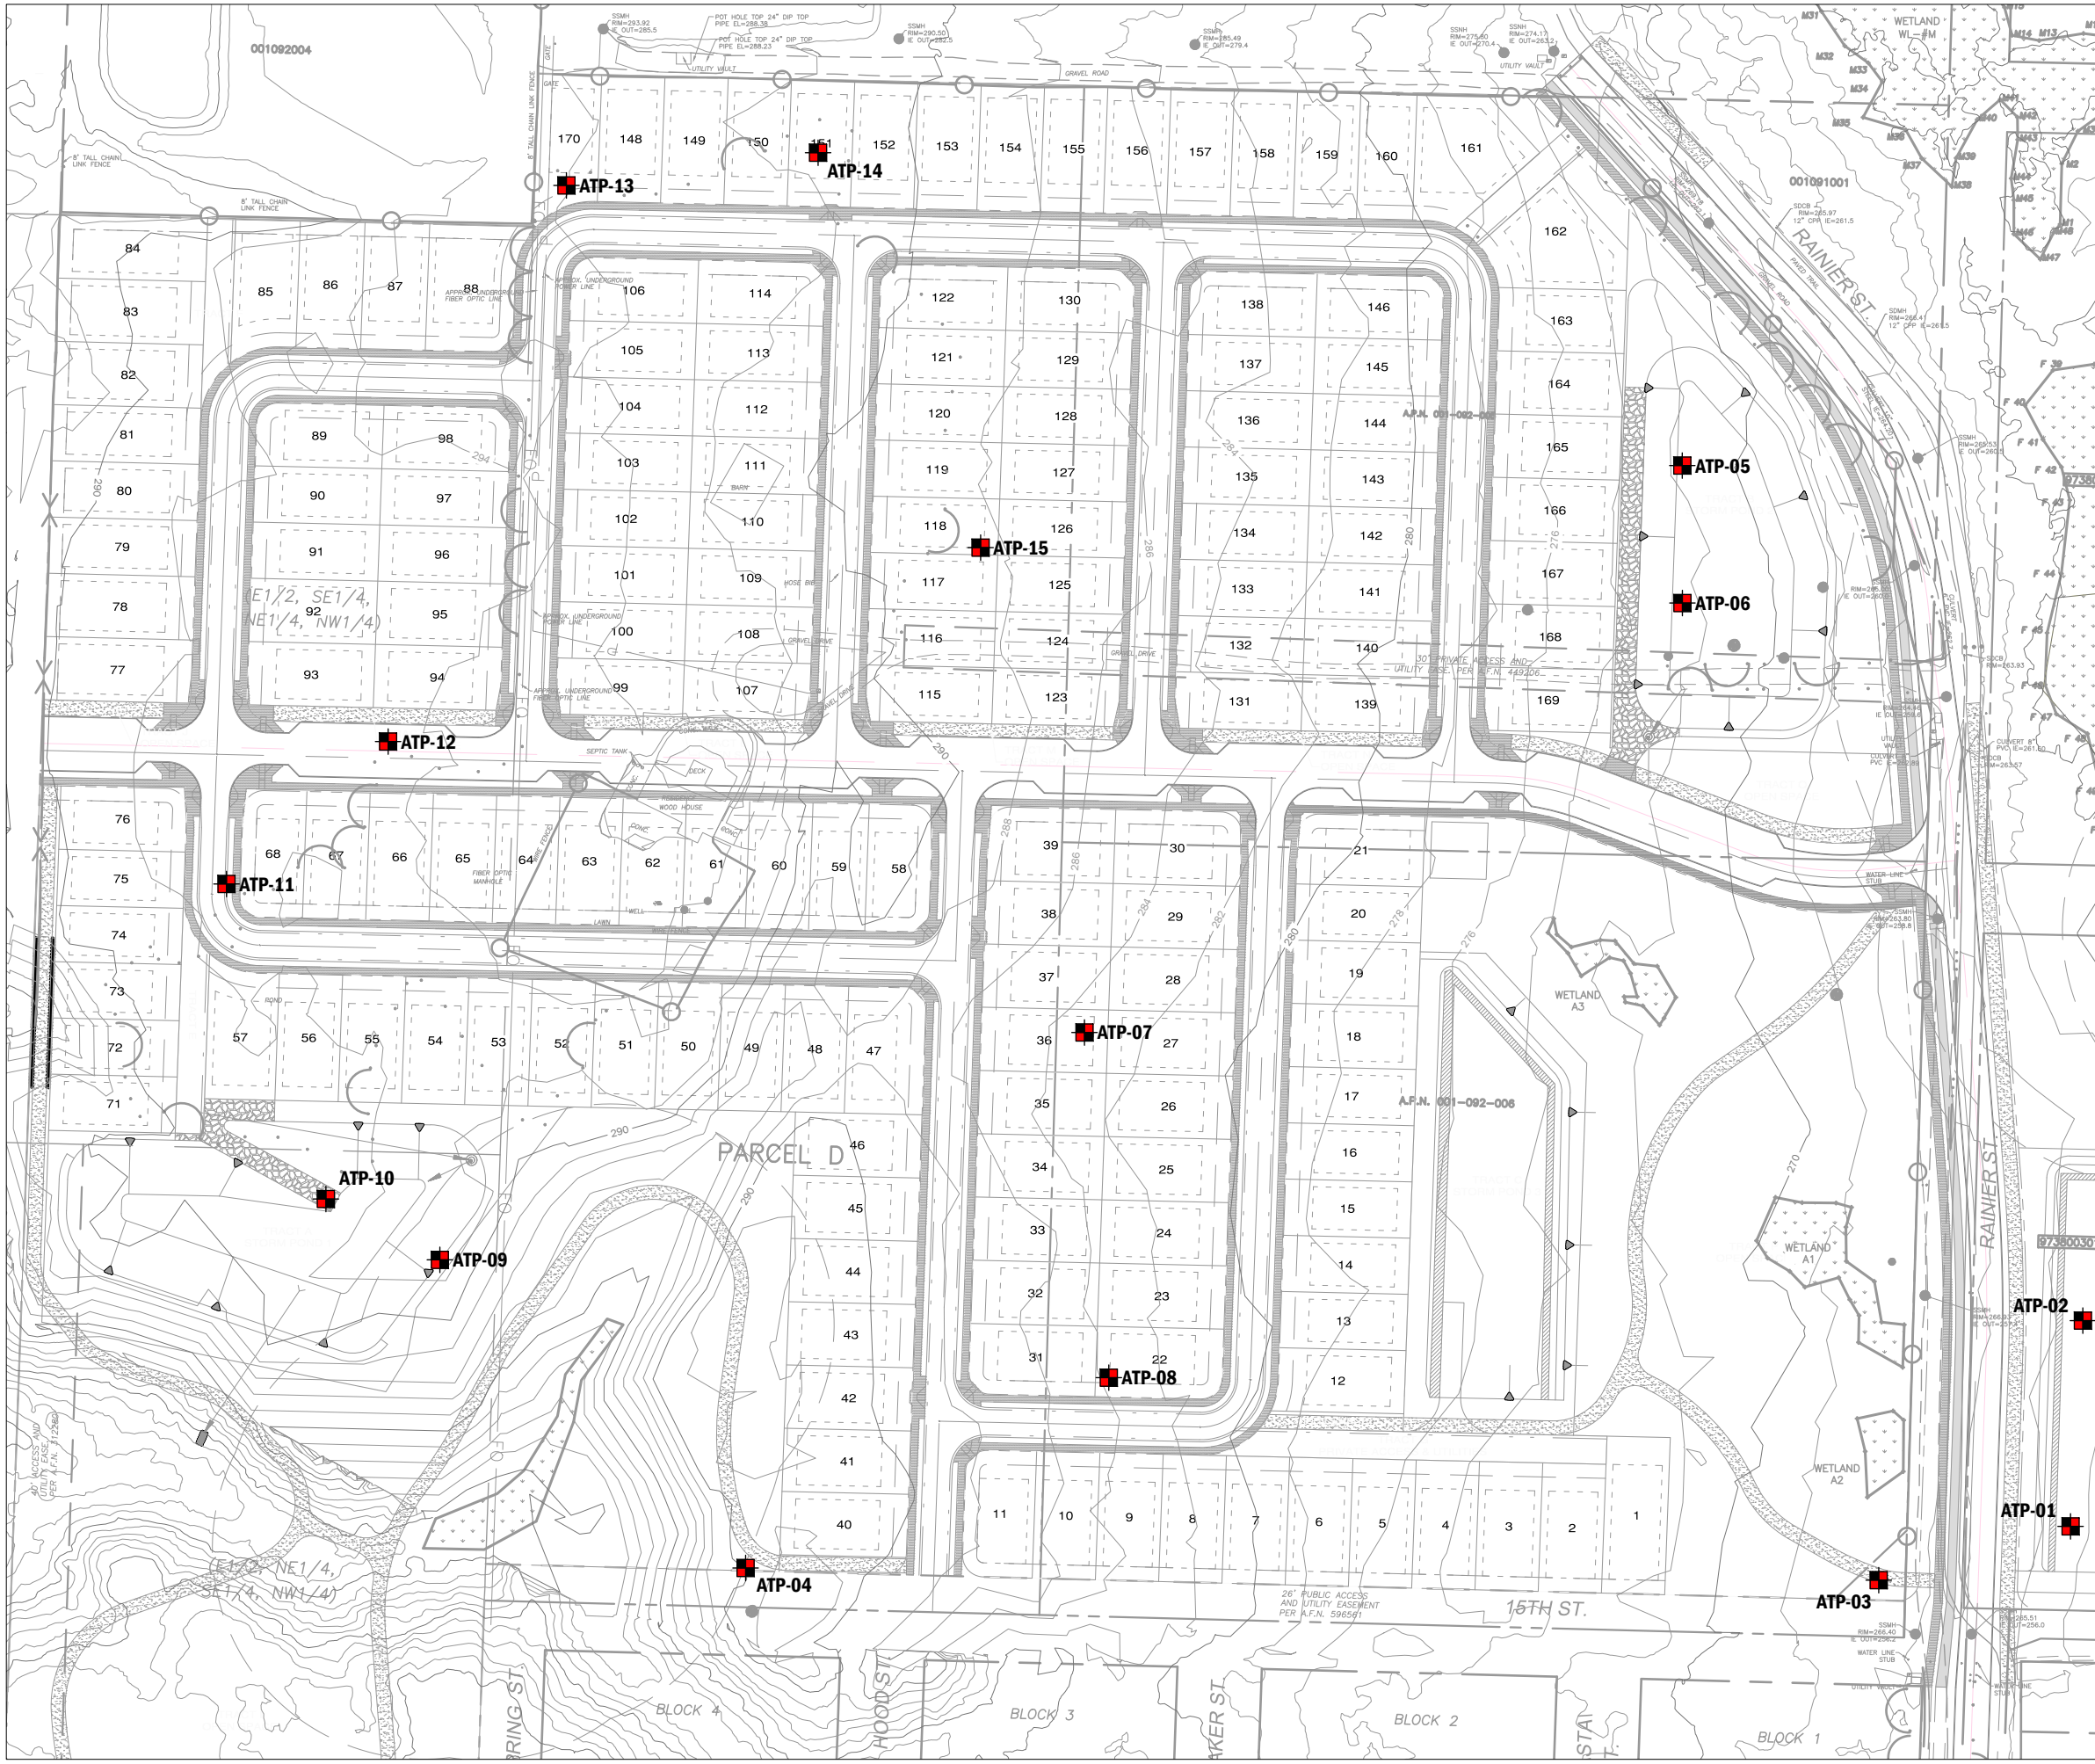
- Test Pit Location
- Elevation Contour (2 Foot Interval)

Aspect conducted a subsurface investigation on July 8, 2021, to collect subsurface soil and groundwater information. Fifteen test pits, ATP-01 through ATP-15, were excavated to depths of 6 to 12 feet below the existing ground surface (bgs). A summary of our field explorations, including geologic soil units and groundwater observations, are presented in the following sections. Detailed descriptions of the subsurface conditions encountered in our explorations, as well as the depths where characteristics of the soils changed, are on the test pit logs presented in Appendix A. Locations of the explorations are shown on Figure 2.

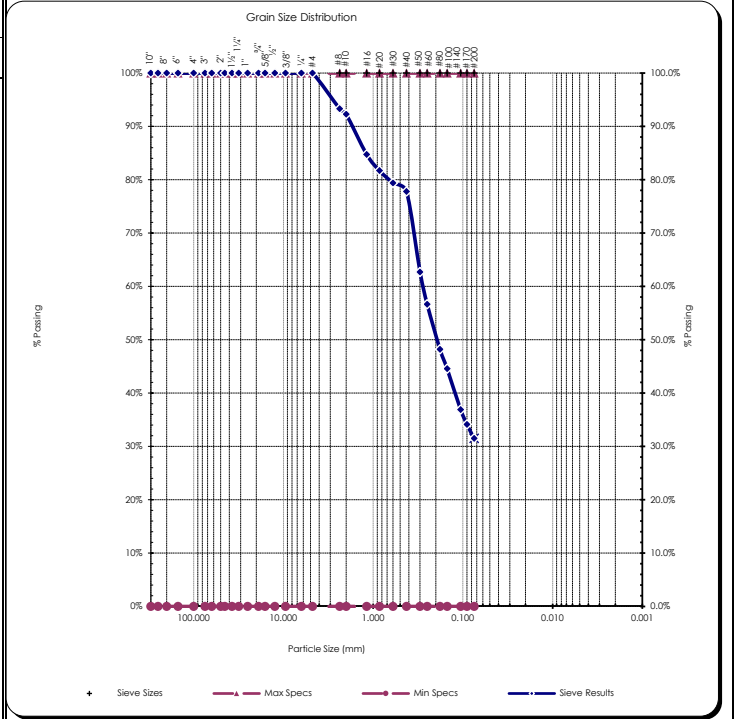
#40	0.425	78%	78%	100.0%	0.0%
#50	0.300		63%	100.0%	0.0%
#60	0.250		57%	100.0%	0.0%
#80	0.180		48%	100.0%	0.0%
#100	0.150	45%	45%	100.0%	0.0%
#140	0.106		37%	100.0%	0.0%

#170	0.090		34%	100.0%	0.0%
#200	0.075	31.5%	31.5%	100.0%	0.0%

Exploration Number	Sample Depth (feet bgs)	Percent Gravel	Percent Sand	Percent Fines	Moisture Content (percent)	USCS
ATP-01	6	0	68.5	31.5	5.8	SM
ATP-01	9.5	0	67.8	32.2	5.3	SM
ATP-02	2	0	79.8	20.2	6.2	SM
ATP-05 + ATP-06	4	8.3	57.9	33.8	10.5	SM
ATP-09	6	11.5	53.0	35.5	5.5	SM
ATP-10	2	6.5	59.1	34.4	8.9	SM

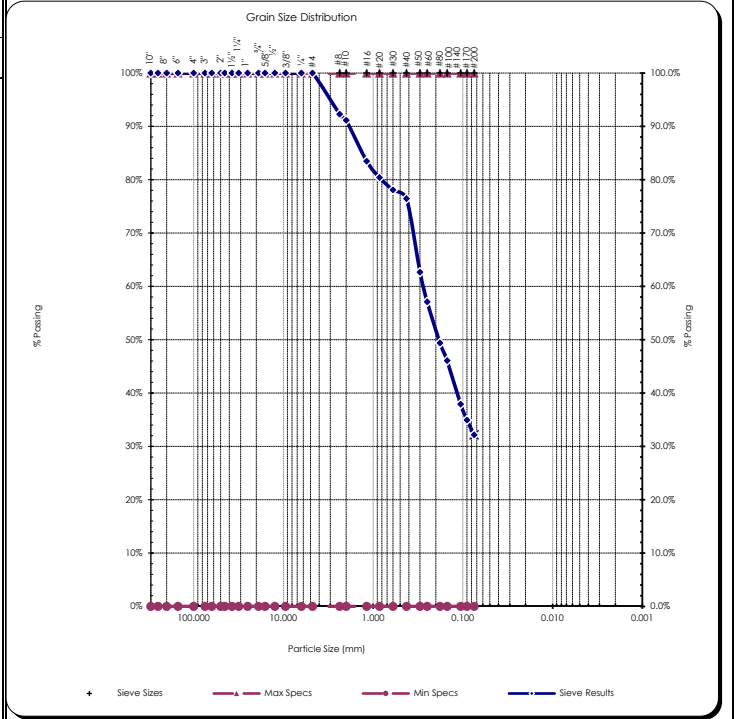
#40	0.425	76%	76%	100.0%	0.0%
#50	0.300		63%	100.0%	0.0%
#60	0.250		57%	100.0%	0.0%
#80	0.180		49%	100.0%	0.0%
#100	0.150	46%	46%	100.0%	0.0%
#140	0.106		38%	100.0%	0.0%

#170	0.090		35%	100.0%	0.0%
#200	0.075	32.2%	32.2%	100.0%	0.0%

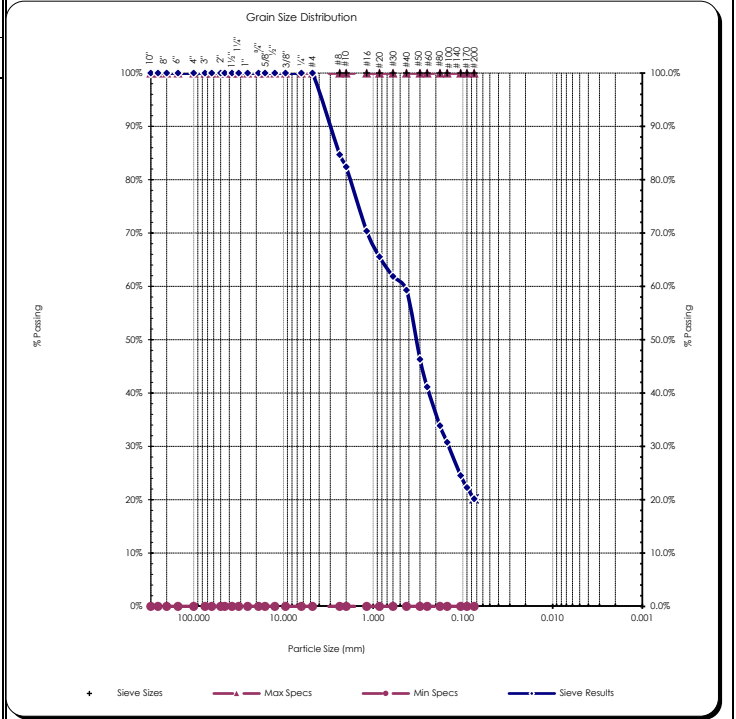
#40	0.425	59%	59%	100.0%	0.0%
#50	0.300		46%	100.0%	0.0%
#60	0.250		41%	100.0%	0.0%
#80	0.180		34%	100.0%	0.0%
#100	0.150	31%	31%	100.0%	0.0%
#140	0.106		25%	100.0%	0.0%

#170	0.090		22%	100.0%	0.0%
#200	0.075	20.2%	20.2%	100.0%	0.0%

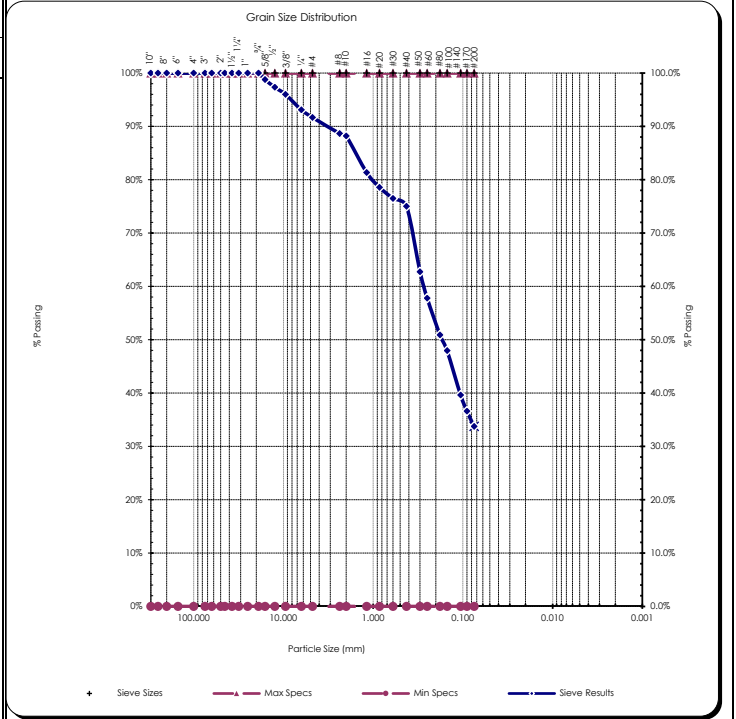
#40	0.425	75%	75%	100.0%	0.0%
#50	0.300		63%	100.0%	0.0%
#60	0.250		58%	100.0%	0.0%
#80	0.180		51%	100.0%	0.0%
#100	0.150	48%	48%	100.0%	0.0%
#140	0.106		40%	100.0%	0.0%

#170	0.090		37%	100.0%	0.0%
#200	0.075	33.8%	33.8%	100.0%	0.0%

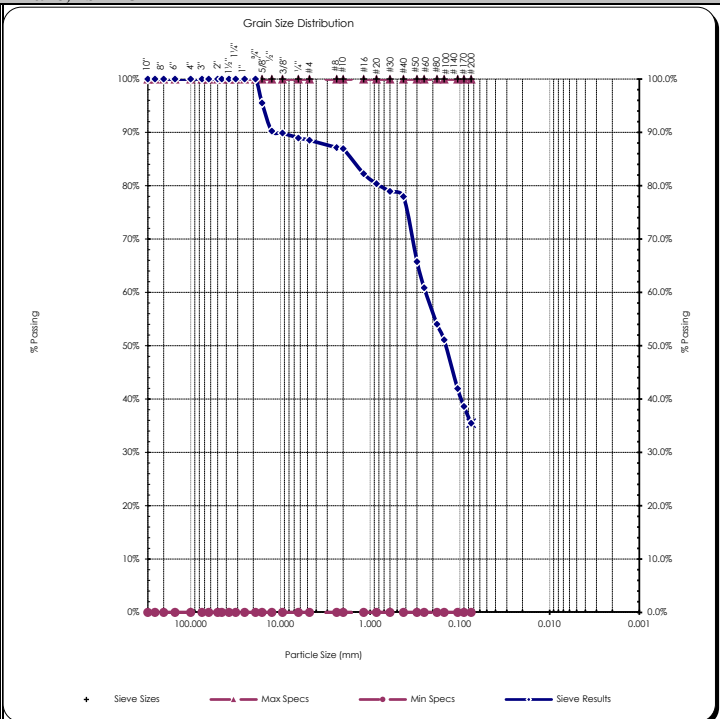
#40	0.425	78%	78%	100.0%	0.0%
#50	0.300		66%	100.0%	0.0%
#60	0.250		61%	100.0%	0.0%
#80	0.180		54%	100.0%	0.0%
#100	0.150	51%	51%	100.0%	0.0%
#140	0.106		42%	100.0%	0.0%

#170	0.090		39%	100.0%	0.0%
#200	0.075	35.5%	35.5%	100.0%	0.0%

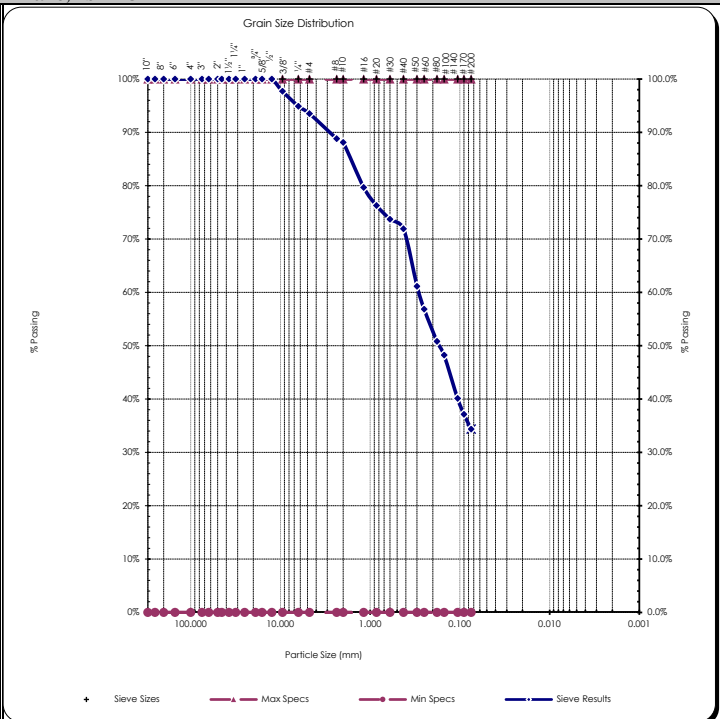
#40	0.425	72%	72%	100.0%	0.0%
#50	0.300		61%	100.0%	0.0%
#60	0.250		57%	100.0%	0.0%
#80	0.180		51%	100.0%	0.0%
#100	0.150	48%	48%	100.0%	0.0%
#140	0.106		40%	100.0%	0.0%

#170	0.090		37%	100.0%	0.0%
#200	0.075	34.4%	34.4%	100.0%	0.0%
