*Subsurface Exploration, Geologic Hazard, and  
Preliminary Geotechnical Engineering Report*

## **WESTERN BOAT YARD EXPANSION**

Port of Port Townsend, Washington

Project No. 20240066E001

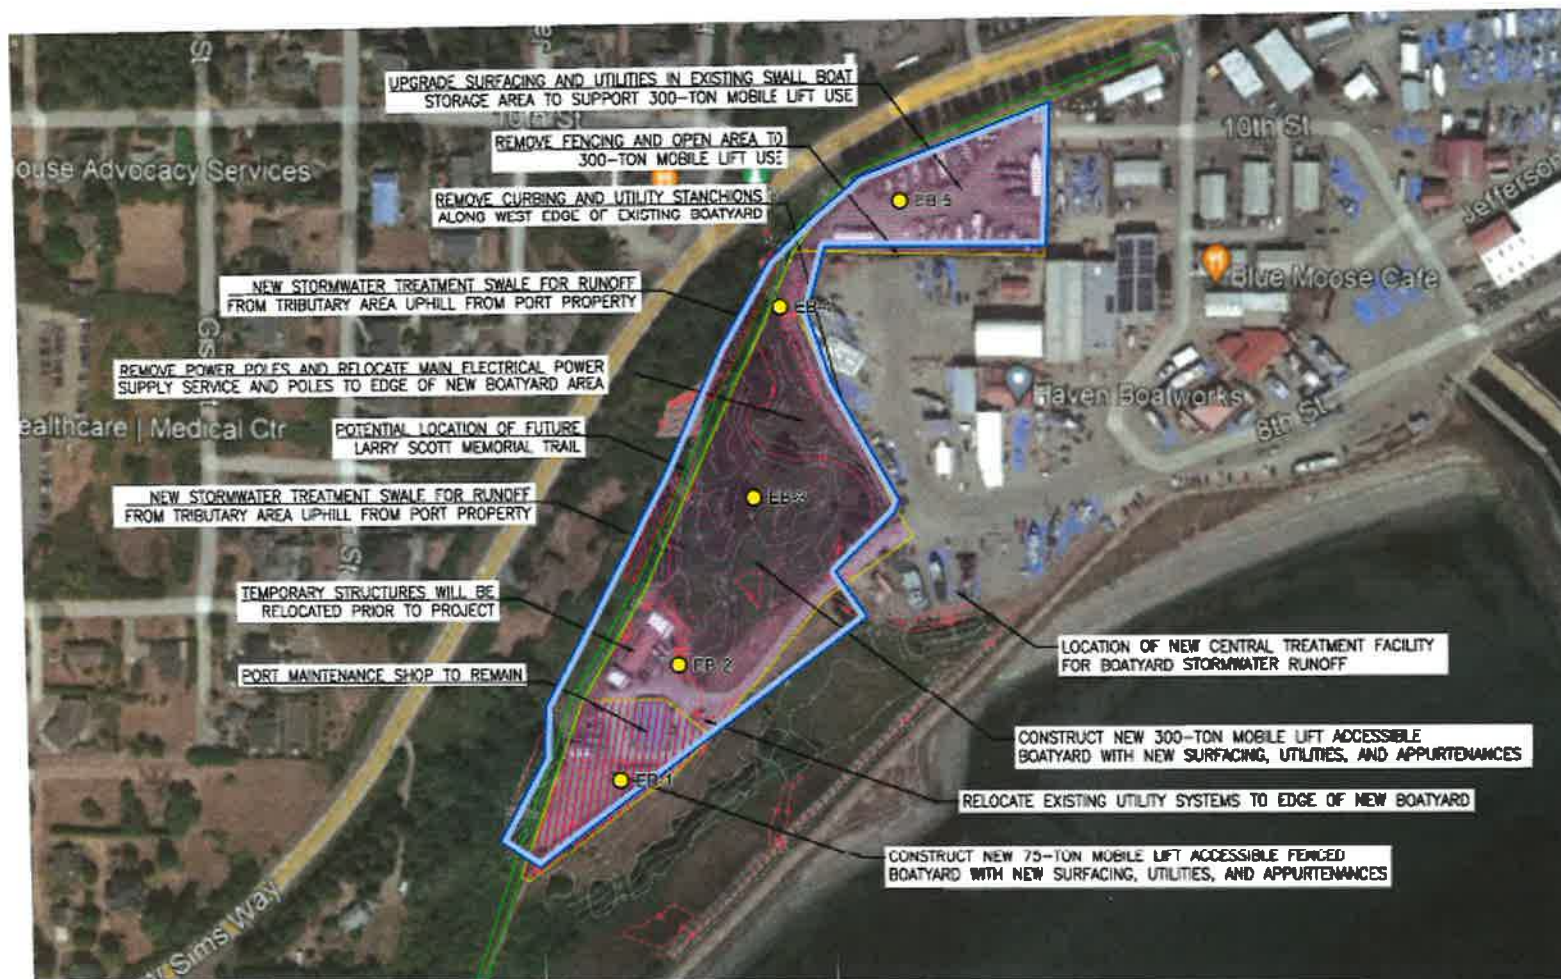
- SITE
- EXPLORATION BORING

Our field explorations for this study were completed on April 15, 2024, and included advancing five exploration borings (EB-1 through EB-5) to define the general soil and shallow groundwater conditions below the area of proposed improvements. The exploration locations are shown on the "Existing Site and Exploration Plan," Figure 2, and the "Proposed Improvements and Exploration Locations," Figure 3. The locations of our field explorations were approximated by measurements from known site features. The various types of materials, as well as the depths where characteristics of the materials changed, are indicated on the exploration logs presented in Appendix A. The depths indicated on the logs where conditions changed may represent gradational variations between material types in the field.
