## 2022 Federal approval documentation in lieu of SEPA Checklist submittal per below correspondence

Subject: Northwest Maritime Center Storm Damage Repair and Mitigation  
(NWS-2021-974)

Proposed: Northwest Maritime Center  
Shoreline Storm Damage Repair  
USACE Ref. #: NWS 2021-974  
In: Port Townsend County: Jefferson State: WA  
Application By:  
Northwest Maritime Center  
431 Water Street  
Port Townsend, WA 98368  
Project Location: 48.1158 Lat., -122.7512 Lon.  
Assessors Parcels: 989700403, 989700401

SHORELINE STORM DAMAGE REPAIR  
NWMC - 431 Water St. | Port Townsend, WA 98368

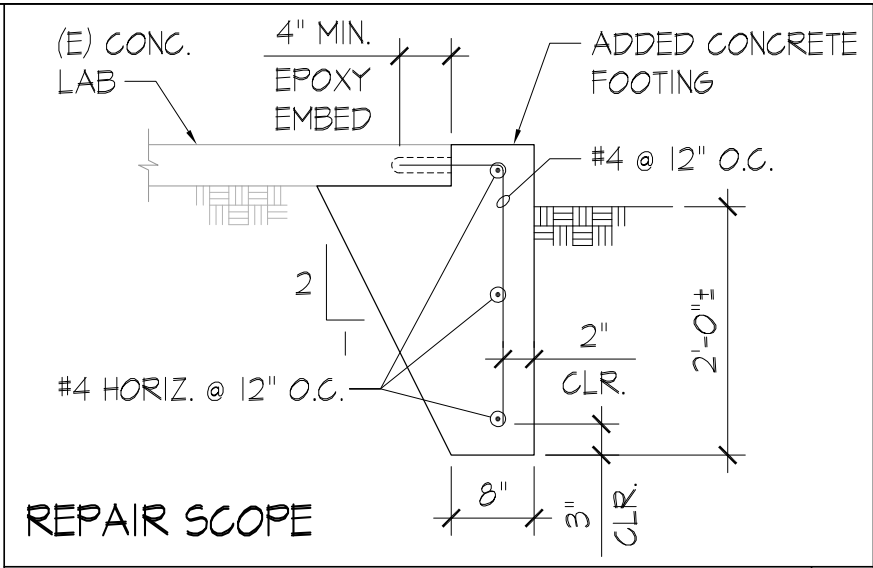
SLAB EDGE REINFORCING - INCREASED FOOTPRINT NOT TO SCALE 2

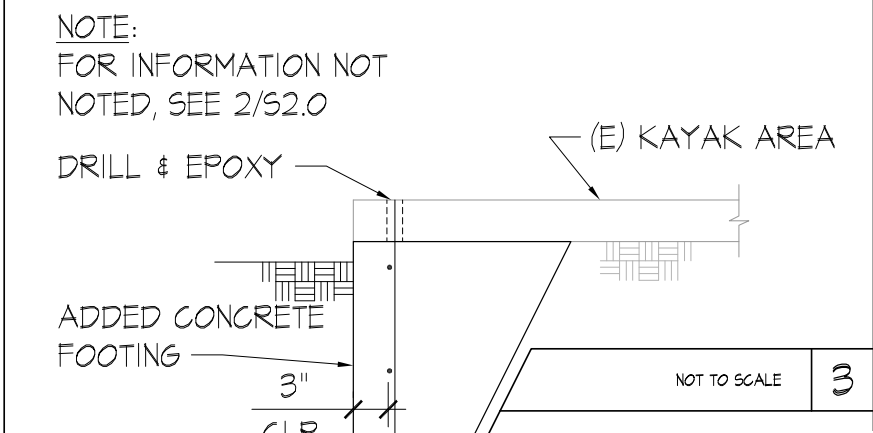
SLAB EDGE REINFORCING - SAME FOOTPRINT

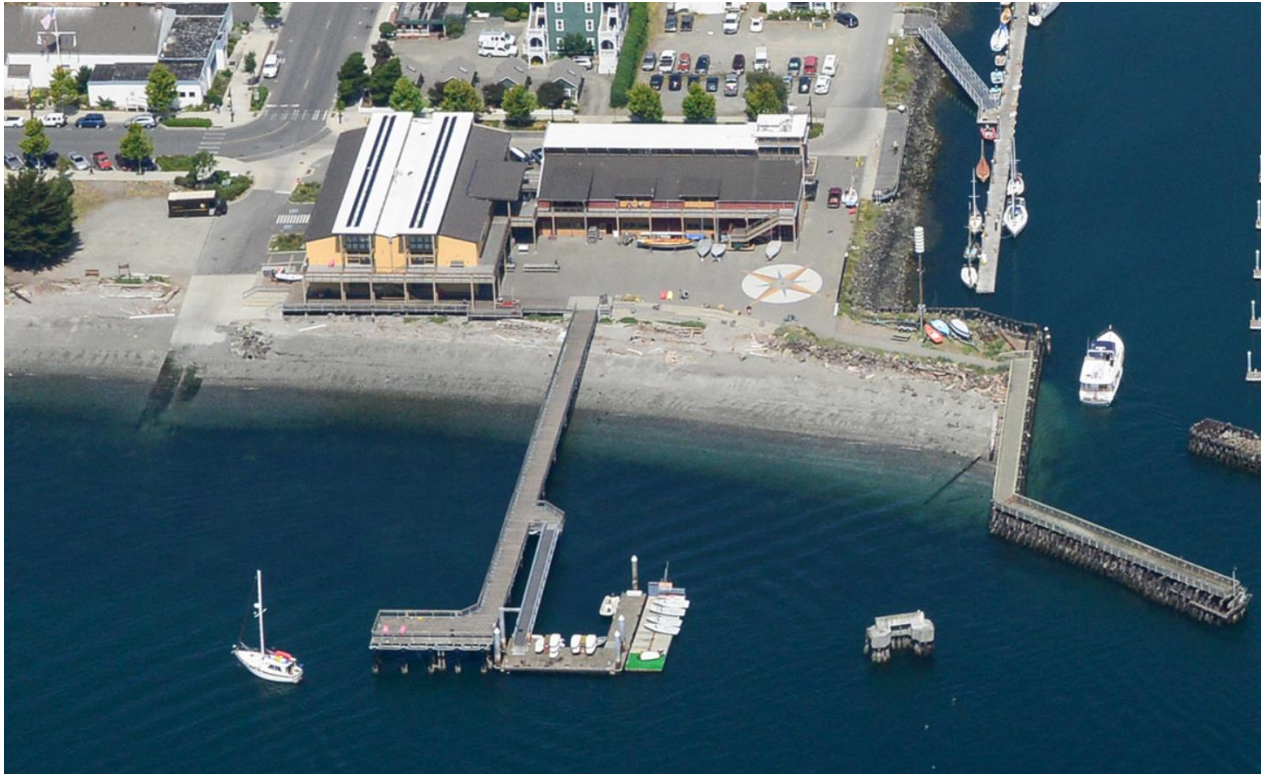
**Figure 2. Close-up of Department of Ecology shoreline photo (dated 7/25/2016) to show project site**

As all previously installed protection logs were detached during storms and the beach has lowered, leaving the beach and the porch deck more exposed to storm wave attack. The upper beach elevation could be further lowered in a future storm which would allow more wave energy to reach the structures. Considering the limited under-deck clearance, future extreme high-water storms would put the porch/pier deck at the risk of under-deck wave impact (as occurs at the Cannery Building several blocks to the southwest). Therefore, a certain level of protection measures are warranted to reduce future risk potential. Purposely placed large boulders, scattered and in groups, should work effectively as debris barriers.

Washington State Department of Ecology’s Coastal Atlas Map shows no appreciable drift along the shoreline and the slope stability is classified as “modified”. The Coastal Atlas Map has also mapped the shoreline in front of the Northwest Maritime Center as an artificial pocket beach (Figure 6). Fringe (patchy) kelp and eelgrass is mapped along the project shoreline (WDNR 2001). The project site is not included in the Washington Department of Natural Resources’ eelgrass monitoring data (WDNR); however, during a dive completed by MSA on September 9, 2021, eelgrass was observed over 200 ft from the OHWM, starting on the shoreward end of the L-shaped float as seen in Figure 2.

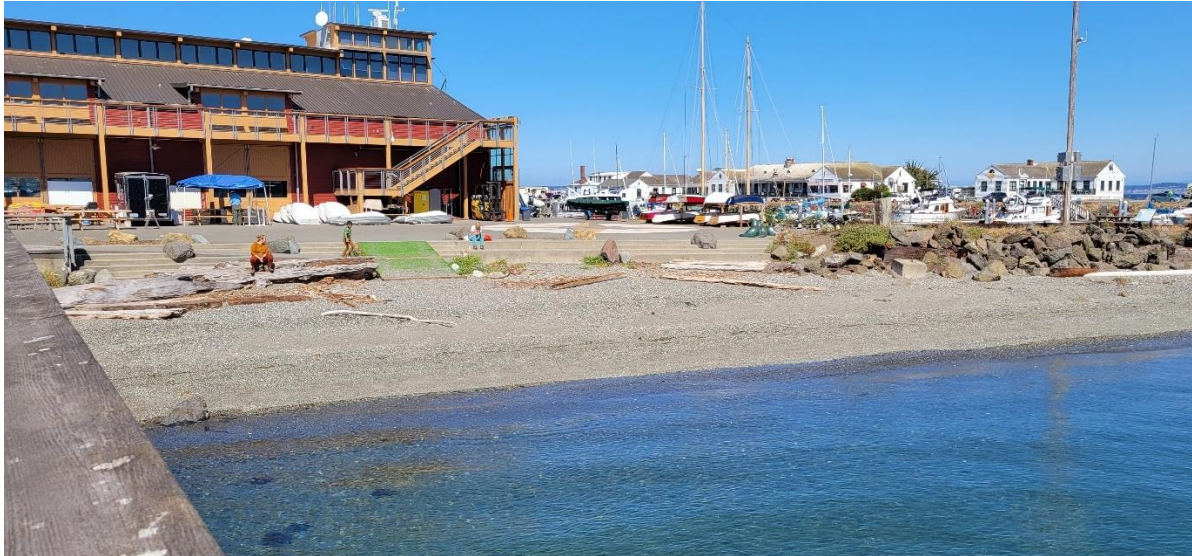
**Figure 4. View of the beach on the north side of the pier**

The upper beach consists of gravel and shell hash on a sandy base with a narrow band of pea gravel and sand below MHHW (+8.52 ft MLLW) and a narrow band of sand above. Below approximately +6 ft MLLW, the substrate transitions into larger cobble. No attached submerged aquatic vegetation was found within the project area. There are a few large drift logs along the upper beach, next to the existing structures.

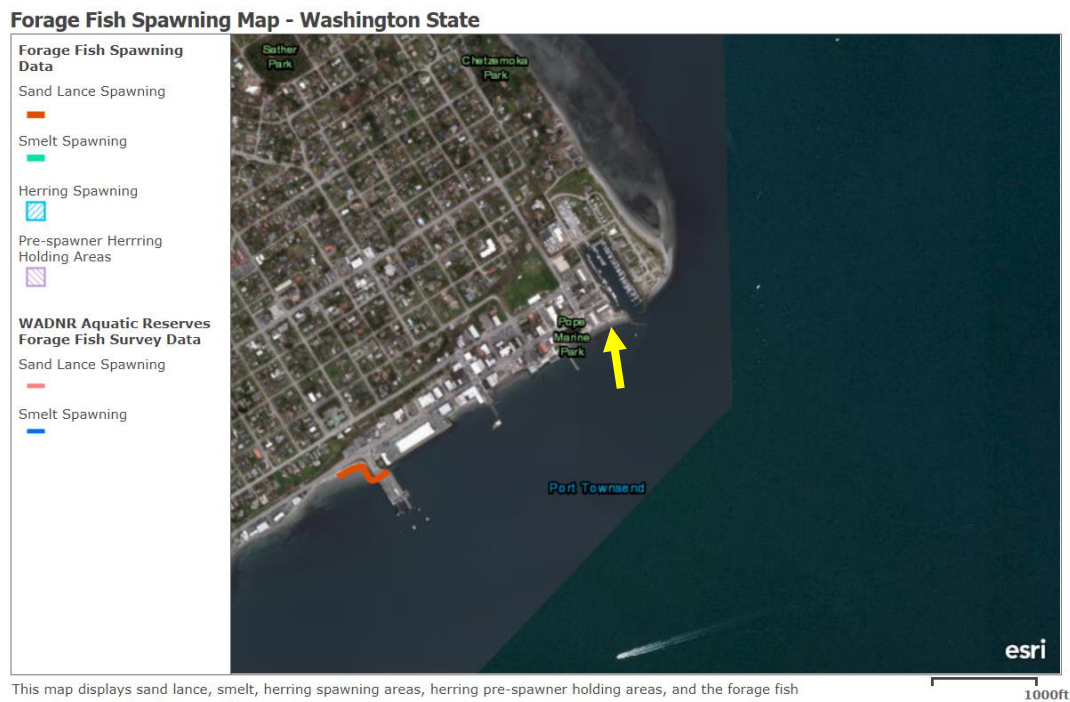
**Figure 7. WDFW documented forage fish spawning habitat**

Migrating salmon utilize baitfish such as Pacific herring (*Clupea harengus pallasii*), sand lance (*Ammodytes hexapterus*), and surf smelt (*Hypomesus pretiosus*) as prey resources. These forage fish form a very important trophic link between plankton resources and a wide variety of predatory marine organisms as well as providing food for marbled murrelets and bald eagles. According to WDFW, there is no documented forage fish spawning habitat along the shoreline at the project site; the nearest is sand lance spawning habitat approximately 0.5 mile southwest of the site (Figure 7).
