# Tree Preservation Plan- Landmark Live Oak 1520 Lawrence Street

Richard R Hefley

Consulting Arborist – TRAQ Certified – ISA# PN784A

**Draft Date :** 03/13/2026

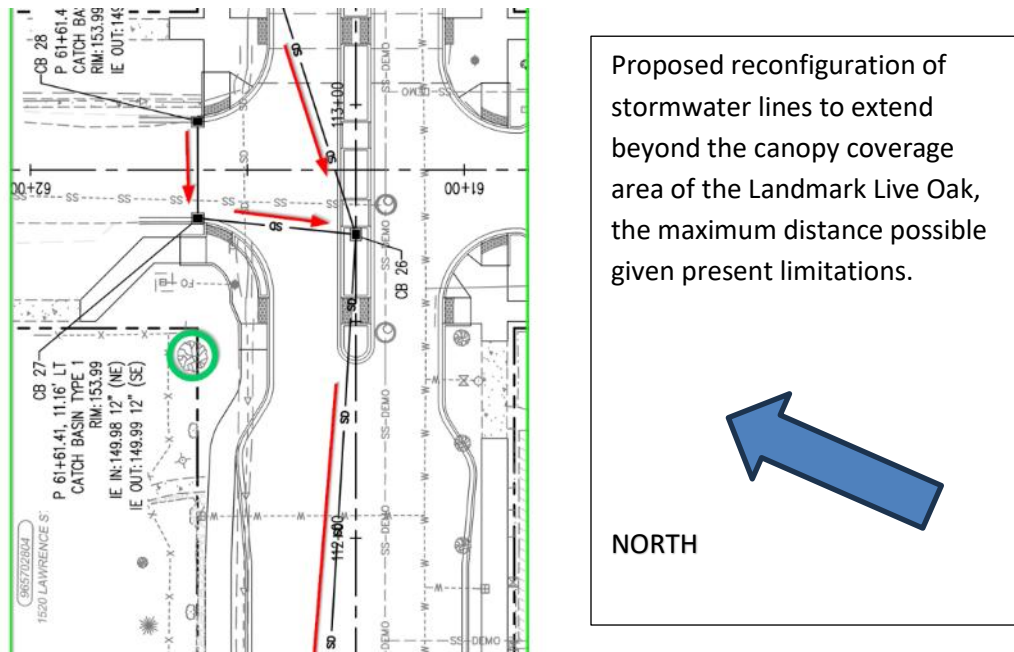
The City later provided an alternative schematic stipulating the new stormwater line to veer well south of the tree as shown by the red arrows on the following diagram.

*This proposed redirection of the stormwater line placement is the single best available mitigation for the CRZ (Critical Root Zone) of this Landmark Live Oak.*

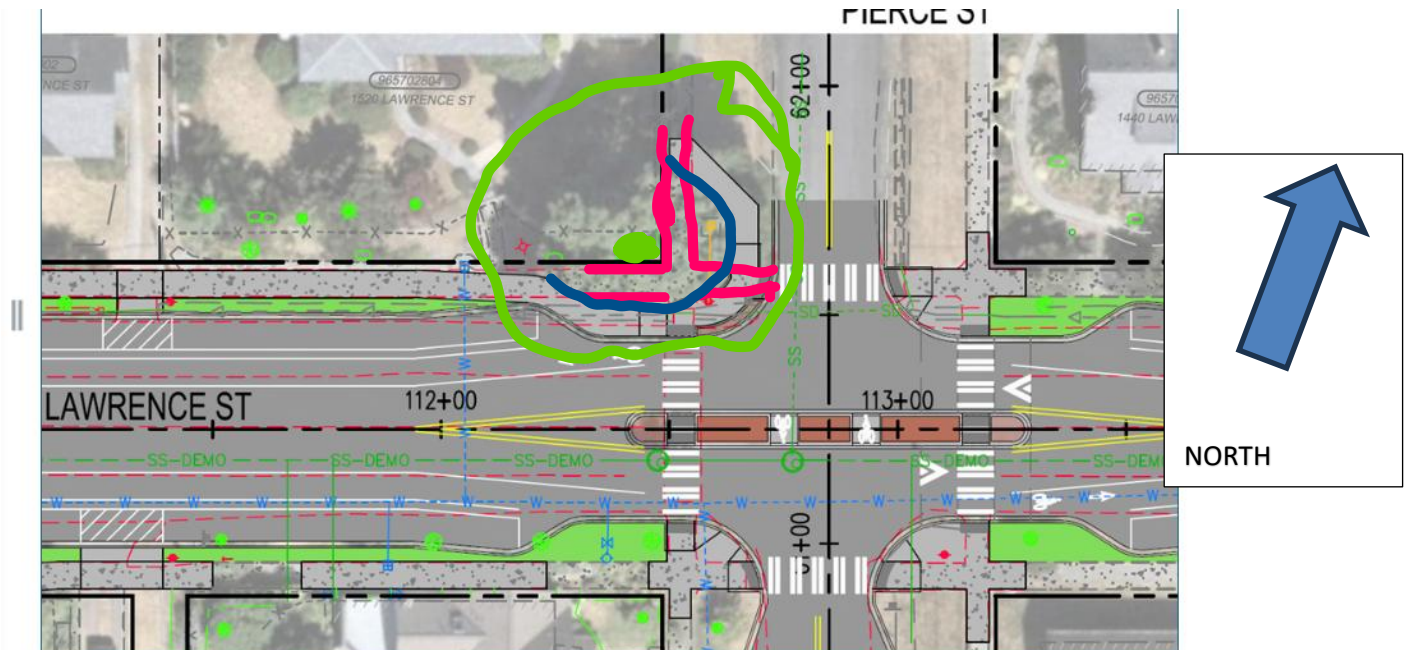
**The current sidewalks to be removed are highlighted in solid red.**

**The tree trunks are the solid green circle immediately adjacent. The extent of the canopy is indicated by the irregular green around this.**
