2020 Periodic Inspection Report

*Lords Lake North Dam and East Dam
Jefferson County, Washington*

August 2020

DSO Files JE17-0243 & JE17-0357

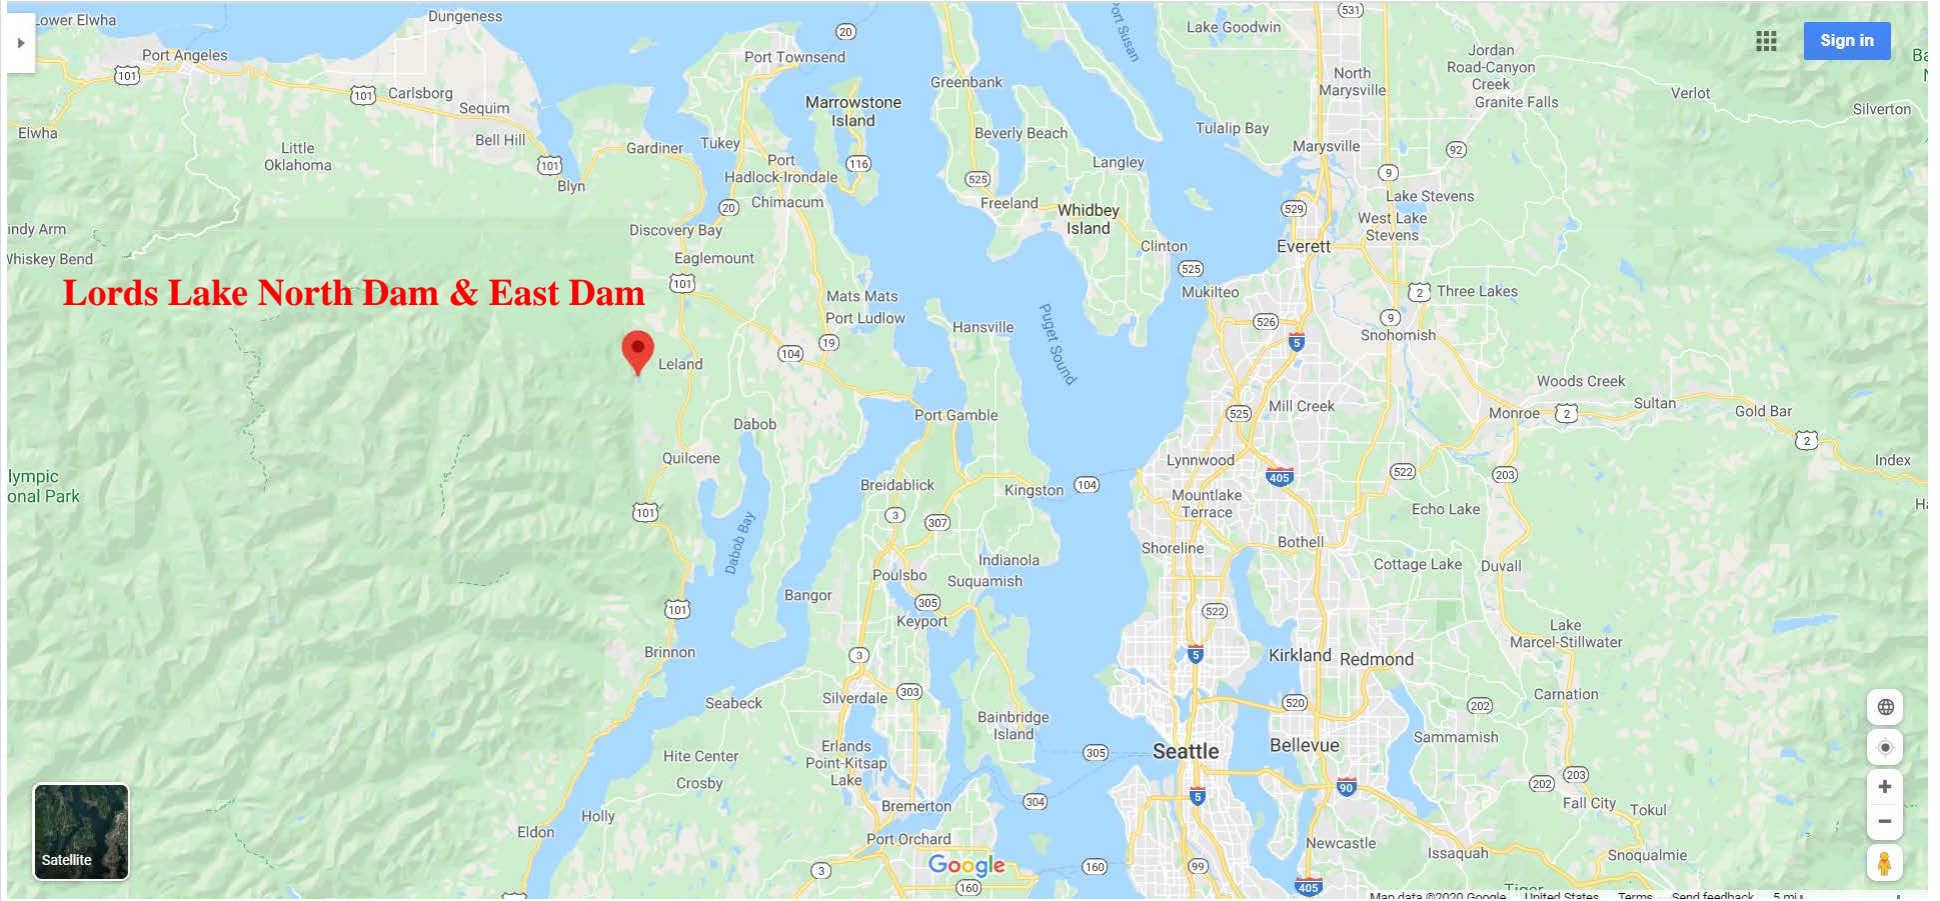
Figure:
2

REGION MAP

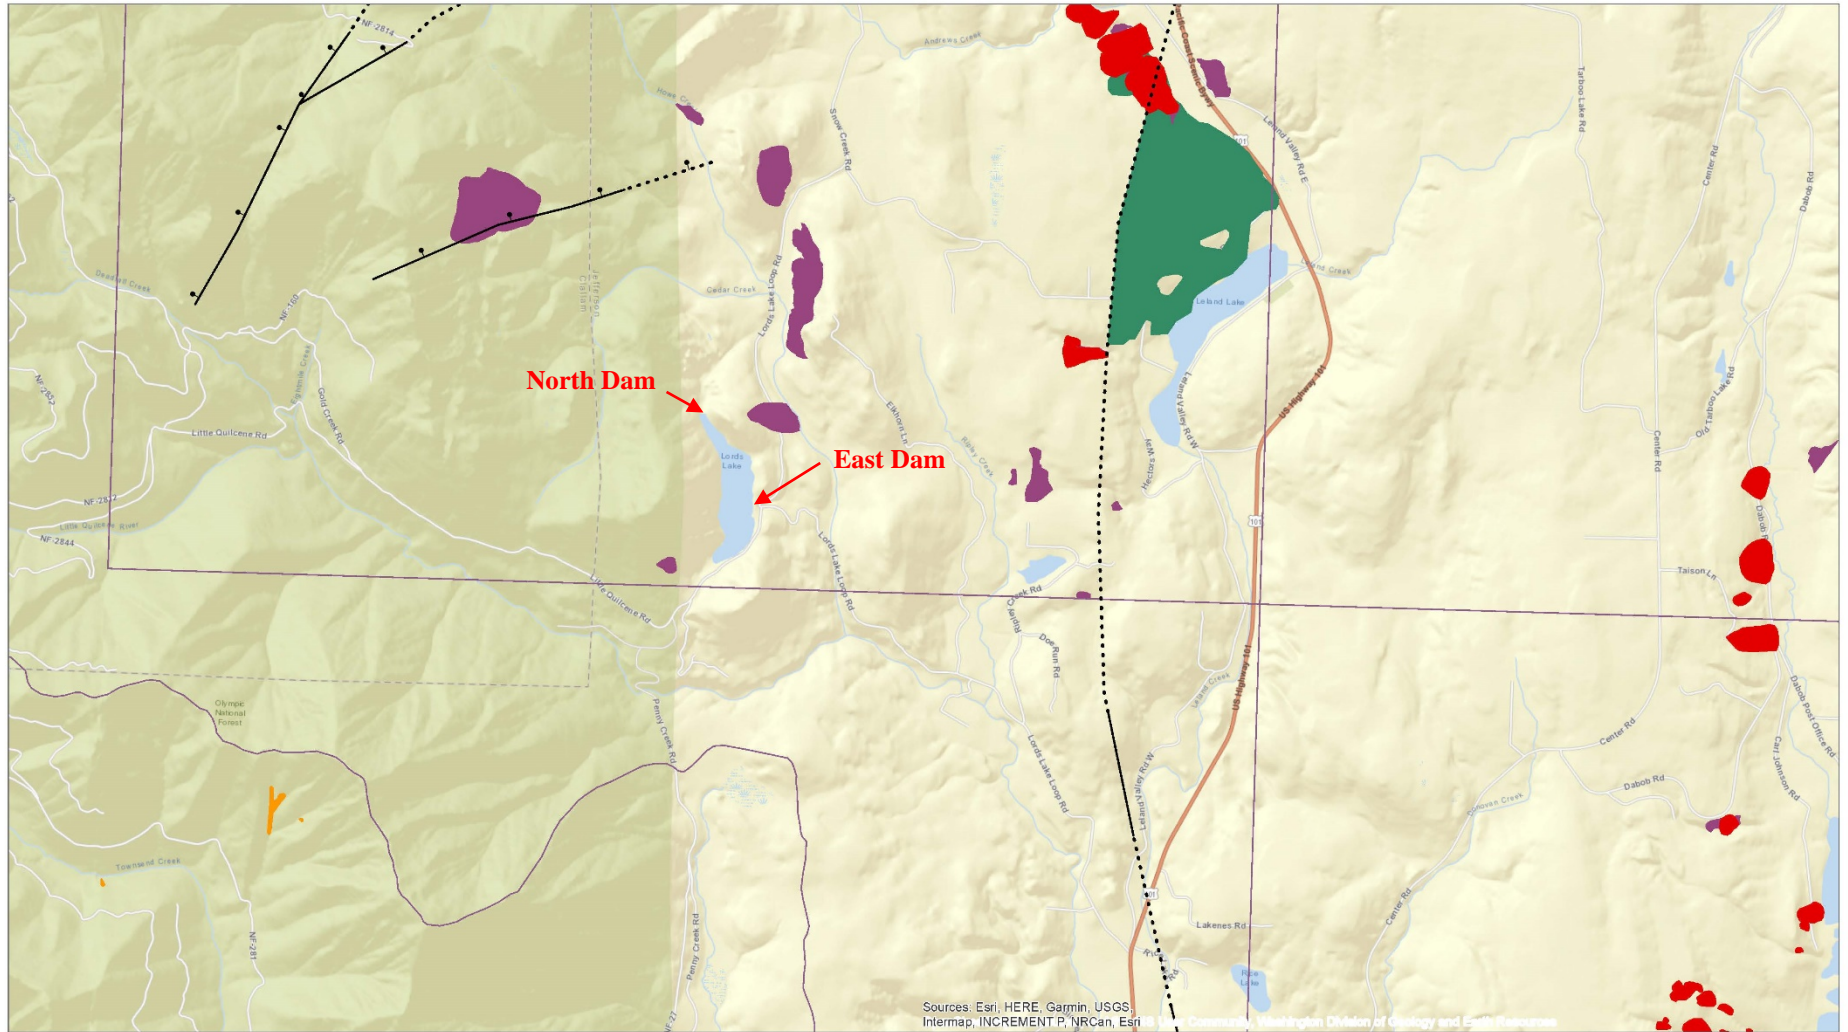
lidar coverage of the area (see Figures 3, 4 and 5) and WA DNR landslide information¹ (see Figure 6) revealed no obvious evidence of significant landslides on the slopes around the reservoir that could pose a threat to the safety of the dams.

<p>DEPARTMENT OF ECOLOGY State of Washington WATER RESOURCES PROGRAM DAM SAFETY OFFICE</p>	<p>2020 Periodic Inspection Report Lord Lake North Dam & East Dam Jefferson County, Washington DSO Files: JE17-0243 & JE17-0357</p>	<p>WA DNR-GIP LANDSLIDES</p>	<p>Figure: 6</p>
--	---	------------------------------	-----------------------------
