Port Townsend Condition Assessment

Summary Report

September 11, 2019

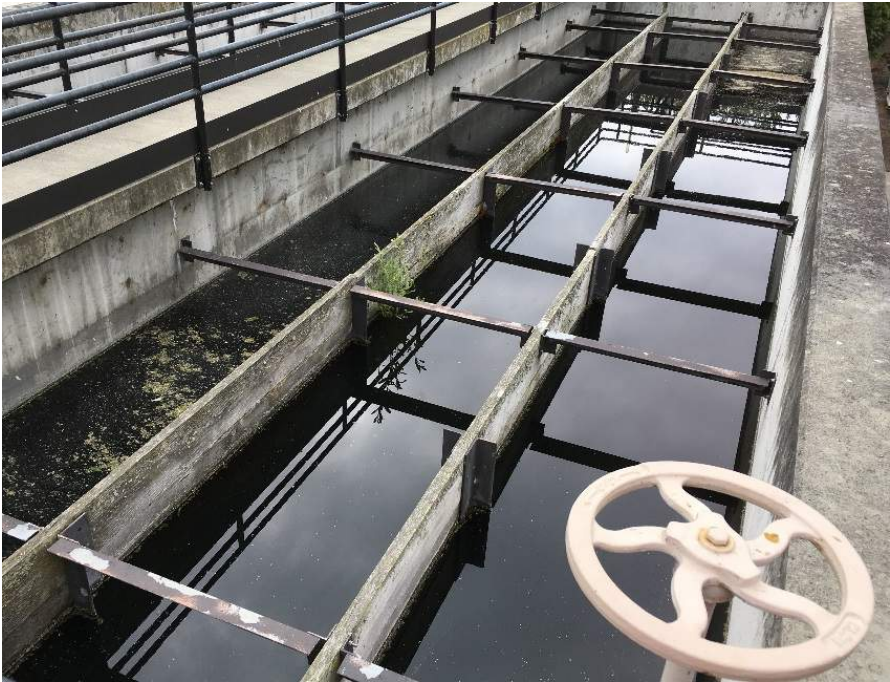
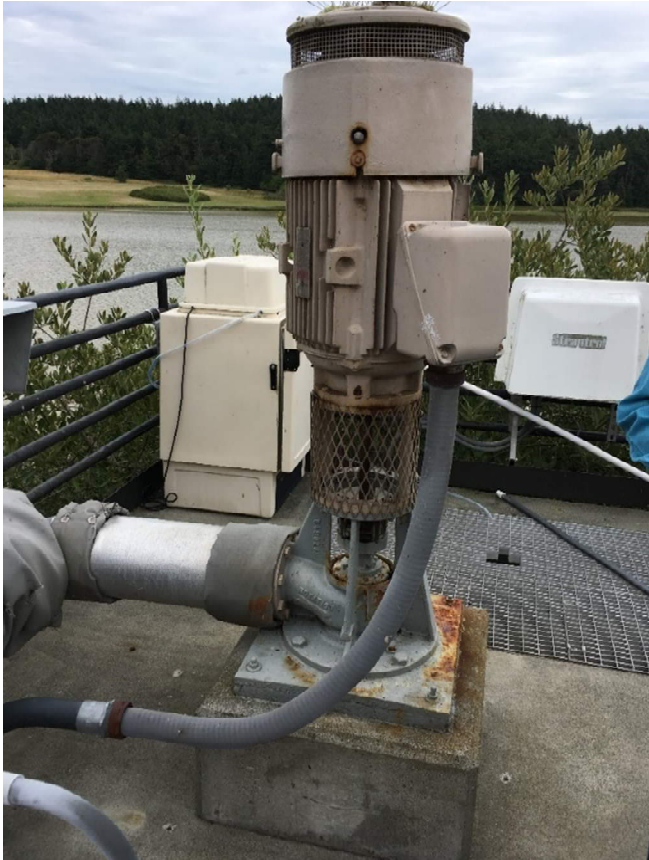
Secondary clarifier effluent enters the Chlorine Contact Basins, has hypochlorite solution diffused into the stream, passes thru the serpentine flow path that is designed to achieve a design contact time and then discharges to the outfall. There is the wide spot just prior to outfall discharge that provides a wet well for vertical turbine, W3 pumps to pull suction. There are no capacity, functionality, or condition issues with this process or equipment (Photos 15 and 16).

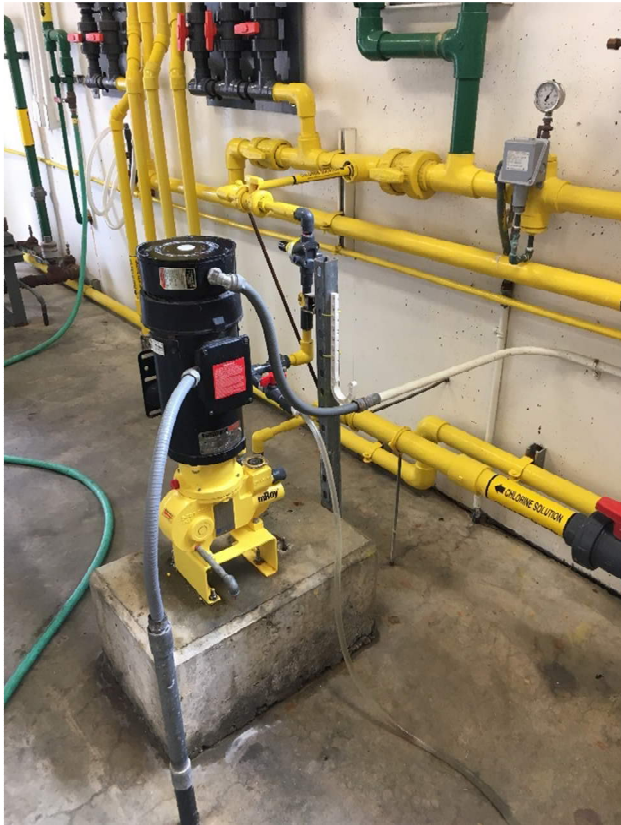
Photo 17: Hypochlorite Metering Pump

Hypochlorite is delivered in 12% concentration and stored in a new 6,200 HDPE tank. This is a black tank. The black tank (increased temperature of the hypochlorite) could possibly be contributing to an increase observed in off-gassing and vapor locking of the hypochlorite metering pumps (Photo 17) from prior operations. It also may have nothing to do with it.

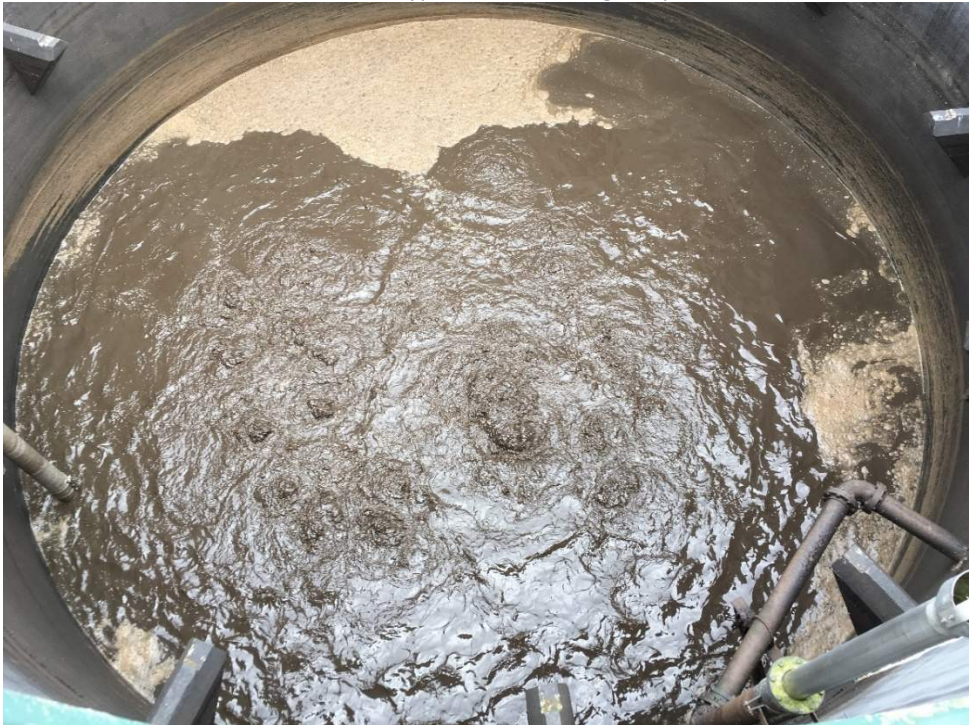
Photo 18: WAS Aerobic Digester

WAS is pumped to the aerobic digesters (Photo 18) where it is aerated in order to avoid odor issues as well as to facilitate aerobic digestion of the sludge.

- Capacity. There appear to be no capacity issues.
- Equipment. There are likely some missing coarse bubble diffusers in the aeration system. The air is shut off daily for about 4 to 5 hours to allow the sludge to settle and thicken. The tank is decanted back to the influent pump station and the thickened sludge, around 8,000 mg/L, is pumped to the belt press for dewatering (Photo 19). Approximately 30,000 gallons per day of thickened WAS is delivered to the belt press. The dewatered cake is about 14% solids, suitable for blending with wood chips in the composting process. The cake is hauled out to the landfill where the composting system is located. The composting

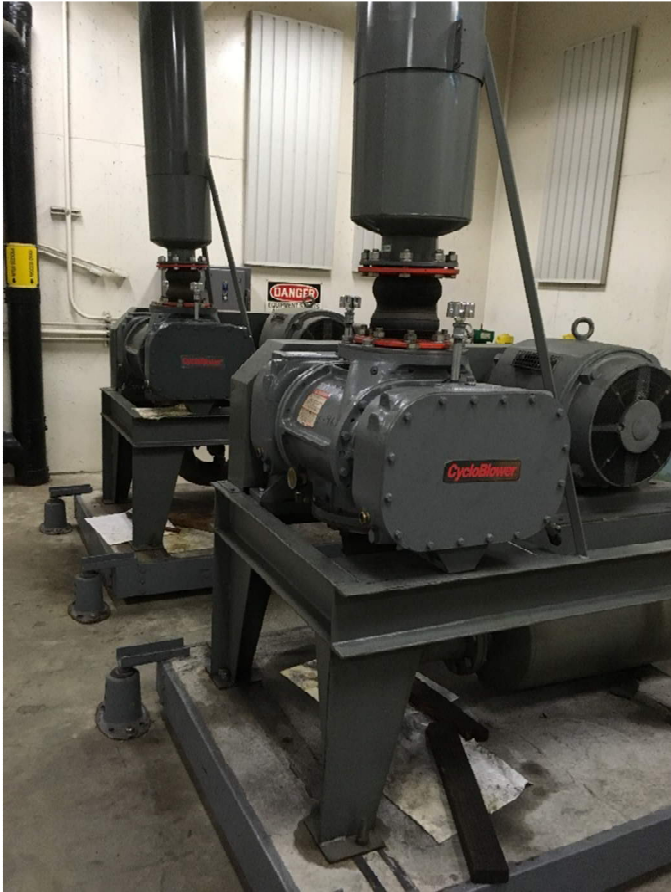
Photo 20: Aerobic Digester Blowers

Air is delivered to the aerobic digesters (waste activated sludge [WAS]) via a pair of rotary lobe blowers located in the lower level of the Operations building. They have 60-horsepower motors and produce about 1,200 cfm of air (Photo 20). They operate around 19 hours per day with additional run time in the summer. These blowers are in good condition and have adequate capacity. However, rotary lobe blowers are not particularly efficient from a power-usage standpoint. This could be a consideration with respect to upgrading these blowers, as is discussed in Section 3.

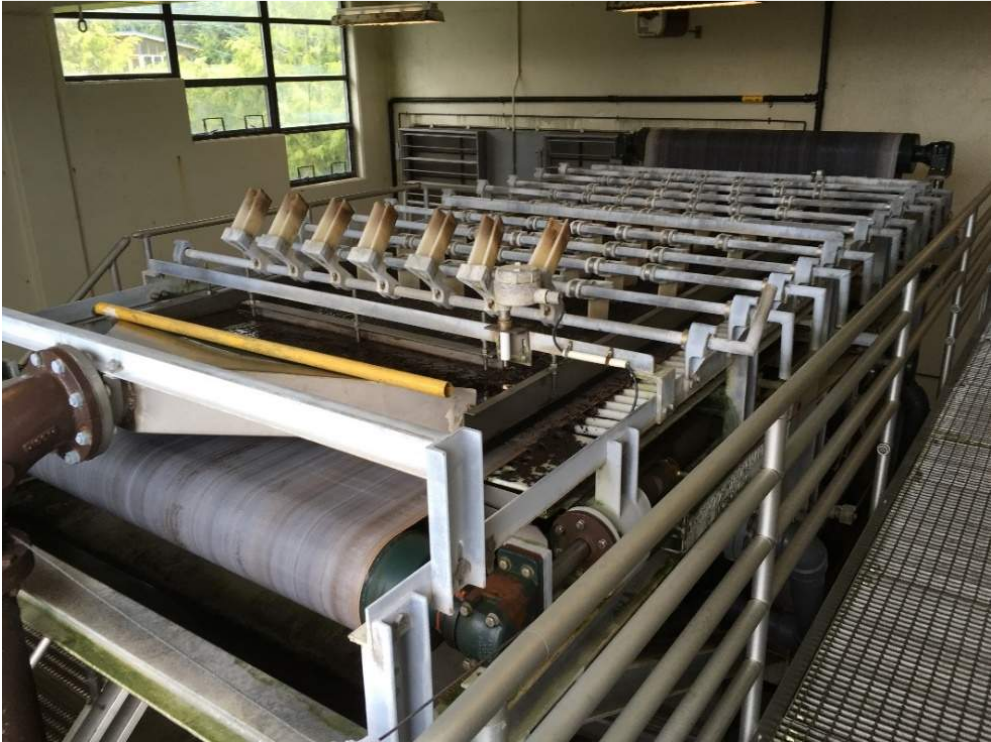
Photo 21: Belt Press

There are no capacity or equipment issues with the belt press or belt press room (Photo 21).

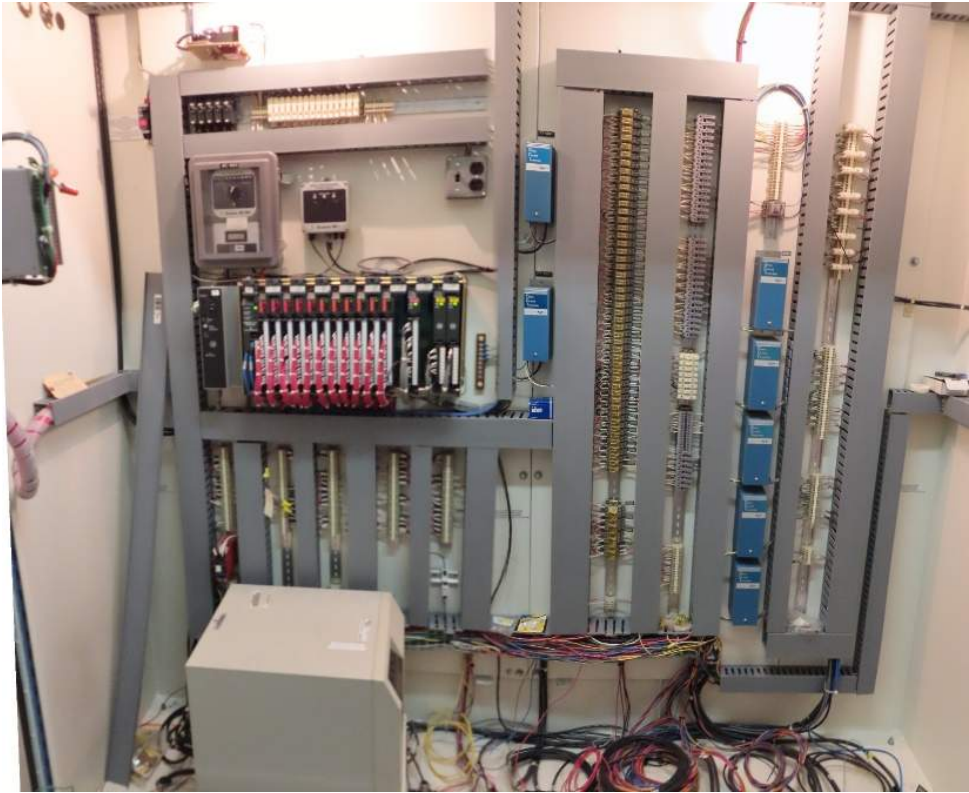
The majority of the instrumentation and control systems and instruments remain from the 1990s upgrade of the WWTP to secondary treatment. Equipment, cabinetry, and panels are kept clean and good working order (Photo 22). Control panels are clean, and wiring is still orderly indicating proper care has been taken during maintenance (Photo 23). Overall, the instrumentation and control systems and instruments have been well-maintained and are in good working order.

Photo 22. Equipment is clean and in good working conditions

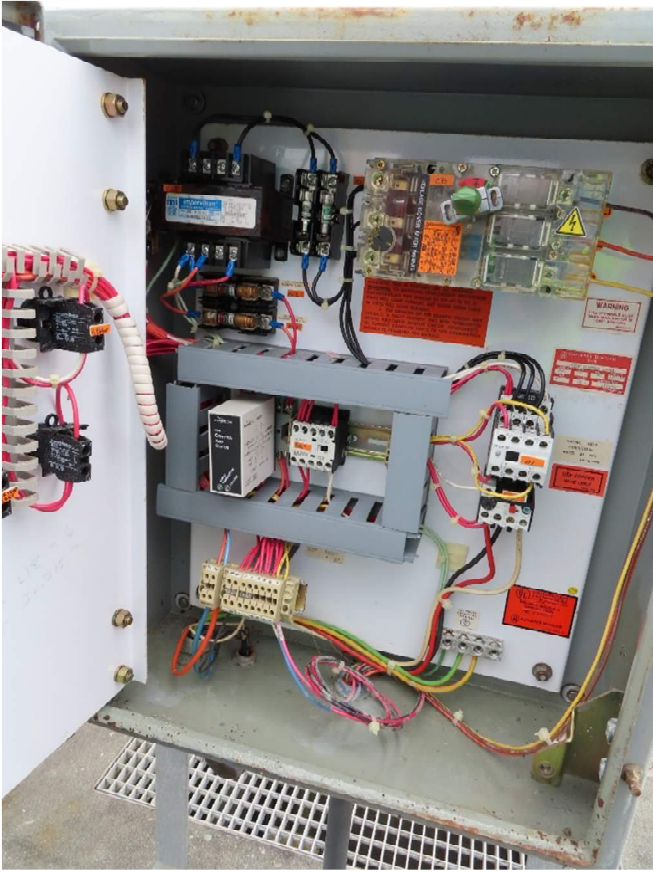
Photo 13. Control panels are clean and in good conditions

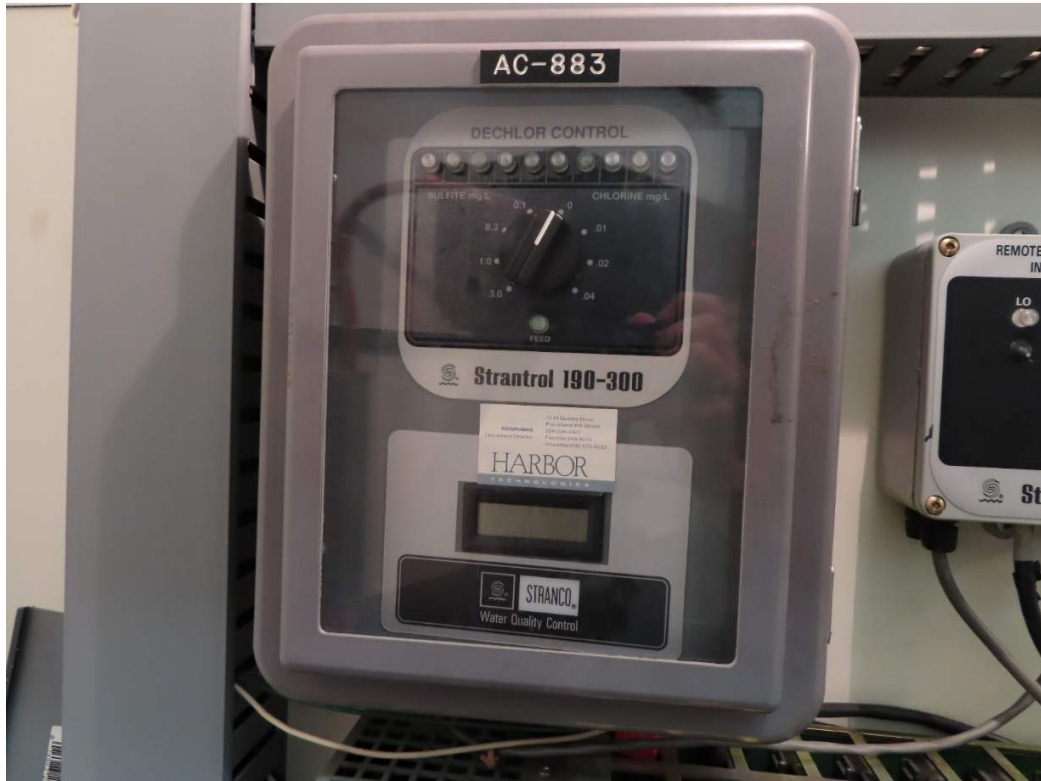
- Many of the flexible conduit connectors show rust, these should be coated with a rust protectant coating (Photo 30).
- Previous upgrade projects resulted in abandoning some components that are still in place. The network radio antenna's function has been replaced by a new network service to the facility (Photo 31). The new Sodium Hypochlorite tank uses a visual tank measurement, leaving the Milltronics transmitter located in the containment abandoned in place (Photo 32). The sodium bisulfite is metered with manual settings. A Strantrol Dechlor controller that was apparently previously used for metering is de-energized inside of CP1 (Photo 33). There may be other instruments that due to change in process needs have been abandoned in place.

Photo 33. Deenergized Strantrol Dechlor controller

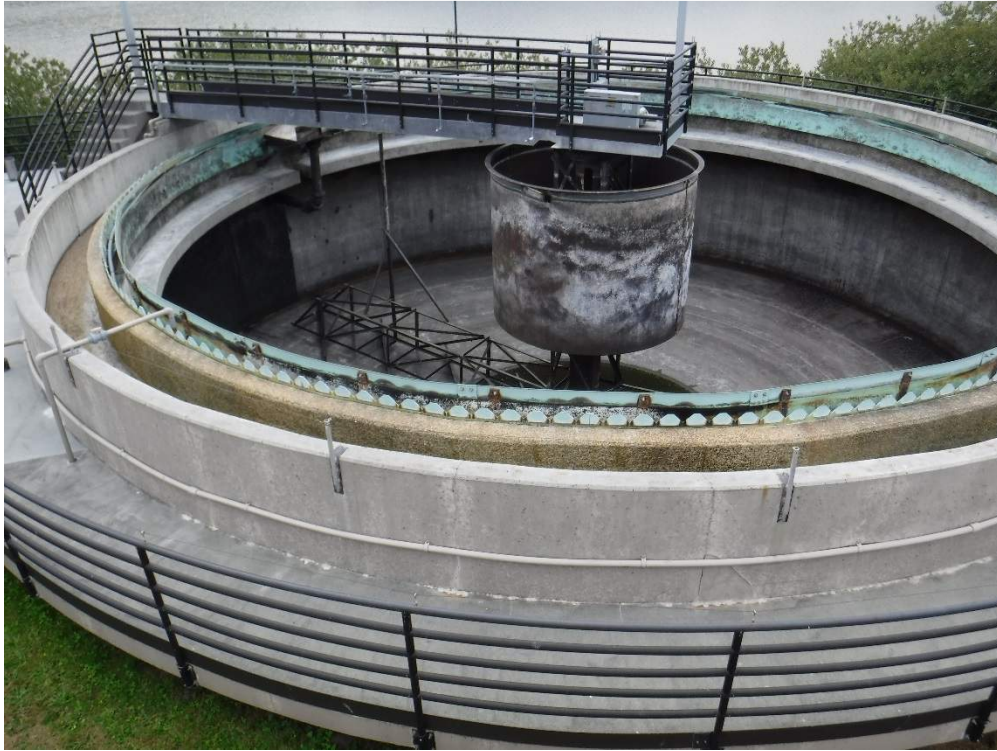
- The south secondary clarifier was drained and available for visual observation (Photo 44).

Photo 44. South secondary clarifier, empty at the time of inspection.
