Port Townsend Condition Assessment

Summary Report

September 11, 2019

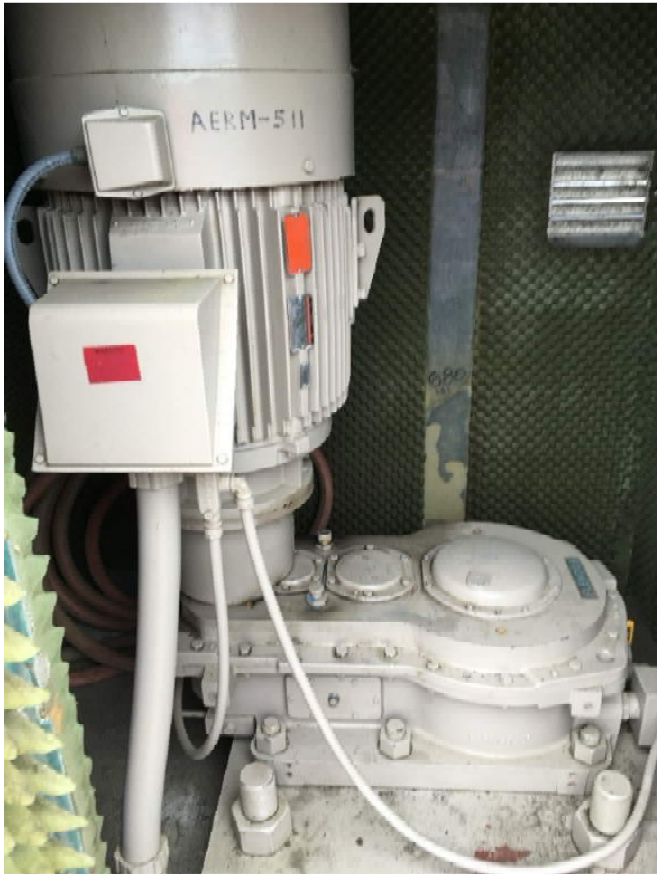
- Equipment. The aerators and oxidation ditch design was done by Eimco. There are large, gearbox assemblies that drive the mixer shaft (Photo 10) that sit in noise enclosures (Photo 11) on the oxidation ditch deck. This equipment has worked well and there is a spare motor on site.

Photo 10: Paddle Aerator Drive

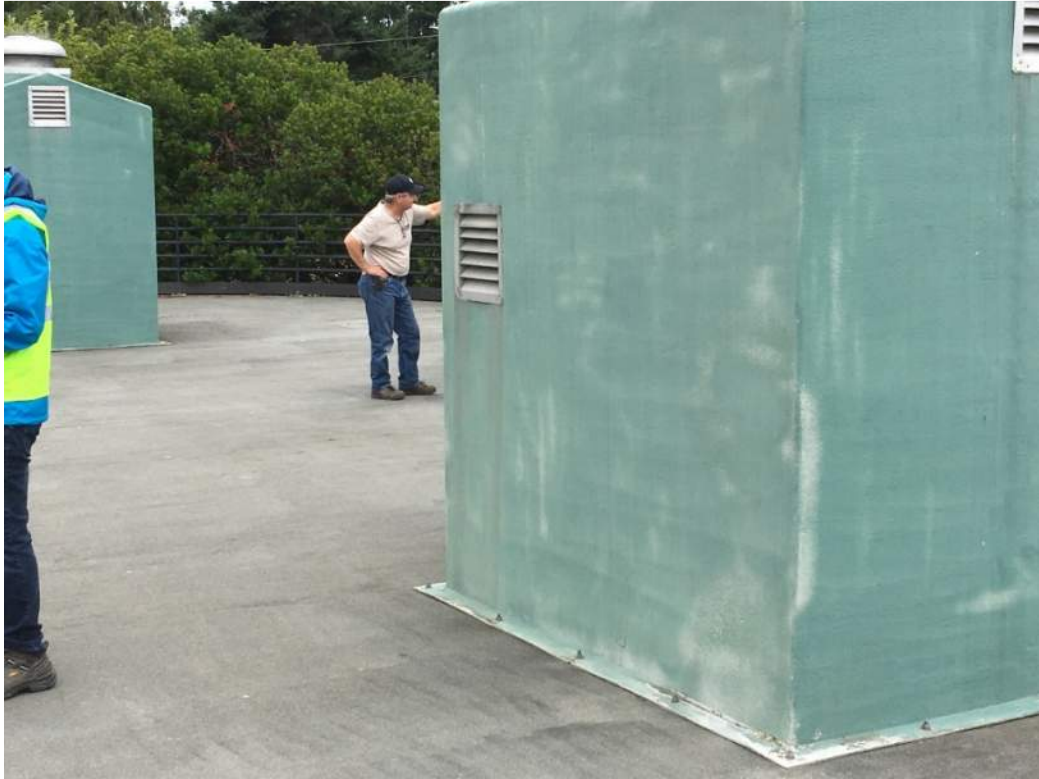
Photo 11: Paddle Drive Enclosures

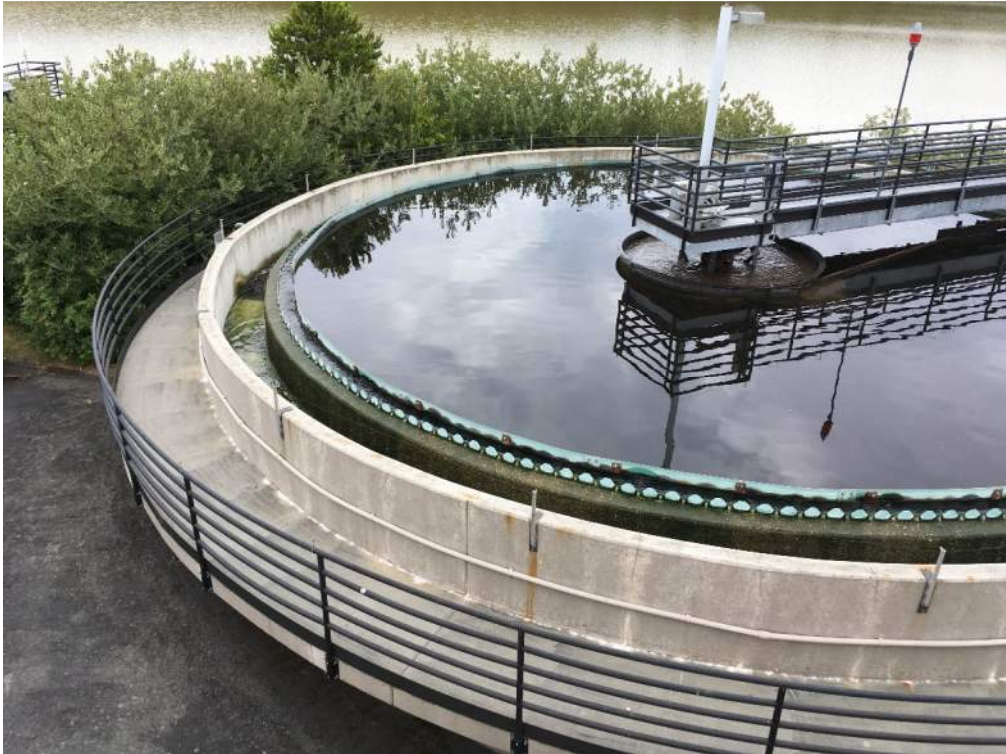
Mixed liquor splits to either of two secondary clarifiers. During summer flows, one clarifier can be down for service (Photo 12). There are no process mechanical issues with the secondary clarifiers.

Photo 12: Secondary Clarifier

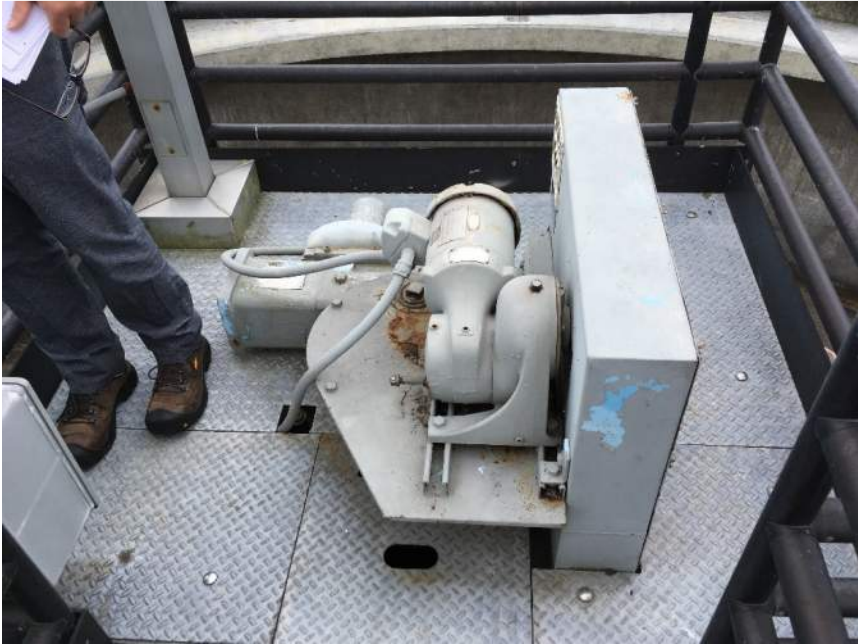
- Capacity. There appear to be no capacity issues.
- Equipment. The clarifier mechanisms are manufactured by Eimco. The original drives and motors are in service. Typically, well-maintained clarifier drives have long life spans (Photo 13).

Photo 13: Clarifier Drive Mechanism

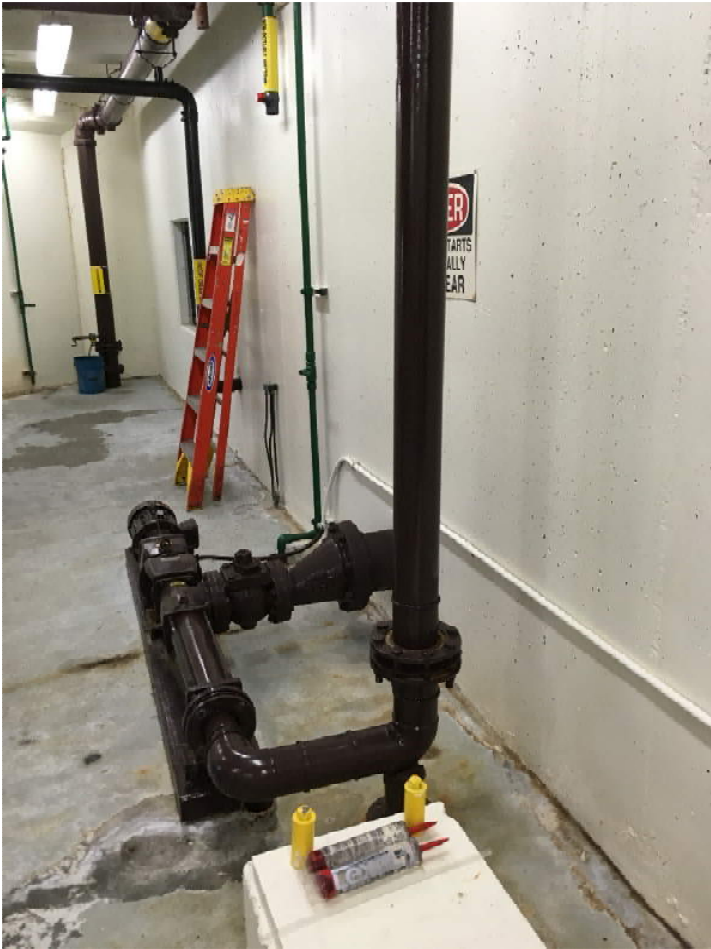
The RAS pumps pull settled mixed liquor from the floor of the secondary clarifiers and return to the mixing and splitter box just downstream of the Parshall flume at Headworks. The Waste Activated Sludge (WAS) pumps pull from the bottom of the clarifier and send waste mixed liquor sludge (theoretically the quantity of biomass grown on a daily basis) to the WAS aerobic digester/holding tanks for later dewatering on the belt filter press. The Secondary Scum pump pulls secondary scum from the scum sump between the secondary clarifiers and pumps to the WAS holding tank. No issues with capacity, functionality, or condition were observed (Photo 14).

Photo 14: Secondary Scum Pump in RAS/WAS Pump Room

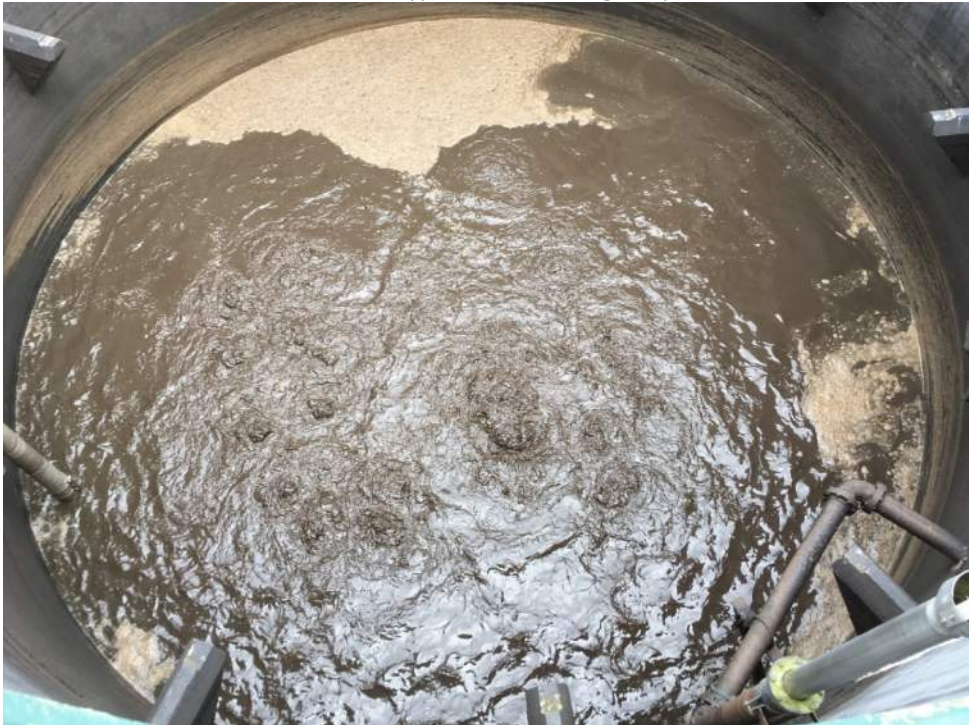
WAS is pumped to the aerobic digesters (Photo 18) where it is aerated in order to avoid odor issues as well as to facilitate aerobic digestion of the sludge.

Photo 18: WAS Aerobic Digester

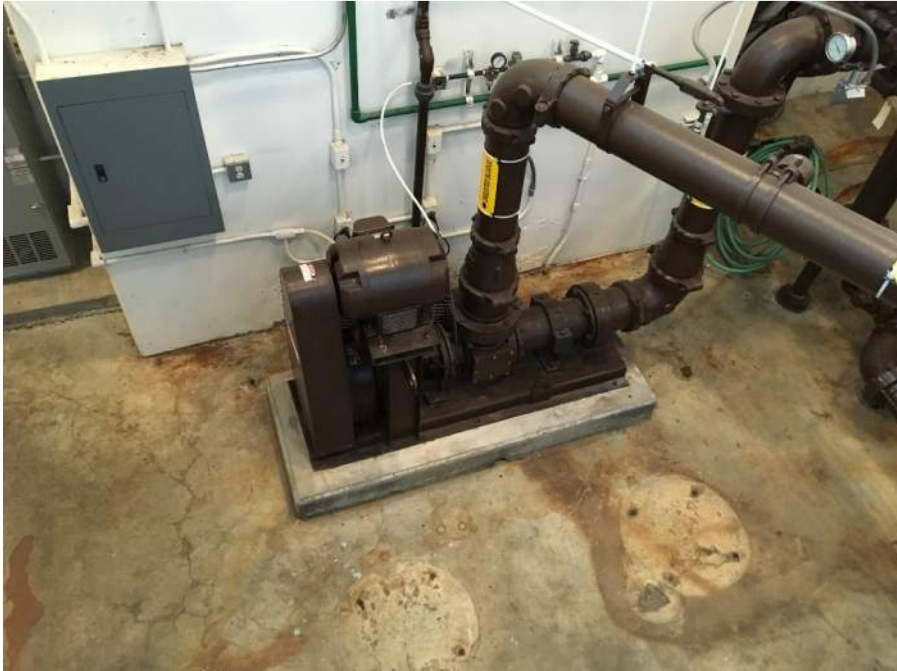
influent pump station and the thickened sludge, around 8,000 mg/L, is pumped to the belt press for dewatering (Photo 19). Approximately 30,000 gallons per day of thickened WAS is delivered to the belt press. The dewatered cake is about 14% solids, suitable for blending with wood chips in the composting process. The cake is hauled out to the landfill where the composting system is located. The composting process generates significant heat rendering a Class A sludge product, available to the public, after a prescribed composting period. These tanks are remnants from the original treatment plant. Likely these tanks would perform poorly in a significant seismic event.

Photo 19: Belt Press Feed Pump

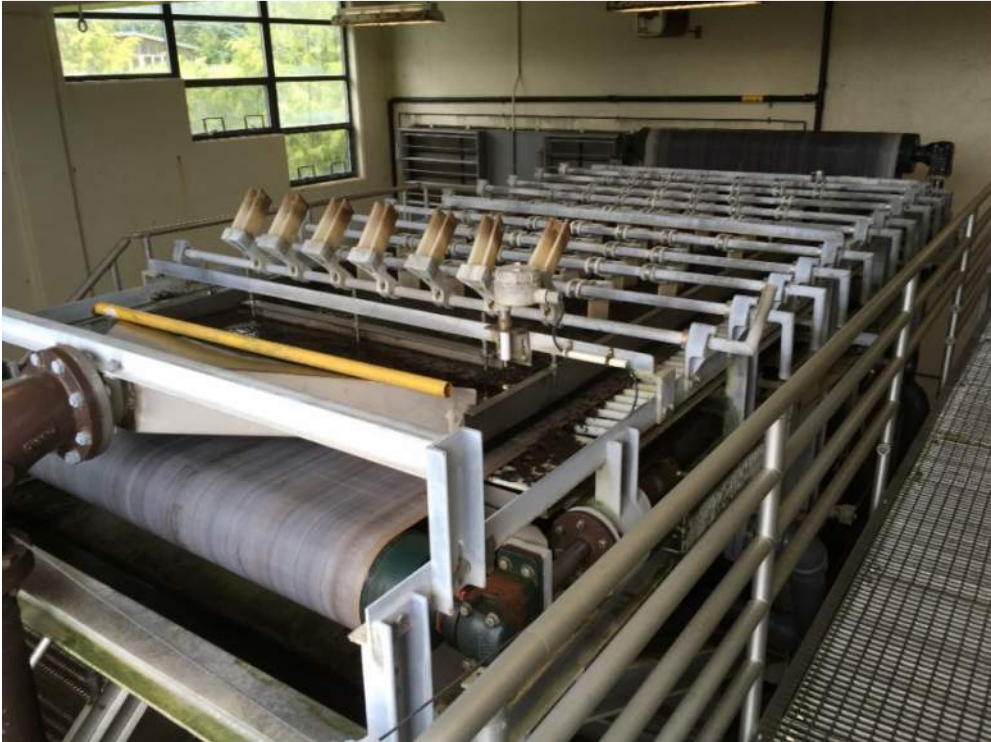
There are no capacity or equipment issues with the belt press or belt press room (Photo 21).

Photo 21: Belt Press

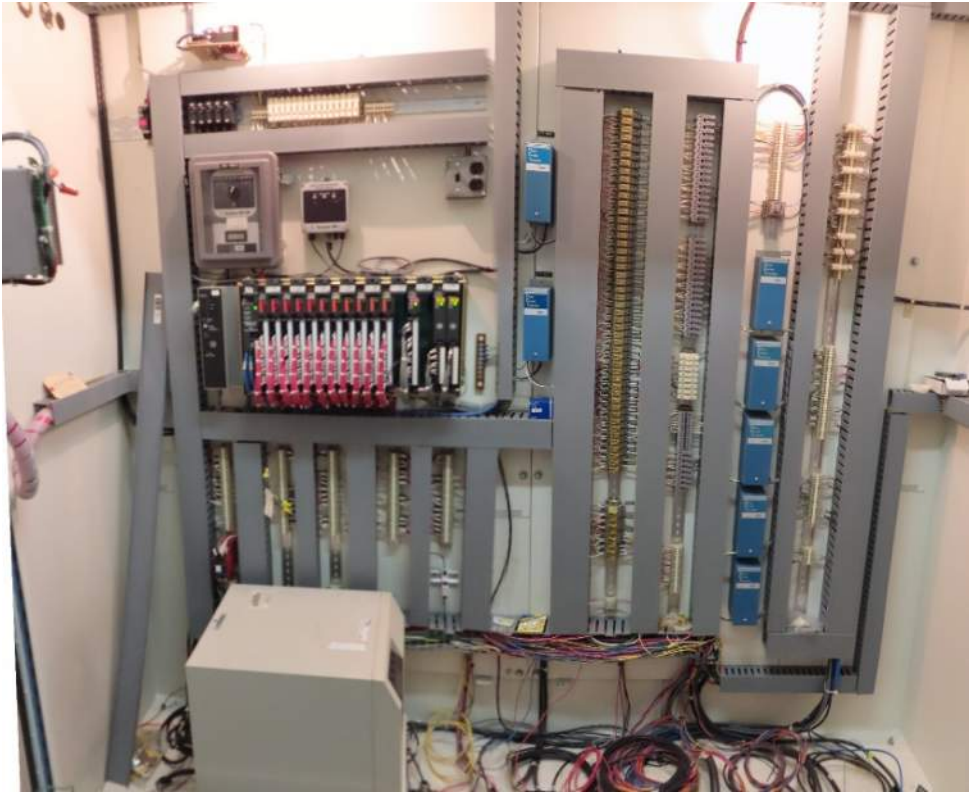
The majority of the instrumentation and control systems and instruments remain from the 1990s upgrade of the WWTP to secondary treatment. Equipment, cabinetry, and panels are kept clean and good working order (Photo 22). Control panels are clean, and wiring is still orderly indicating proper care has been taken during maintenance (Photo 23). Overall, the instrumentation and control systems and instruments have been well-maintained and are in good working order.

Photo 22. Equipment is clean and in good working conditions

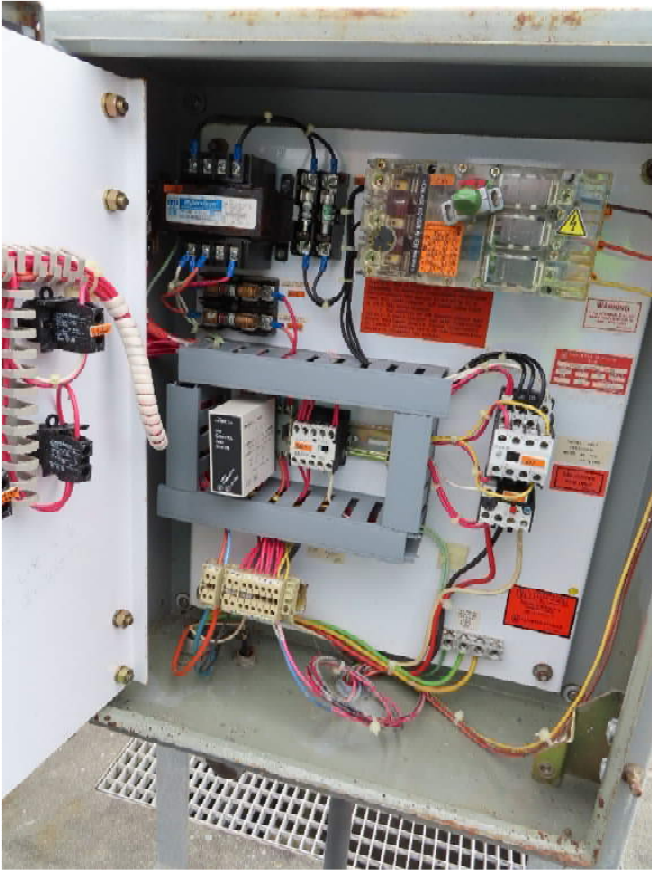
Photo 13. Control panels are clean and in good conditions

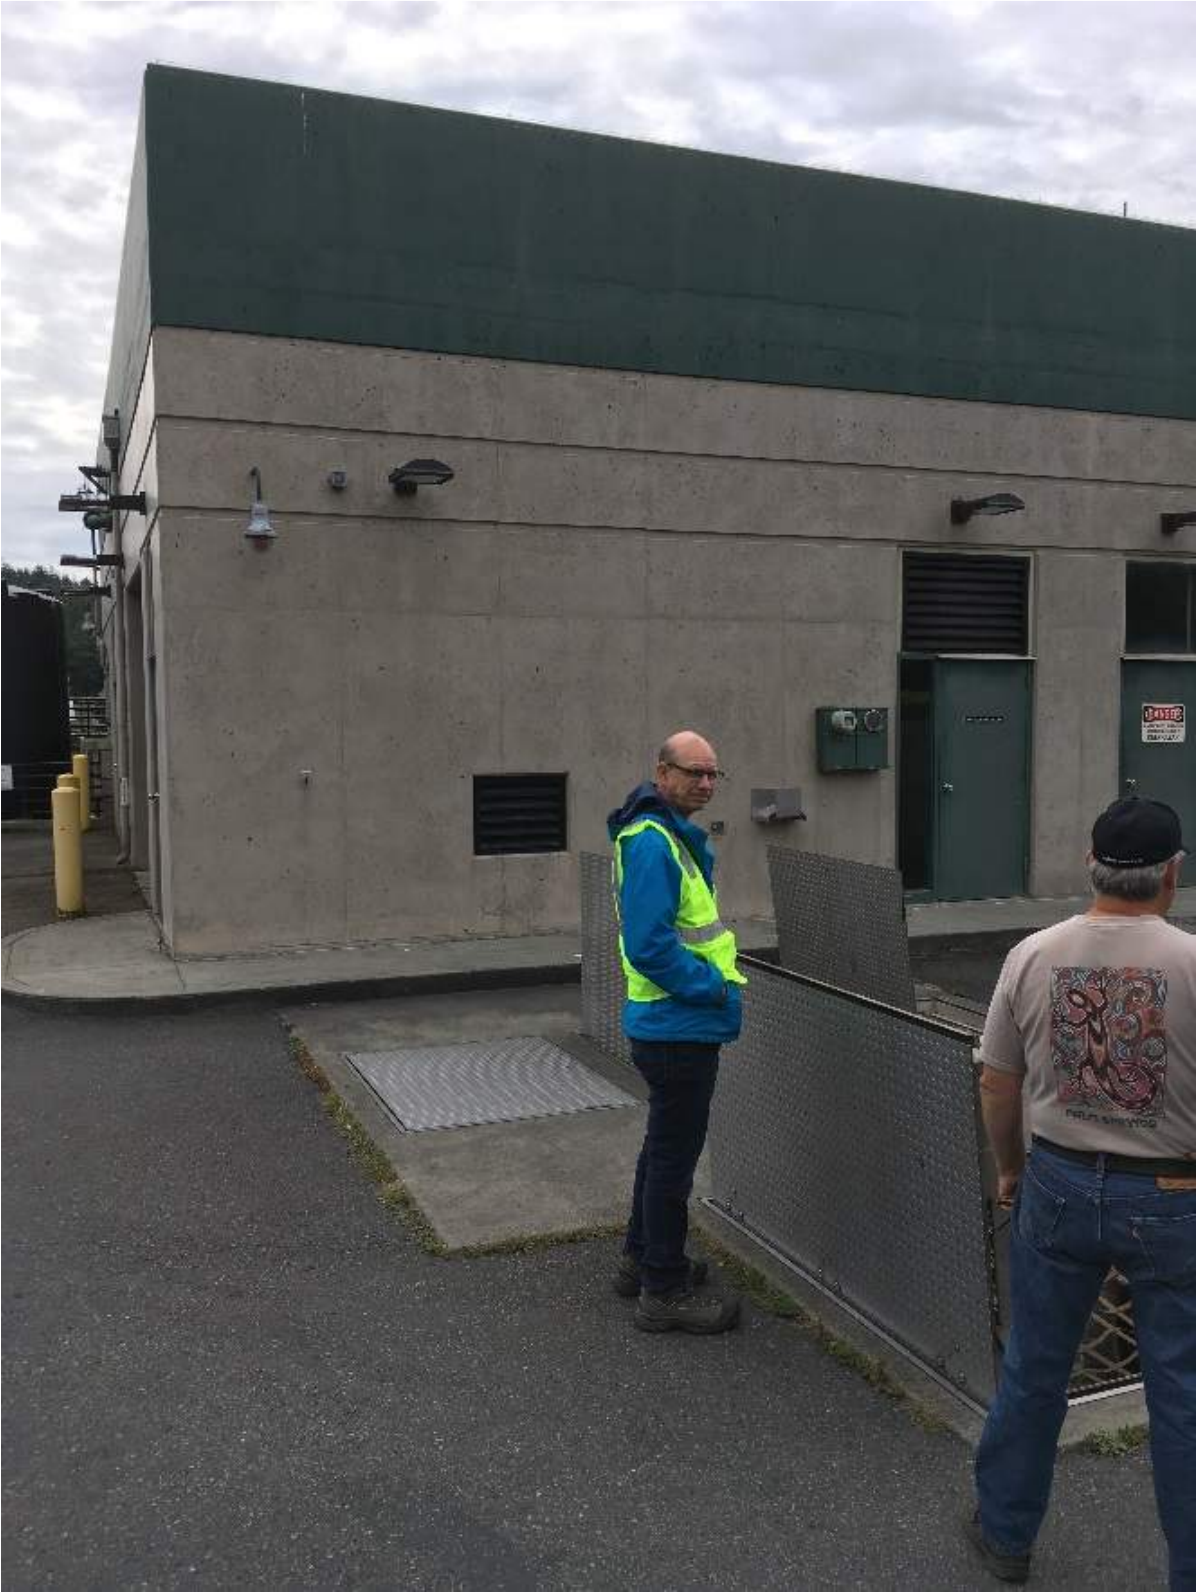
Photo 49: Influent Pump Station Pump Around Discharge to Pass Over Building Parapet

In order to accomplish the bypass pumping around this influent pump station, there will have to be a pump around set up for the wetwell. There is a manhole across the drive from the pump station where temporary pumps could draw suction. (Photo 48). The pumps could discharge thru a hose across the drive and then into a rigid pipe to carry the sewage up to the Headworks Building roof, discharging into a headworks open channel. (Photos 49 and 50). This pump around could last for one month in order to accomplish the coatings prep, concrete repair and new coatings process. During this time, access to the plant offices and lab, sludge cake loadout, and the screenings and grit dumpster would have to be maintained. Possibly a lightweight truss bridge could be constructed to carry the temporary pump discharge above truck height across the drive.

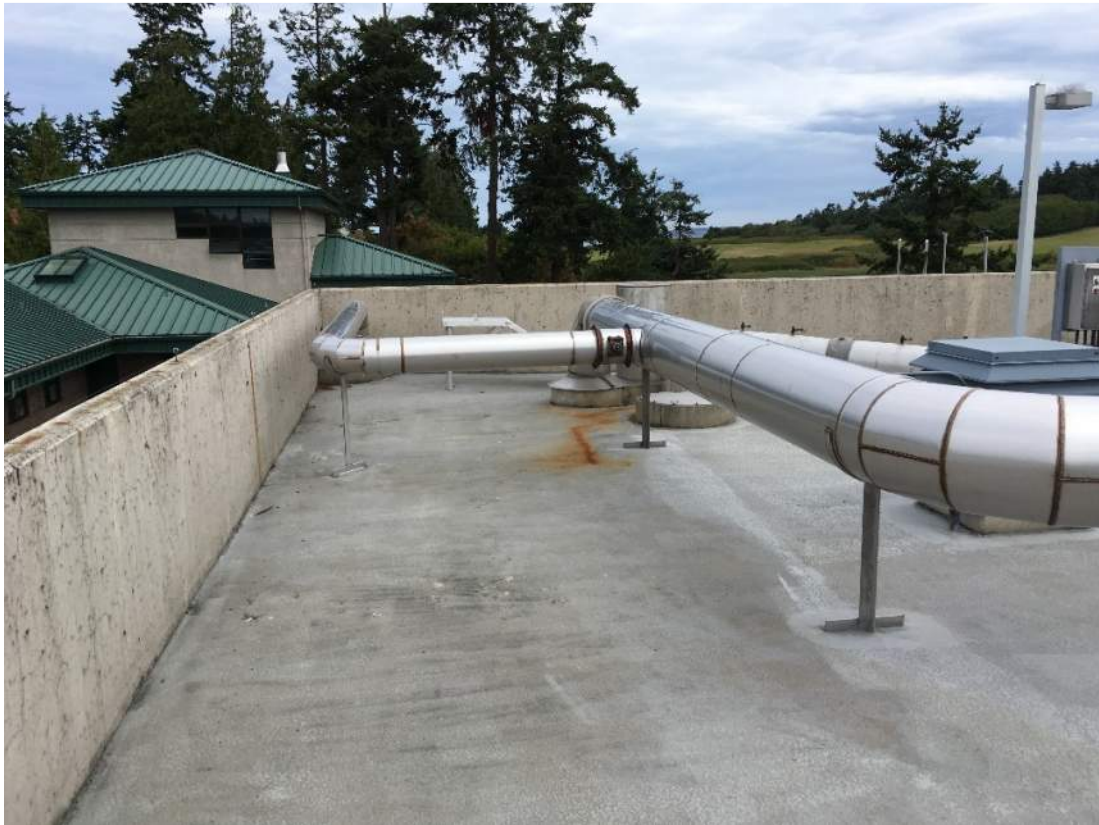
Photo 50: Route of Pump Around Over Parapet to Channel Upstream of Bar Screen and Odor Control Duct Down to Influent Pump Station.
