City of Port Townsend Pool Study

Risk Analysis and Life Cycle
Comparative

City of Port Townsend
Pool Study

Risk Analysis and Life Cycle Comparative

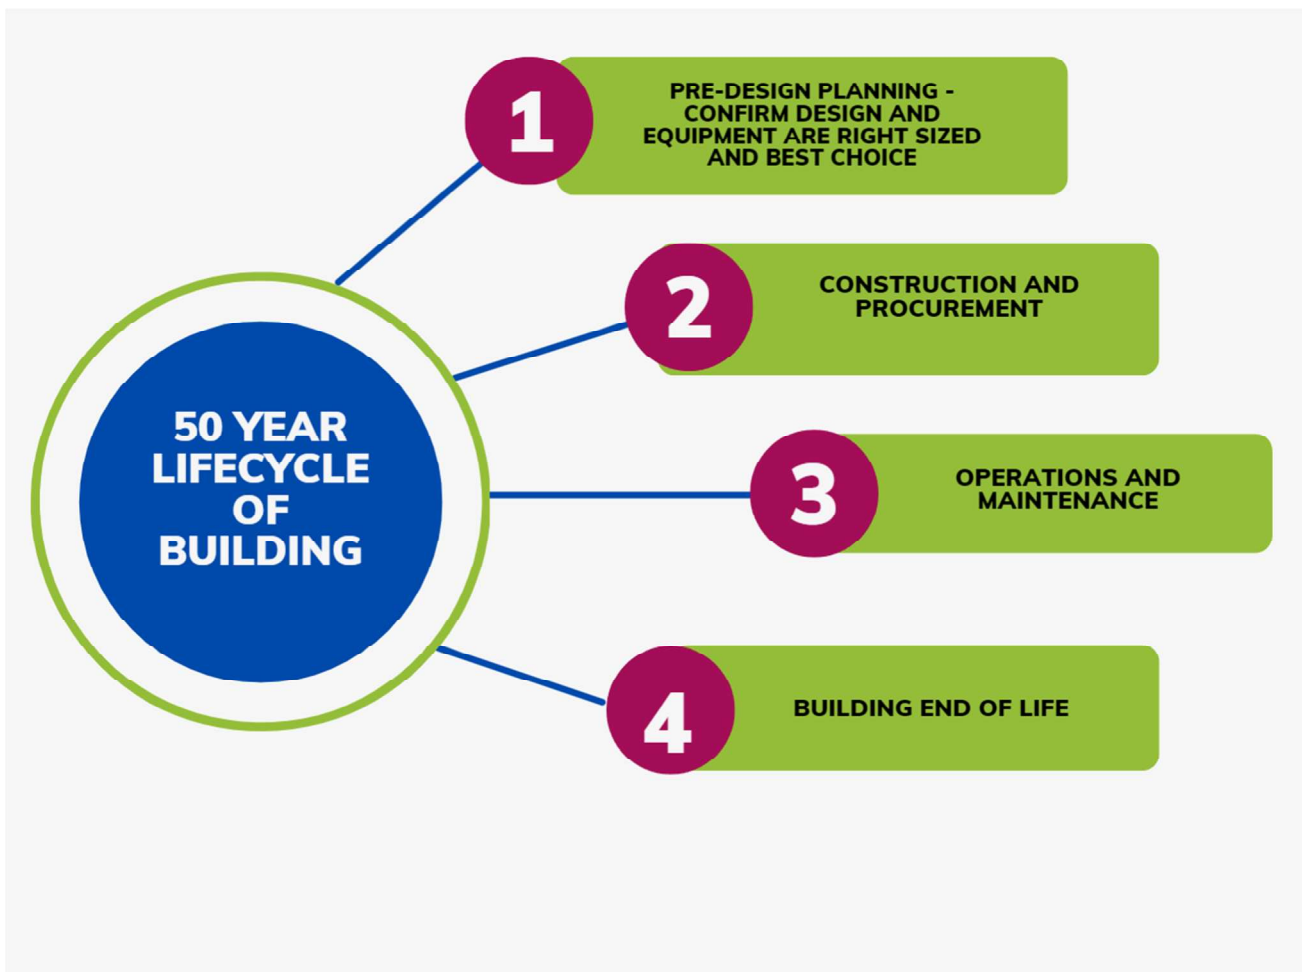
A lifecycle cost analysis considers multiple factors to determine a functional comparative. Each of these elements below are considered to determine the lifecycle of a building.

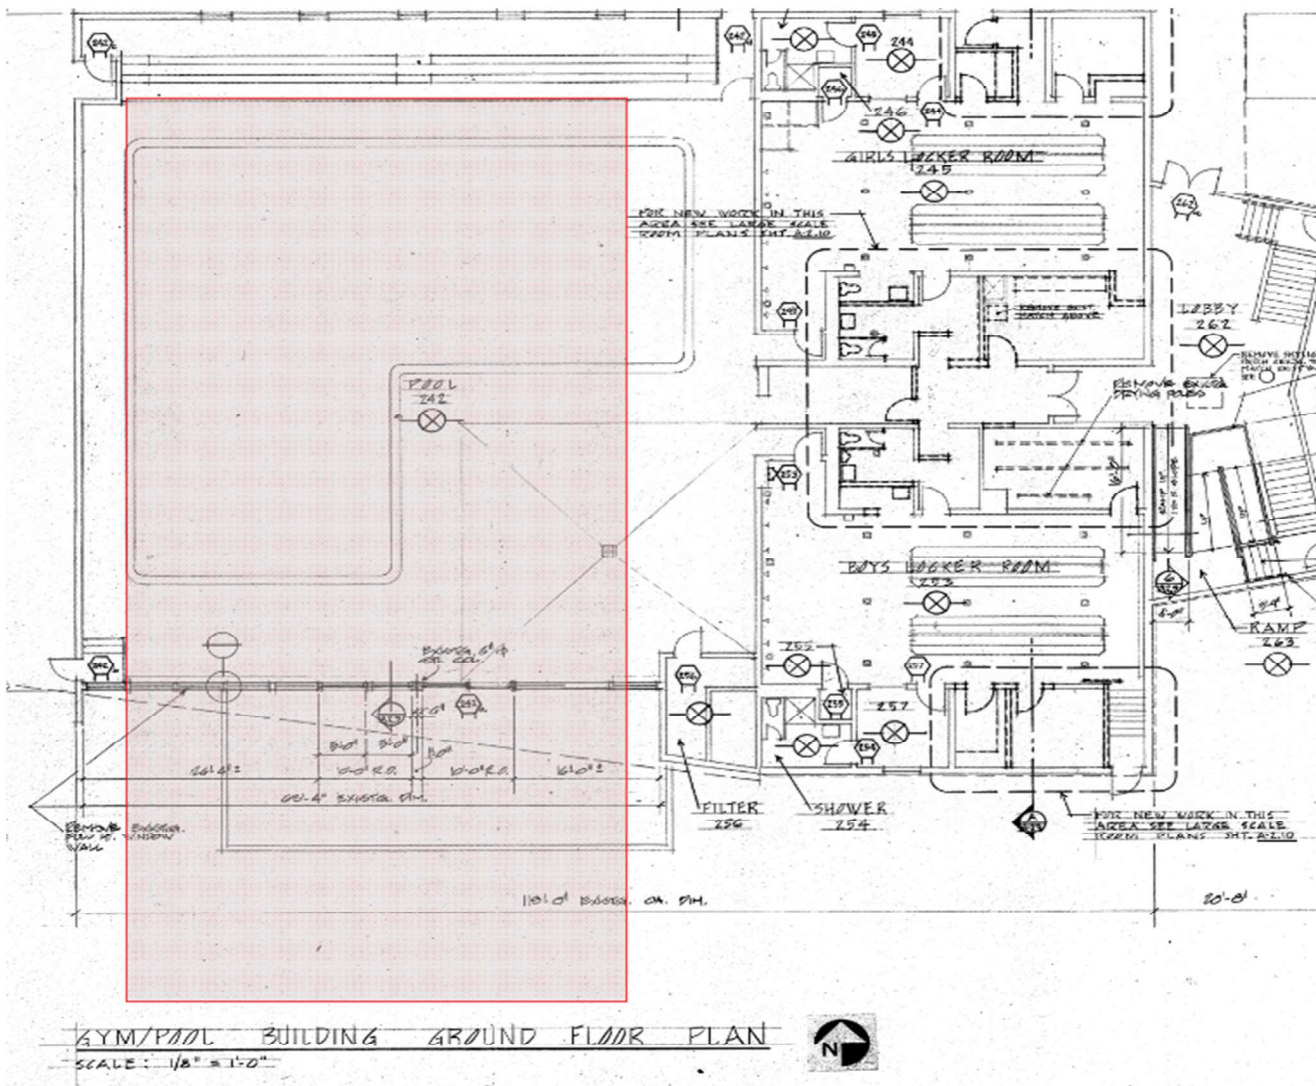
The existing YMCA pool was originally constructed as an outdoor pool. From the documentation provided, the pool was enclosed with what appears to be a tilt- enclosure and membrane roof system. The building is located on Blaine Street with parking and a drive isle in front of the building. The building's entry is on the south side. For the cost study only the entry, locker room and natatorium are considered. The gym portion of the building was excluded. The cost study for the renovation provides a new competition pool by removing the existing pool and north natatorium wall to extend the structure and install a replacement pool. The space presumably does not include an activity pool or spa. The existing locker rooms and restrooms will be repaired and upgraded to meet ADA requirements, The acoustic panels that were painted over will be removed and replaced. There will be new mechanical and electrical systems, bleachers, and pool equipment. The sitework includes modifications to the parking and drive-isle to provide ADA access.

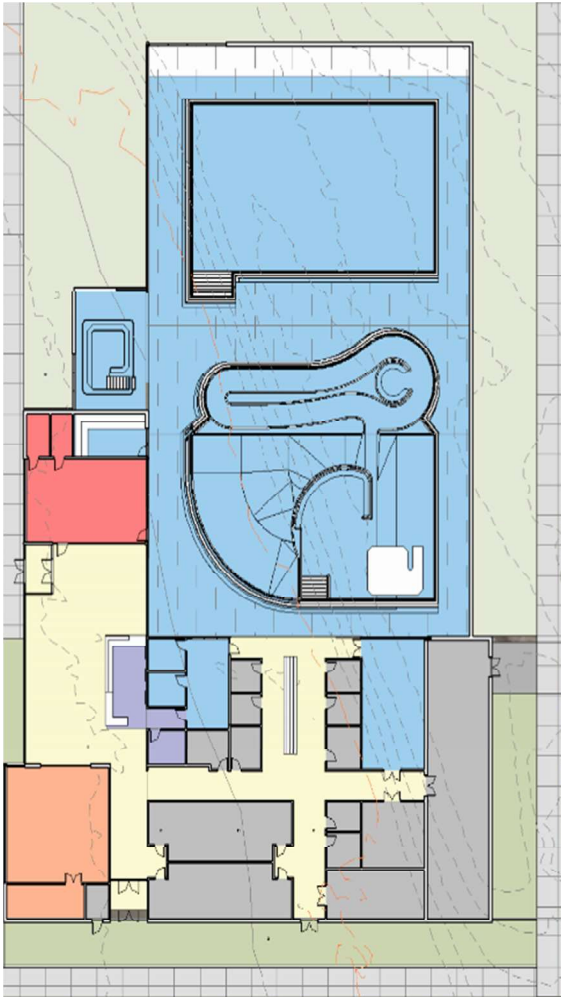
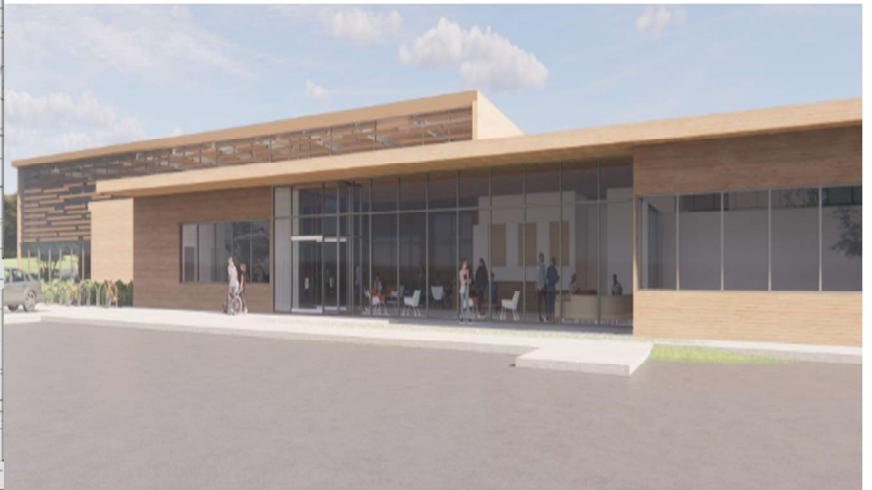
The New Construction facility was designed as a timber framed structure. The building construction location is shown to be on Blaine Street between the YMCA and the Recyclery. The building is planned for 27,900 square feet (SF) and includes a competition lap pool, an activity pool and spa. The additional build out program includes locker rooms, restrooms, mechanical spaces, office, and storage space. The sitework includes access paving, ADA ramps and a 47,000 SF parking area.

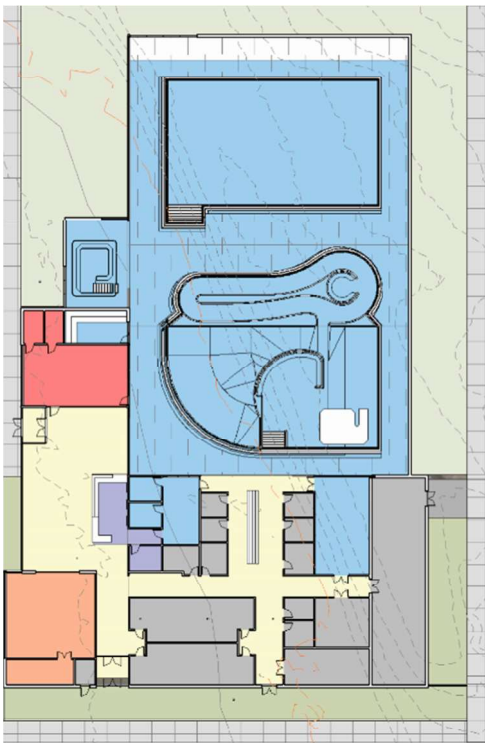
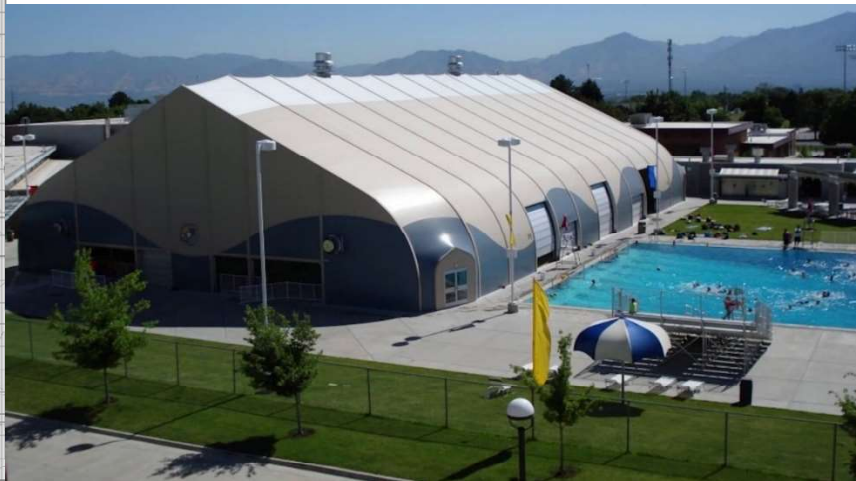
Using the design and location for the new construction pool and support areas, the building enclosure is a Sprung Structure. The building is 27,900 square feet (SF) and includes a competition lap pool, an activity pool and spa. The additional build out program includes locker rooms, restrooms, mechanical spaces, office, and storage space. The sitework includes access paving, ADA ramps and a 47,000 SF parking area.

The Sprung structure is a fully insulated system assembled on site. The structure is aluminum, and the enclosure is a membrane system. Sprung Structures only provides the enclosure system. The entire structure build and build out, pools and equipment are site built by a general contractor.

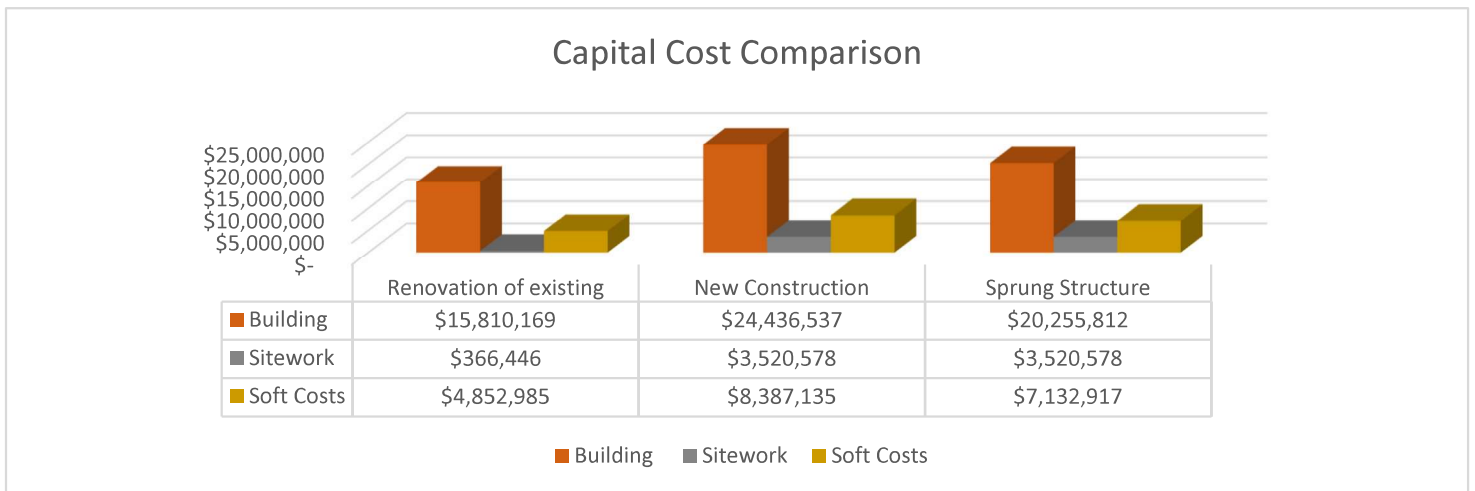
Capital costs are compared here considering first expenditures for renovation or construction. It does not include future expenditures for maintenance.

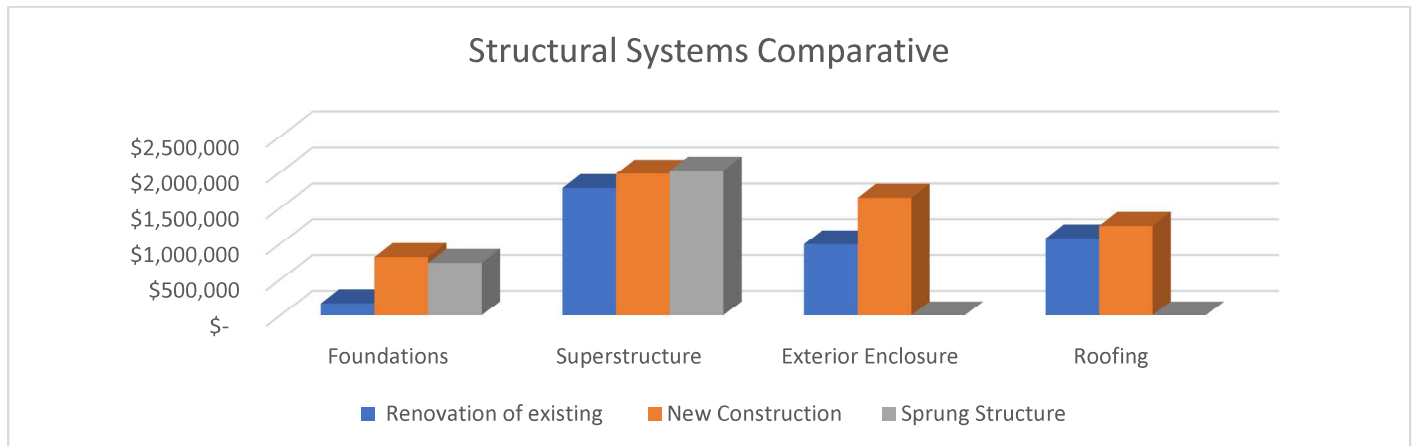
The primary difference between the three options for consideration is in the structural systems. The renovation of the existing building has limited improvements compared to the new construction with all new surfaces. It is important to note that the enclosure and structural system for the Sprung Structure is included under the Superstructure cost since it is an all-inclusive structural system.

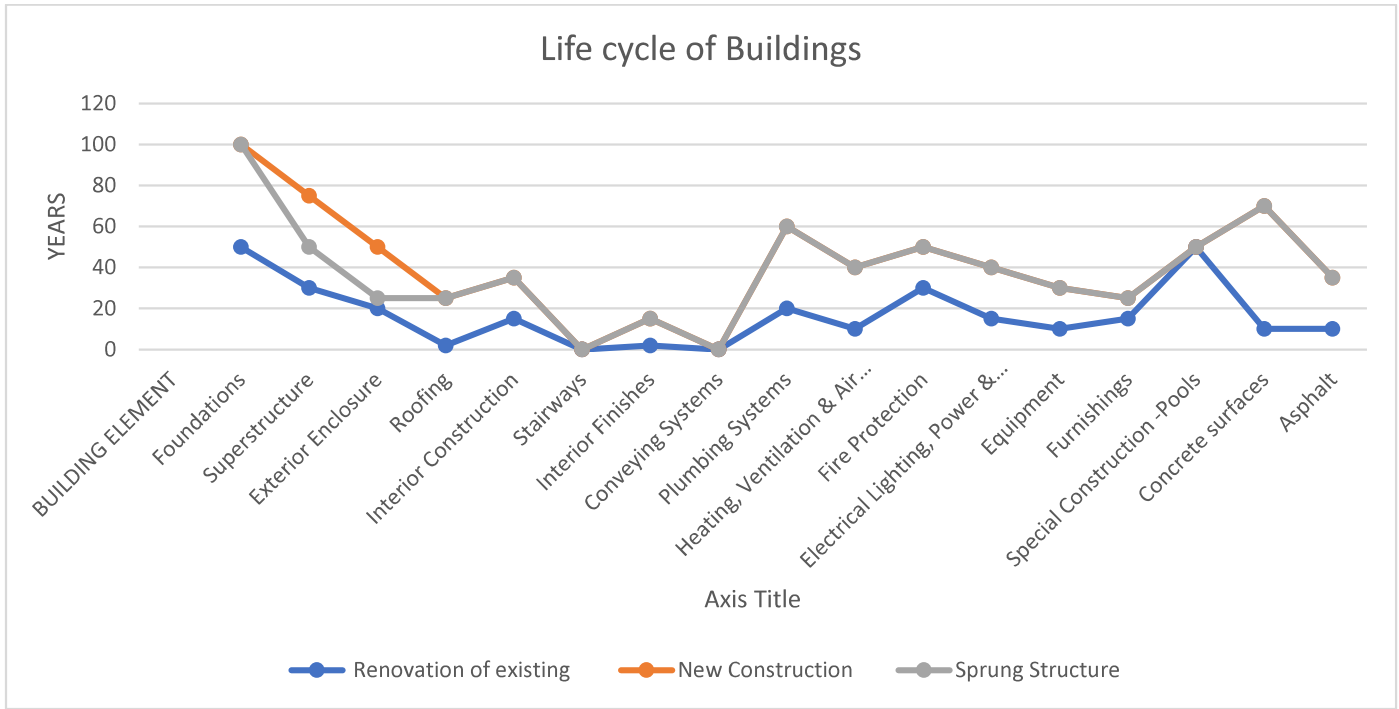
The life cycle of the new construction types follows a similar trajectory where the renovation shows a shorter lifespan on remaining systems.

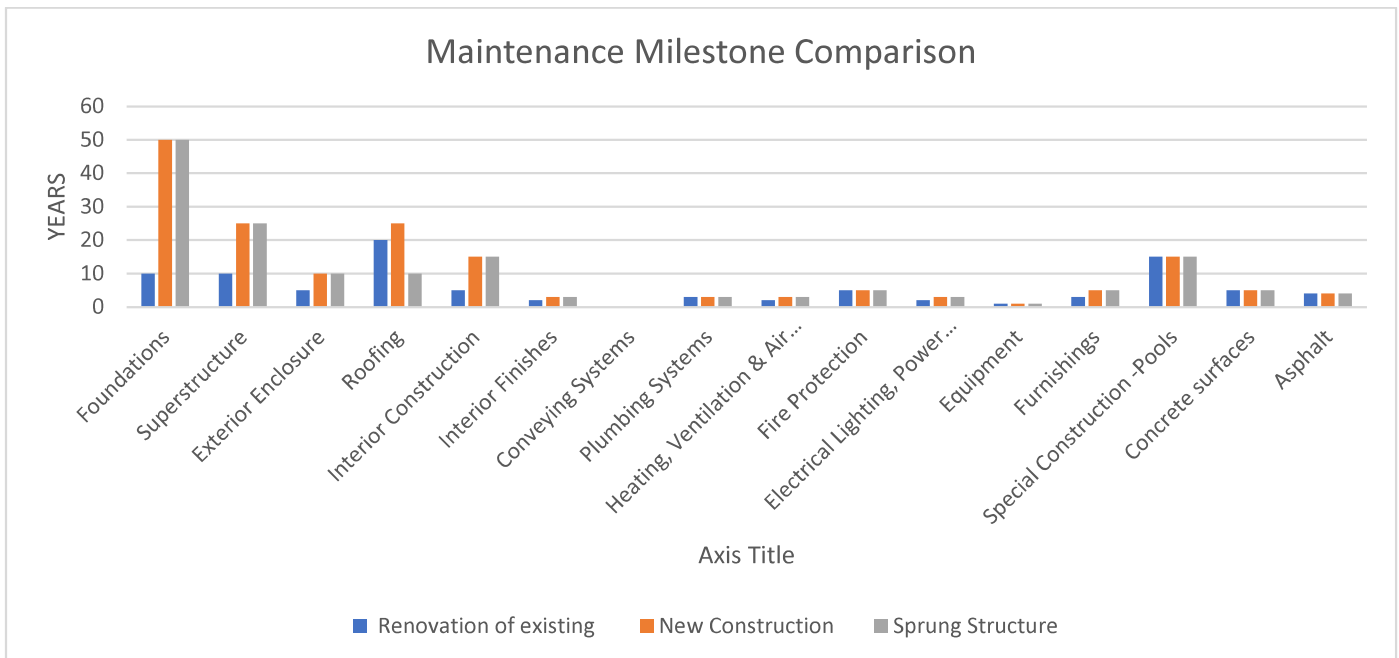
The maintenance milestone demonstrates the comparative durations for each system by building type. It is important to note that the most expensive systems, which include electrical, mechanical, and plumbing systems, should be regularly maintained for maximum efficiency.
