REPORT OF
FOUNDATION INVESTIGATION
TWO PROPOSED EARTH-FILL DAMS
LORDS LAKE
JEFFERSON COUNTY, WASHINGTON
for the
GROWN ZELLERBACH CORPORATION

The scope of this foundation investigation was intended to, (1) determine the nature of the soils underlying each dam site and the borrow areas, (2) determine if seepage at either site would require special consideration, and (3) provide general recommendations for design and construction.

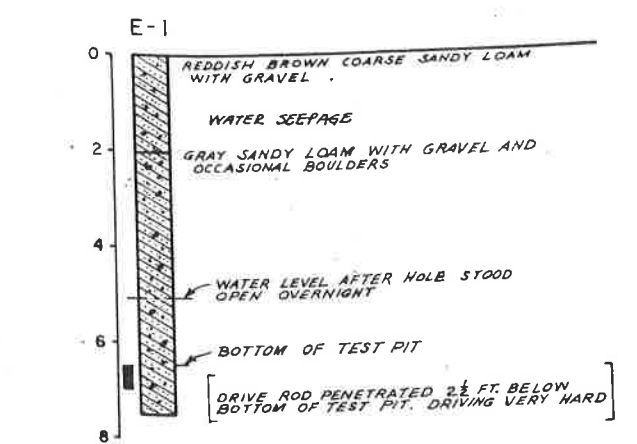
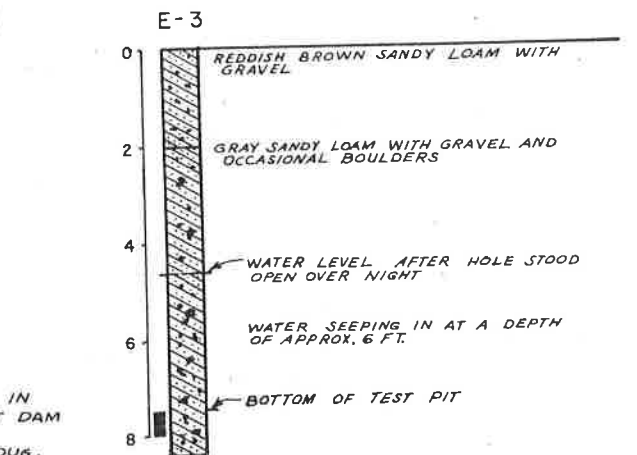
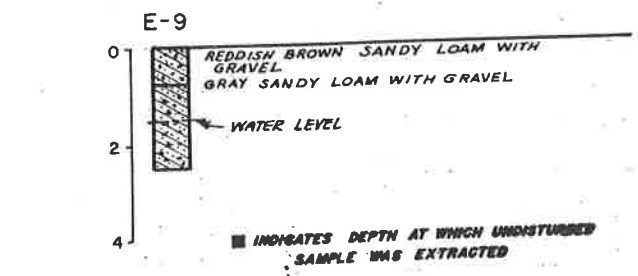
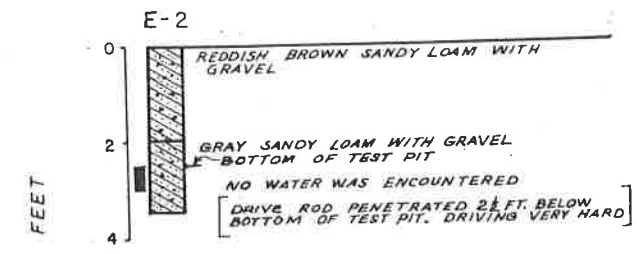
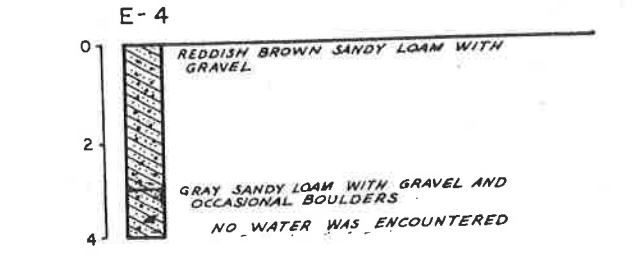
LOG OF TEST PITS

EAST DAM SITE

penetration of two and one-half feet below the bottom of the pits. In both instances the rods drove with difficulty, indicating that no soft soils existed within the depths penetrated.

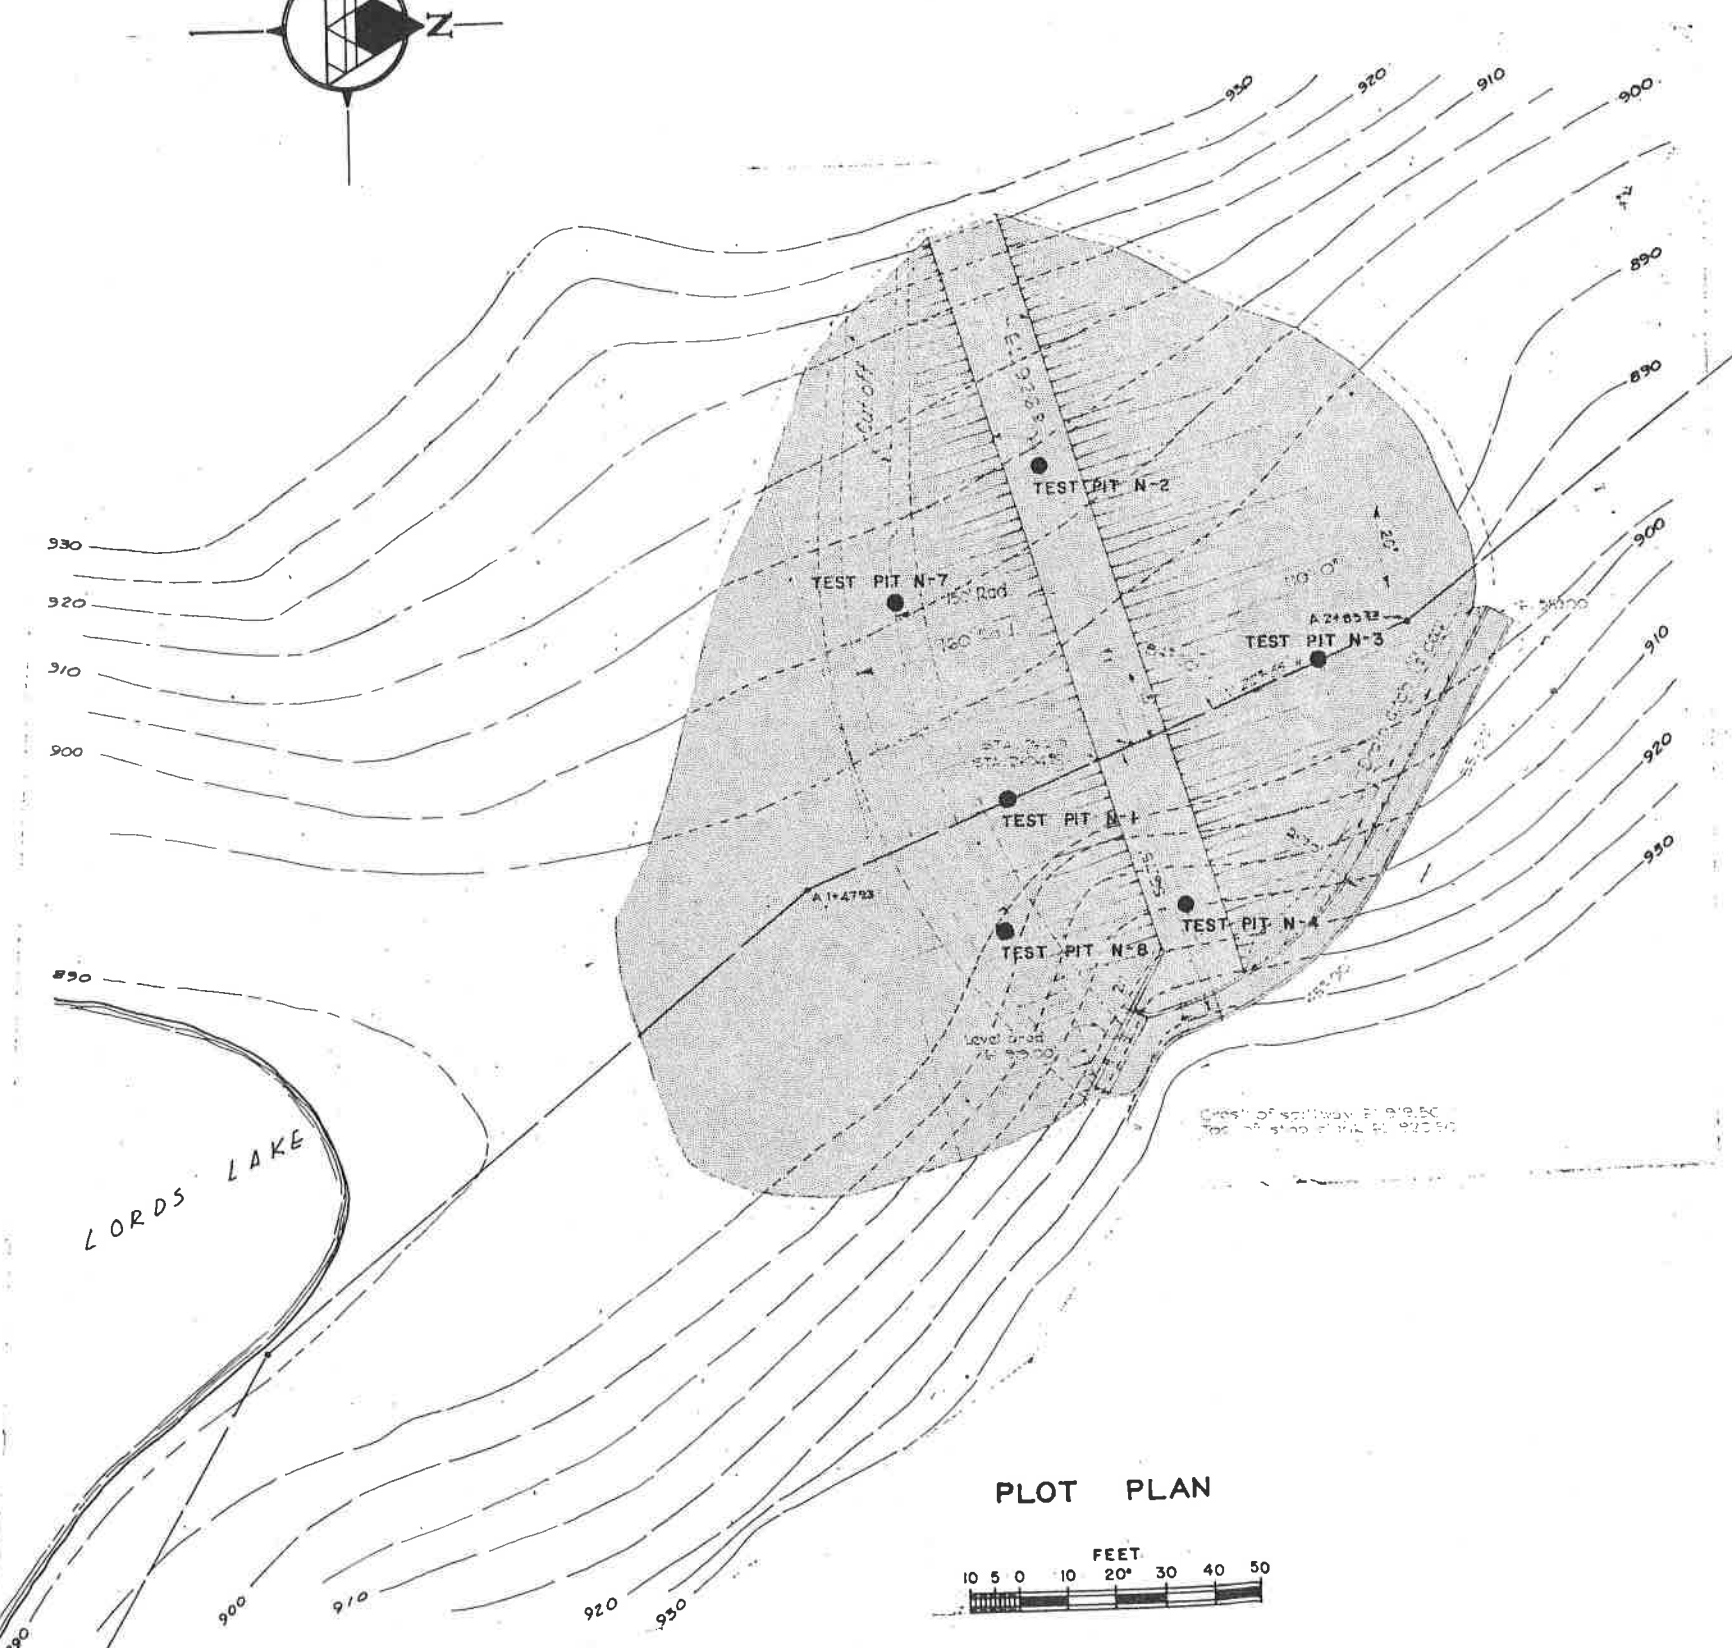
PLOT PLAN

TEST PIT N-6
● (APPROX. LOCATION)

TEST PIT N-5 (APPROX. LOCATION)

REFERENCE: DWS. NO. 570-A-6 ENTITLED
"NORTH DAM" 3963 BY JOHN W.
CUNNINGHAM & ASSOCIATES
DATED: JAN, 1966

Test pits N-5 and N-6 were located nearly 200 feet North of the proposed dam site. The soils encountered in test pit N-5 were similar to that in the pits within the area of the dam. In N-6, about 75 feet North of N-5, gravel and broken rock were present but the matrix was sandy clay and sandy clay loam and was much more impervious than the silty loam matrix in the other pits. The surface soil was dark brown loam with vegetation. Underlying the

Two test pits, N-5 and N-6, were located to the north of the proposed North Dam site. The soils in pit N-5 were similar to those found in the immediate vicinity of the dam. In pit N-6 the soil matrix was sandier and contained clay. There were fewer boulders and large cobbles in the area of this pit and water seeped in quite slowly. Due to the clay, the soils in this area were much more impervious than those at the proposed site. Since the coarse sand and broken rock encountered in test pits N-1 and N-3 were not found at the location of N-6, it is our opinion that further investigation in this area is required. This additional information is necessary in order to make recommendations for the seepage restraining structures. We believe that the additional

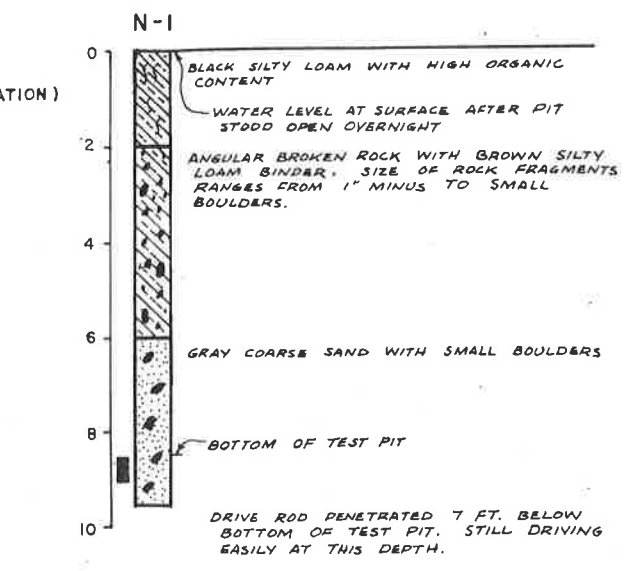
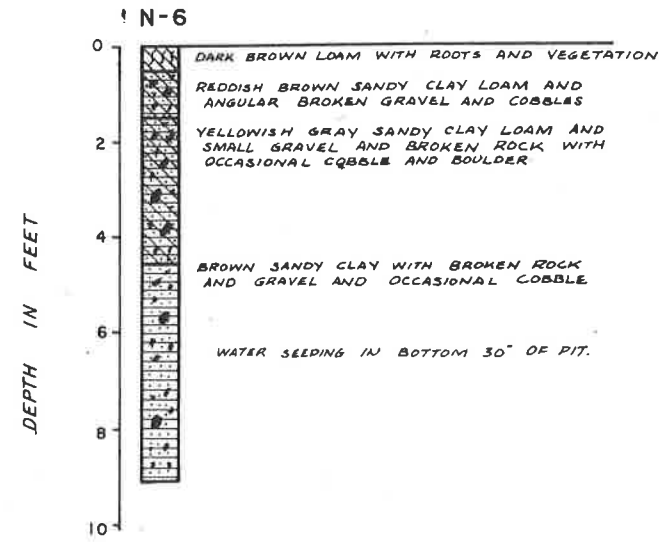
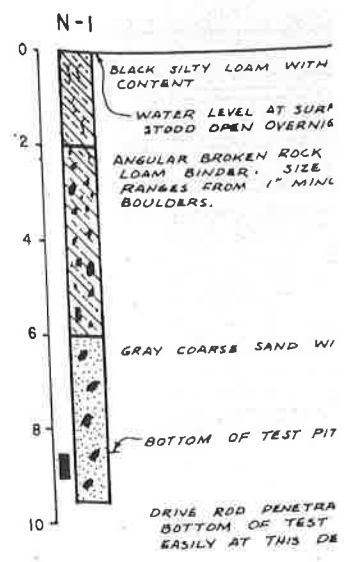
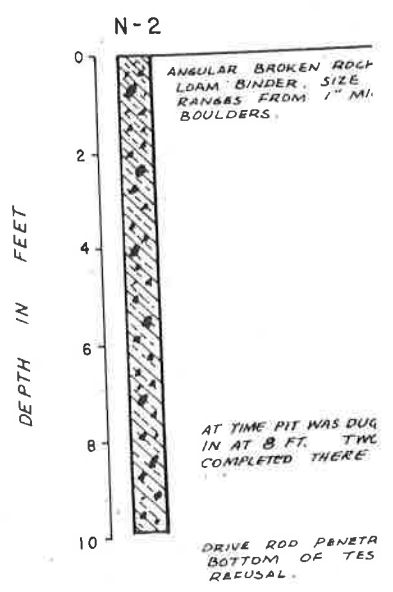
LOG OF TEST PITS

■ INDICATES DEPTH AT WHICH UNDISTURBED SAMPLE WAS EXTRACTED

NORTH DAM SITE

Two test pits were located on each side slope -- N-2 and N-7 on the West side with N-4 and N-8 on the East side. The logs of these pits were similar to each other. Angular broken rock with silty loam binder, similar to the formation occurring at a depth of two feet in test pits N-1 and N-3, was the only material encountered in the test pits on each side slope. Test pit N-2 was dug to a depth of ten feet and the drive rods penetrated an additional six feet before meeting refusal. No water was present in this pit at the time of our inspection; however, we were informed that water was flowing rapidly into the pit below a depth of eight feet when it was dug. The remaining pits in the area of the dam, N-4, N-7, and N-8 were each approximately three feet deep. No water was encountered in N-4 and N-8 but N-7 was terminated due to a rapid flow of water from the up hill side. A drive rod penetrated ten feet below the bottom of pit N-4, driving easily all the way and meeting no refusal. At test pit N-8, the drive rod penetrated three feet below the bottom and met refusal, presumably on a boulder.

The soils at the North Dam site contain large quantities of broken rock and boulders. The matrix was predominantly silty loam and the formations were quite porous. Water flowed freely into most of the test pits dug at the north site but it was possible to keep the pits free of water by constant bailing. The presence of boulders and necessity of constant bailing made these pits difficult to dig. In test pits N-1 and N-3, there was a two-foot layer of

soft soil overlying the broken rock and silty loam binder. At a depth of six feet in each pit the formation changed to gray coarse sand and broken rock. It was impossible to dig these pits deep enough with the available hand equipment to determine the depth of this sand and rock layer; however, in pit N-1 drive rods penetrated to a depth of seven feet below the bottom of the pit-driving with ease all the way. In pit N-3 the drive rod met refusal, possibly a boulder, at four and one-half feet below the bottom of the pit. This sand and broken rock deposit could be localized as it was not encountered in any other test pit; however, the test pits and drive rod records for these pits on either side slope all terminated above the elevation at which this sand and rock deposit occurred in test pits N-1 and N-3. Based on the typical cross section for the dam and the contours on the Plot Plan, it is our opinion that seepage losses through this formation would be excessive if either the cut off wall did not extend below this formation or if an upstream impervious blanket was not provided. Consequently, recommendations as to the type and depth of seepage restraining structures can not be made at this time without additional subsurface information.

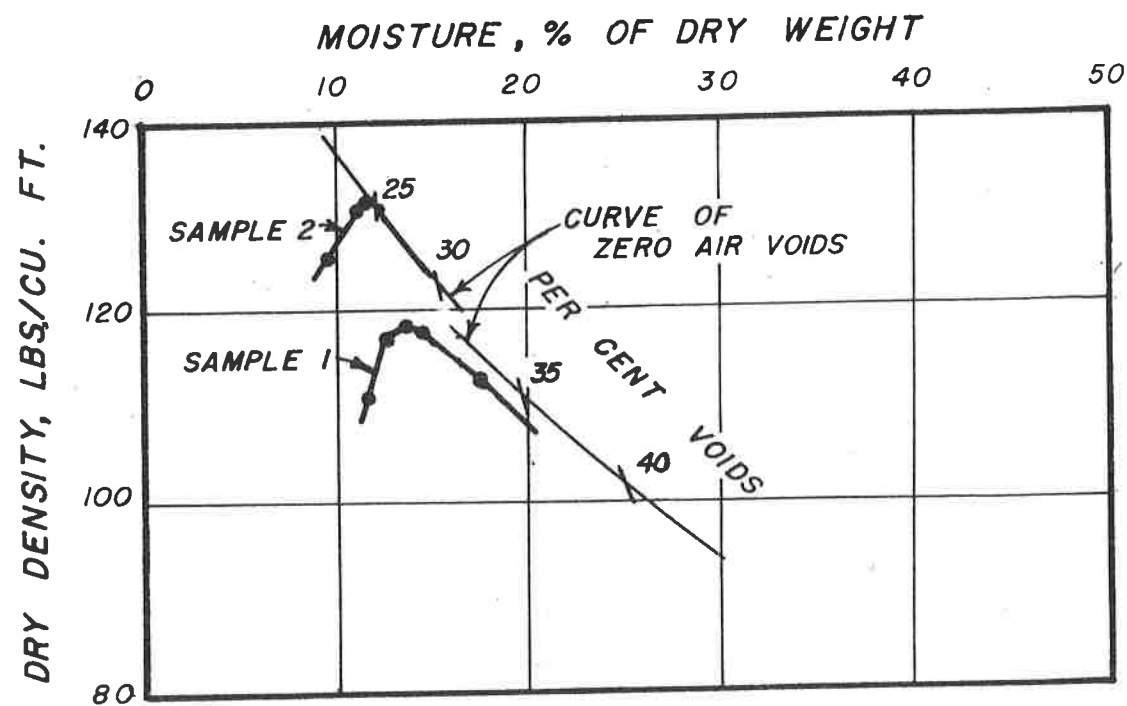
COMPACTION TEST CURVES

SAMPLE NUMBER	SOIL TYPE	MAXIMUM DENSITY	OPTIMUM MOISTURE
1	DARK BROWN SANDY LOAM WITH GRAVEL	118	13.5 %
2	GRAY SANDY LOAM WITH GRAVEL	131	11.5 %

Test pits in the borrow areas revealed that the soils in these areas were predominantly sandy loam with gravel and broken rock the same as was found at the East Dam site. Disturbed bulk samples of these borrow soils were taken to our laboratory for testing and analyses. Tests performed included compaction tests, sieve analyses and direct shear tests on samples compacted to 90 per cent and 95 per cent of maximum density. The methods used in performing the tests are described in Appendix A. The test results are presented graphically on Plate A-1, Compaction Test Data.

Compaction tests were performed on samples of each soil type encountered. The upper soil, dark brown sandy loam with gravel, had a maximum dry density of 118 pounds per cubic foot at an optimum moisture content of 13.5 per cent. The lower soil, gray sandy loam and gravel had a maximum dry density of 131 pounds per cubic foot at an optimum moisture of 11.5 per cent.

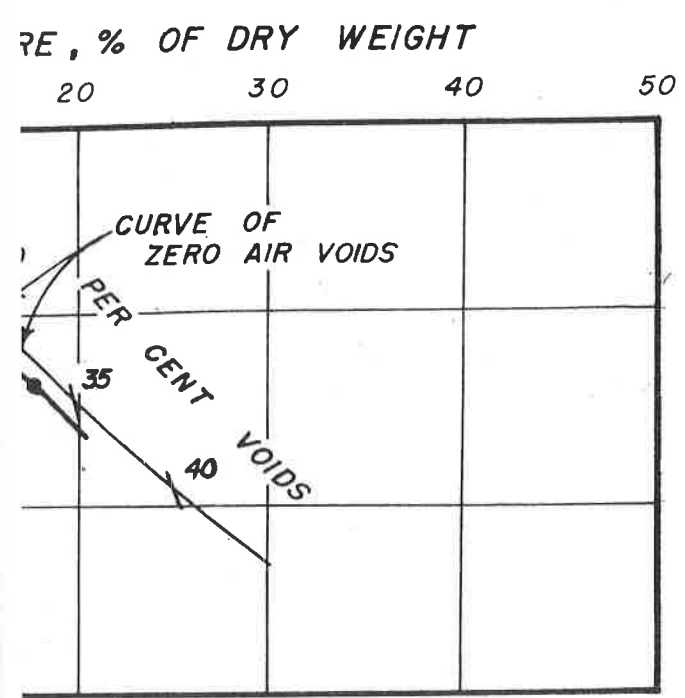
ON TEST CURVES

SOIL TYPE	MAXIMUM DENSITY	OPTIMUM MOISTURE
BROWN SANDY WITH GRAVEL	118	13.5 %
INDY LOAM GRAVEL	131	11.5 %
